ARCHITECTURAL REPORT KURCAJ BRIDGE

22644-001_ALB_EU4C_RFP_01 - "Provision of Consultancy for Design services for EU4CULTURE Project - Support for revitalization of cultural heritage sites and monuments affected by Earthquake in Albania."

1. GENERAL

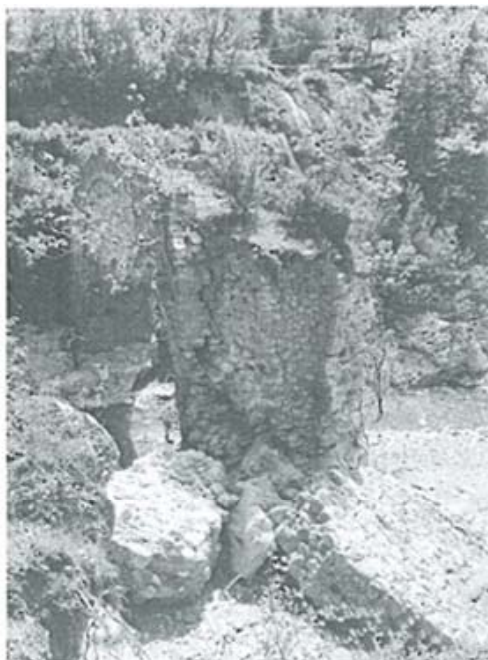
Fig. 6. Photo from the damages found in the project of 2018 (extracted from the IMK Archive)

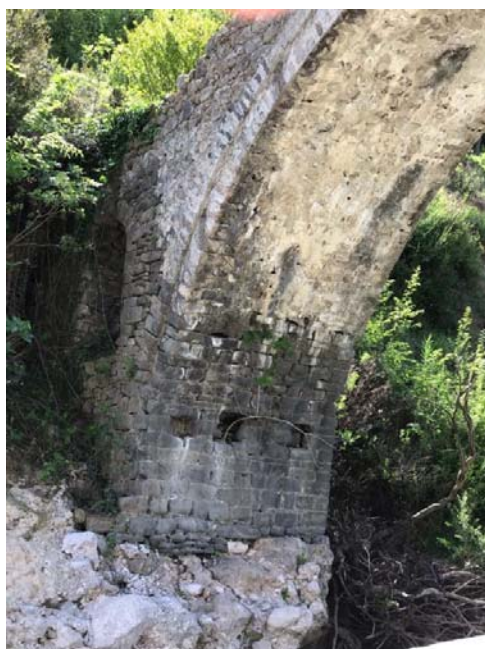
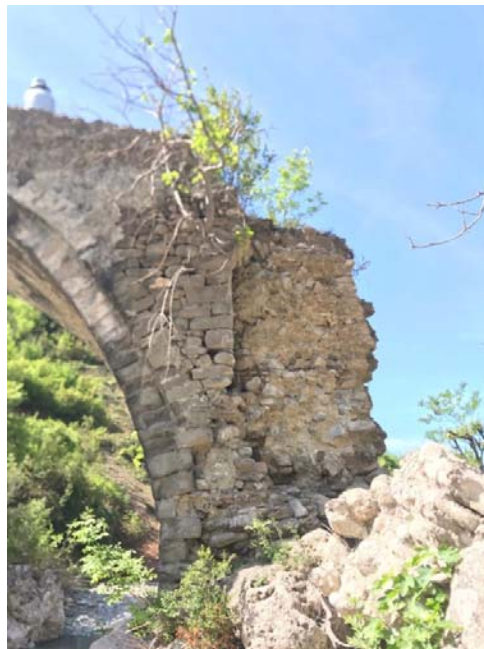
Fig. 14. Photos of the bridge, current condition: damages on the bridge's wings; stone wall decay; moss and humidity; deterioration of the vault stones due to reaction between atmospheric agents+humidity+river bank activity; inappropriate added layers (lime mortar) in an attempt to preserve the bridge.

The current condition of the bridge is problematic as there are several considerable deteriorations visible. Thus these should be addressed as soon as possible, so as to maintain the static balance of the structure.

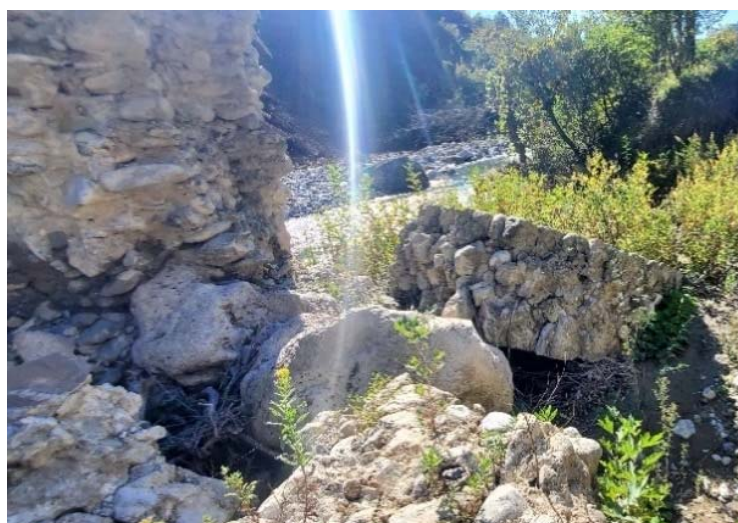
Fig. 16. Detached stone wall on the right side of the Kurcay bridge

- ✓ To restore the stone walls with the stitching technique using authentic materials: local stones.
- ✓ Replace any subsequent inappropriate material / additives / coatings with original and authentic materials to restore the bridge to its original condition. These materials should be local to be easily found (stones, cobblestones, etc.)

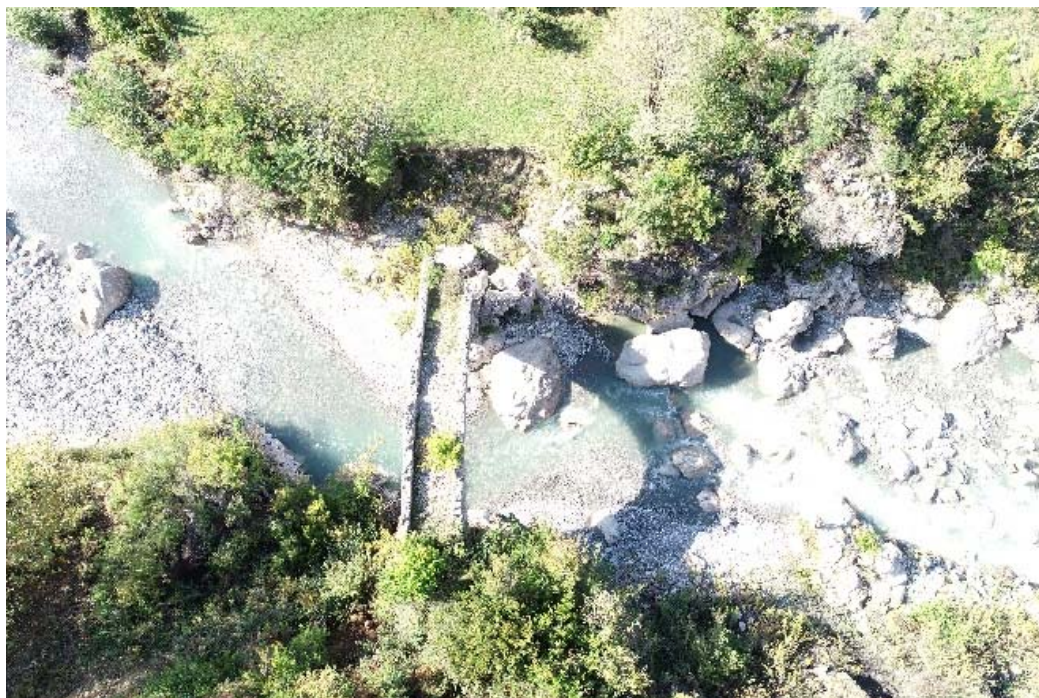
Fig. 18. Detachment of the Kurcaj bridge from the ground in the northern part

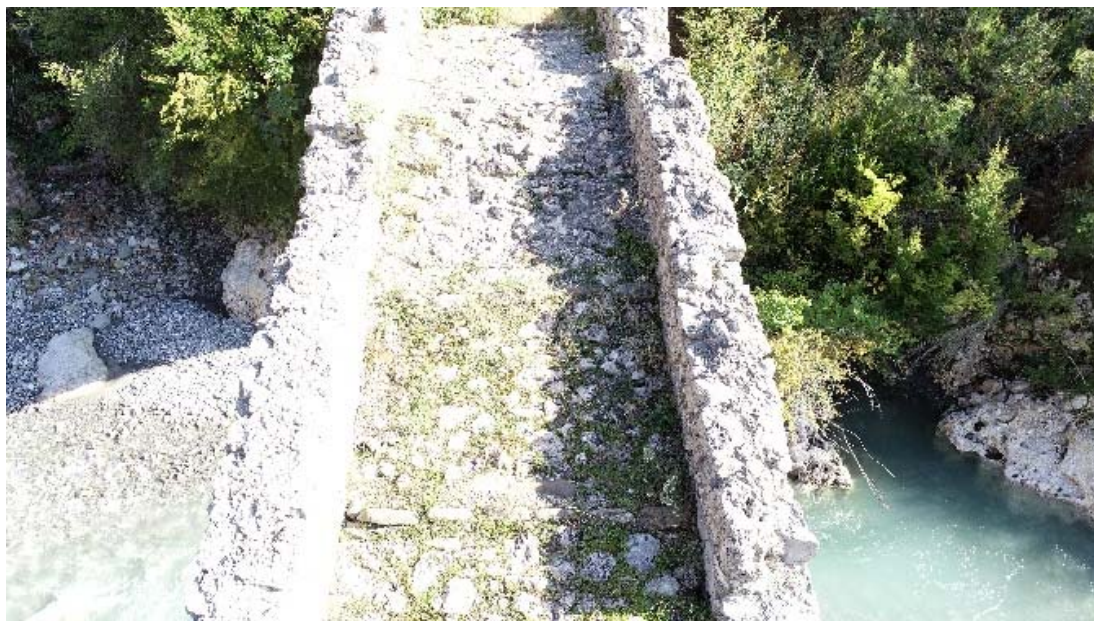
Fig. 20. Damage to the Kurcaj bridge

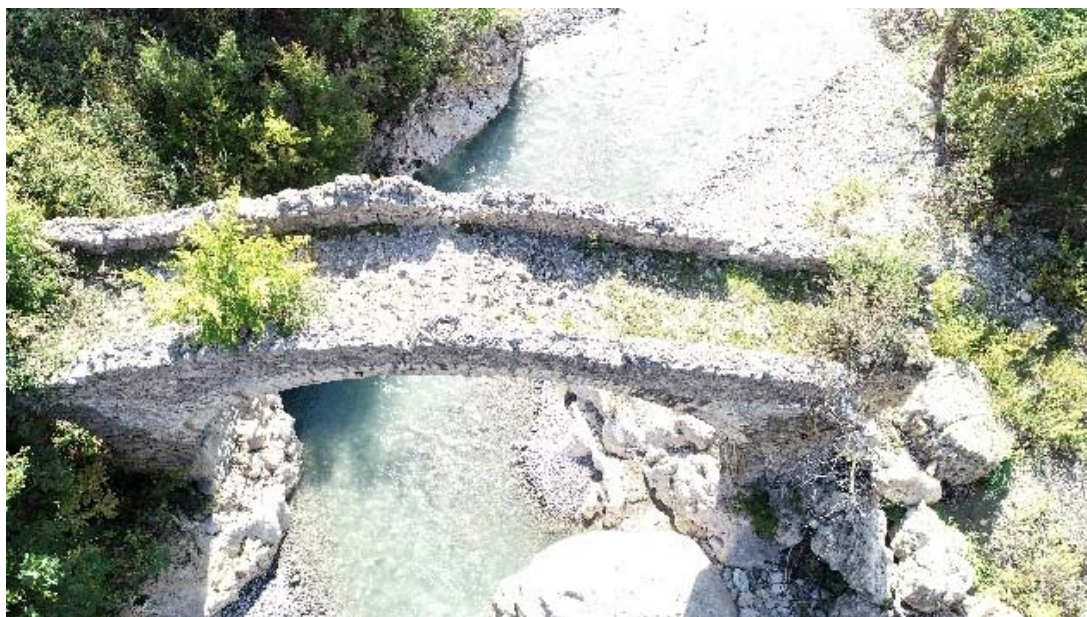
Fig. 21. Vegetation on the bridge and damaged parapet

- Restoration of the cracks by internal injection;
- Cleaning of the biological patina;
- Cleaning of the aggressive plants;
- Restoration of the stone wall with the stitching technique;
- Filling the joints with mortar;
- Removal of the innappropriately added volume/surfaces;
- Cleaning of stones and joints;
- Filling with stone wall;
- Consolidation of the parapet with local stones.

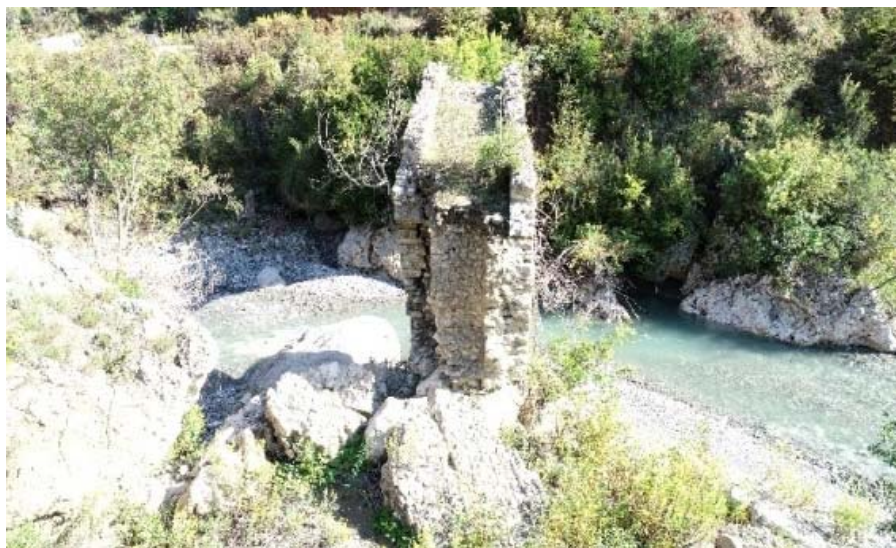
Fig. 22. Cracking on the inner wall.

- ✓ The cracks will be filled implementing the internal injection technique to avoid further disintegration of the mortar and detachment of bridge parts.

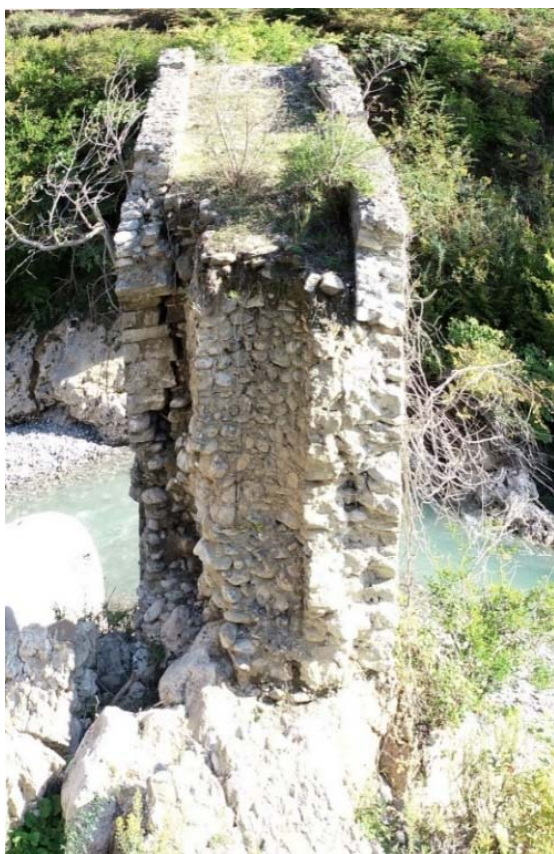
Fig. 23. Enclosure of the detached window.

- The river activity itself, which was modified at the moment when the left chamber was closed. The flow of the river meets the obstacle in it, exerting pressure on the structure, pressure which would normally be discharged symmetrically through the chambers.
- Low and high vegetation, aggressive plants, which have corroded the bridge materials by chemically interacting with them under the effects of atmospheric agents.
- Asymmetric discharge of the water pressure has damaged the foundation of the right wing of the bridge as well as the front walls or fillings between them, reducing the stability of the bridge.

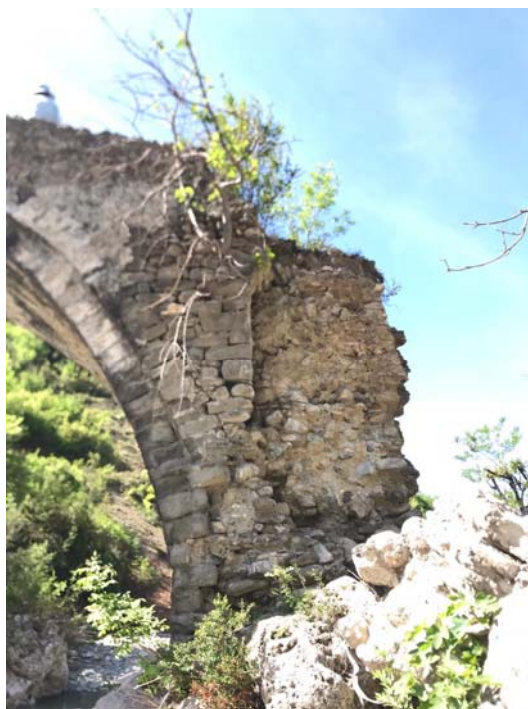
Fig. 26. Detached right wing of the bridge

The conservation and restoration interventions are related to restoring the bridge to its original state of construction. As it was found in the analysis of the existing condition, a part of the bridge has collapsed and will be rebuilt implementing traditional techniques, using traditional materials such as local stones and hydraulic lime mortar. The 6.11 m bridge on the left side and 0.68 m on the right side will be rebuilt.

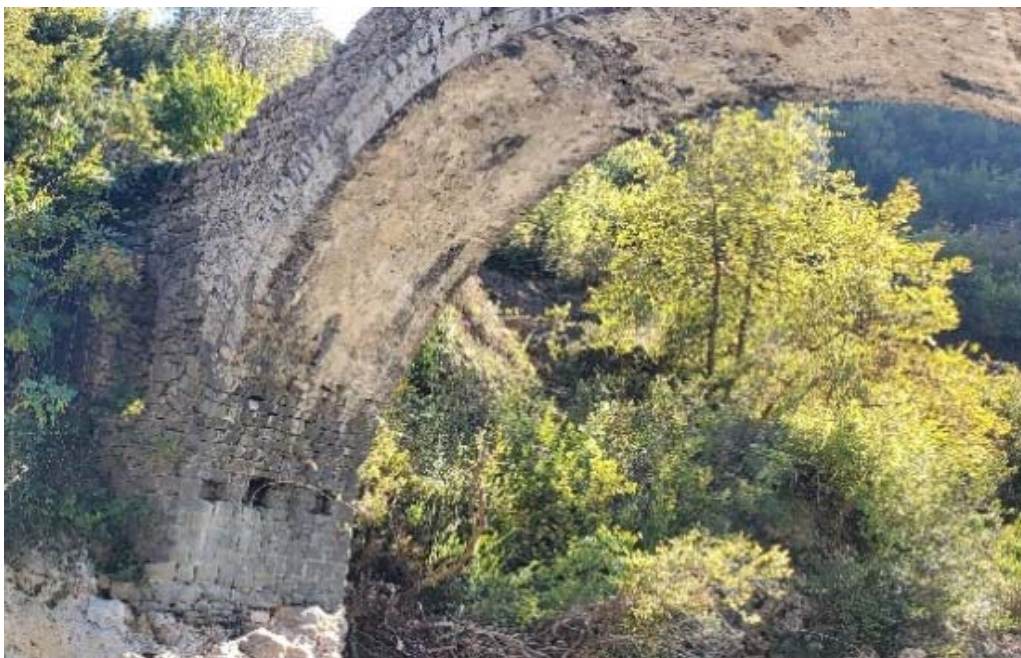
Fig. 27. Calcification and leakage of the mortar layer

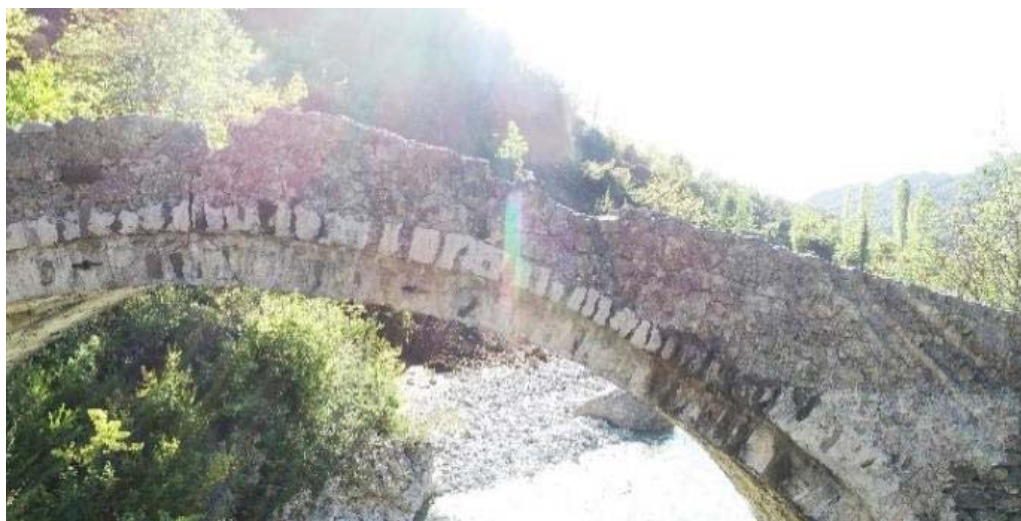
Fig. 28. Cracks on the vault

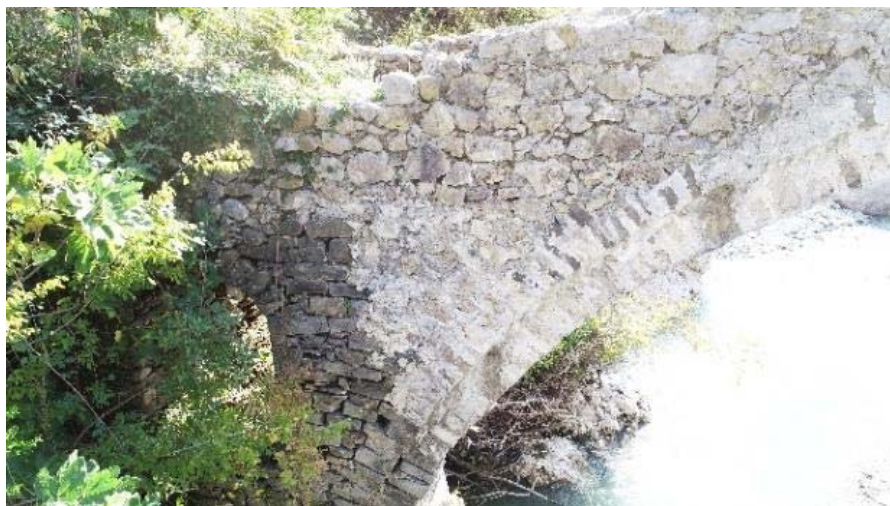
Fig. 29. Repairs during different periods of time adding inappropriate layers, which, by interacting with chemical and atmospheric agents have damaged the foundations of the Kurcay bridge

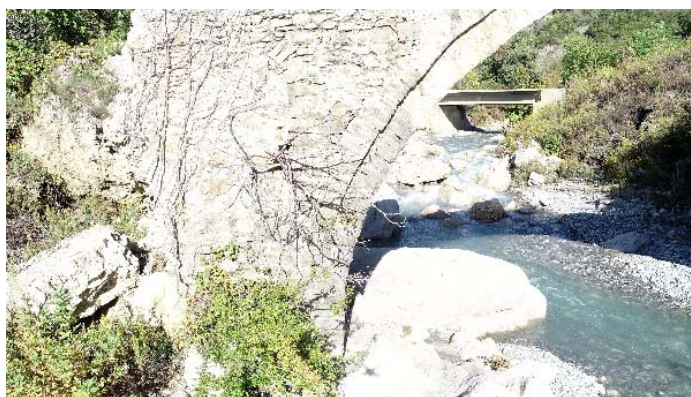
Fig. 31. Greenery on the side walls
