# THE ARCHITECTURAL REPORT HAMMAM, DURRËS

**22644-001\_ALB\_EU4C\_RFP\_01 - "Provision of Consultancy for Design services for EU4CULTURE Project - Support for revitalization of cultural heritage sites and monuments affected by Earthquake in Albania."**

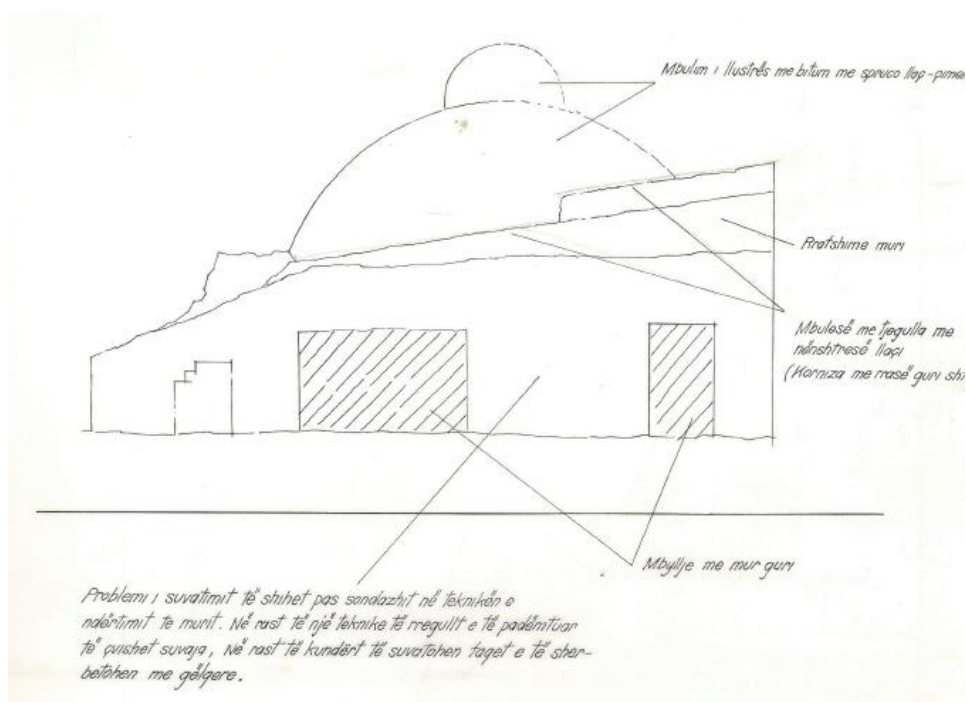
Figure 11. Documentation of the deteriorations, 1983

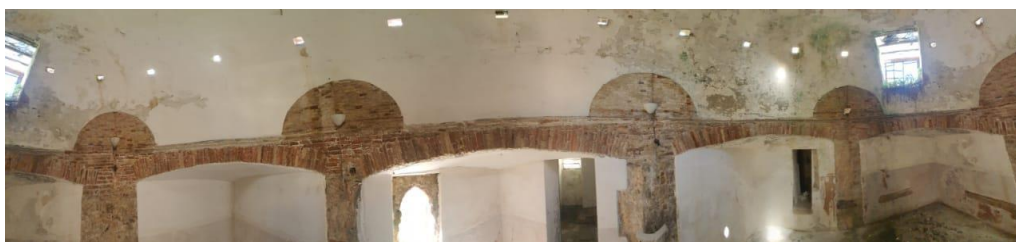
- o Mold and moisture : especially in the upper part of the hammam. This is due to the moisture present in almost the entire structure of the hammam. Moisture is present along the walls and in the vicinity of the floors.
- o Cracks in the stone masonry, as a result of its depreciation over time.
- o Moisture problems arising from lack of drainage or improper realization.
- o The growth of vegetation on the walls, windows and in the dome, blocking the view while at the same time damaging the walls. This is due to lack of maintainance for a long time, as well

Figure 31. Presence of moisture, mold and vegetation

- Removal of plaster skating of stone masonry, restoring the wall and joints.
- It is important to build a drainage system as a solution for excess moisture present in the hammam.

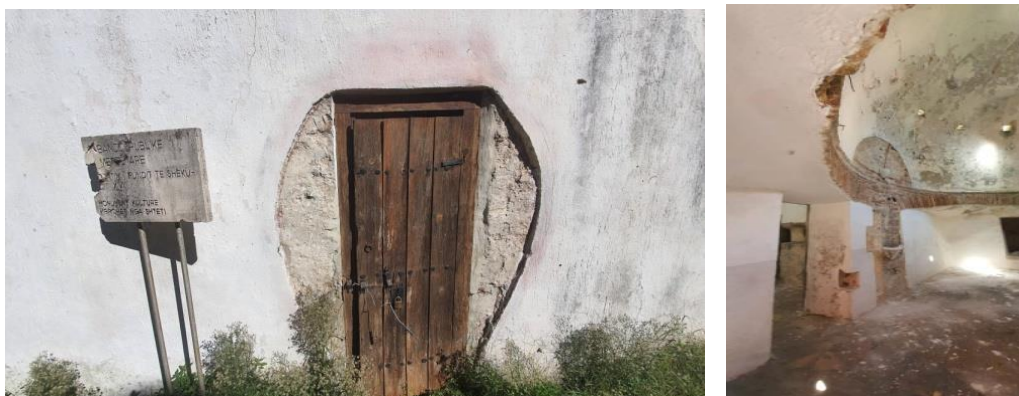
- Detachment and falling of the plastered finishing layer.
- Lack of windows.
- The building has only one main wooden entrance door. Internal cracks of the door are noticed, which are in the stone masonry and in the vault. In the main door of the hammam and in the part of the domes, deteriorations of the type of detachment and falling of plaster are noticed, as a result of the deterioration in time.

Figure 32. Entrance door deterioration; Detachment and drop of plaster

- Glass globes for lighting and ventilation chimneys will be replaced according to the original model
- Doors and windows will be replaced according to the original model with wooden material.

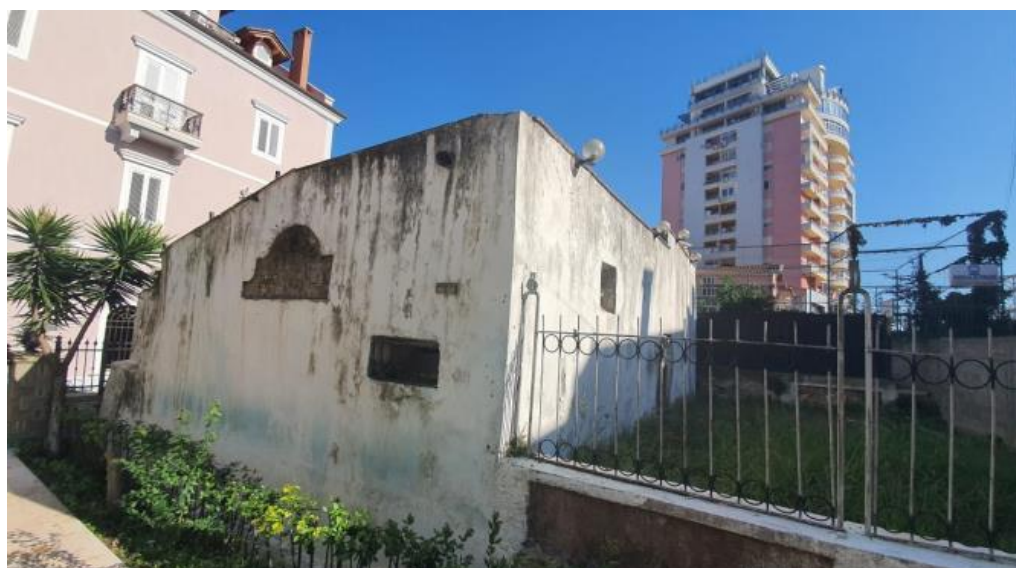
Figure 33. Presence of moisture and mold as well as deterioration of plaster on the facade
