ARCHITECTURAL REPORT THE ARCHEOLOGICAL MUSEUM OF DURRËS

22644-001_ALB_EU4C_RFP_01 - "Provision of Consultancy for Design services for EU4CULTURE Project - Support for revitalization of cultural heritage sites and monuments affected by Earthquake in Albania."

REPUBLIKA E SHQIPËRIË
MINISTRIA E KULTURËS

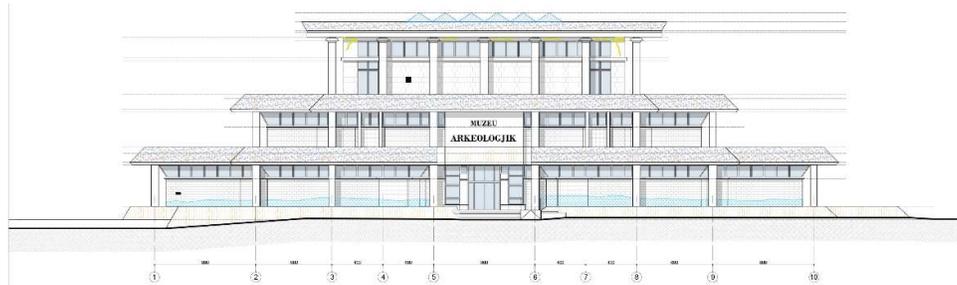
Fig. 17: The Southwestern acade of the museum, Current Condition

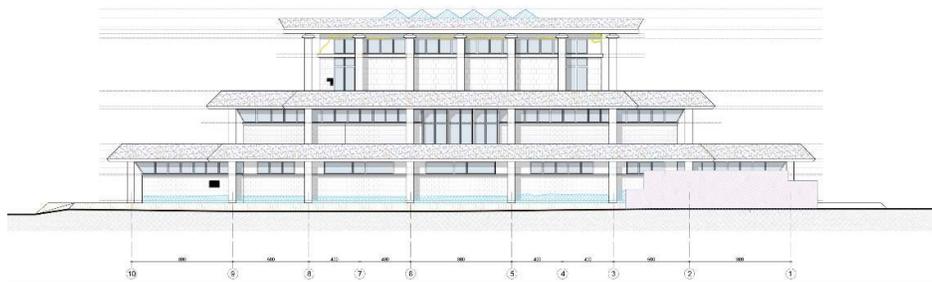
Fig. 18: The Northeastern facade of the museum, Current Condition

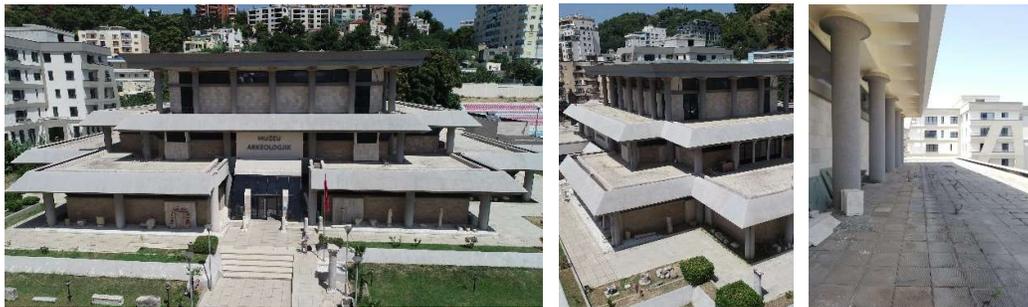
- Cement-based plaster as a finishing layer of the perimetral walls and acrylic plaster finish on the columns. Both have been observed to have suffered the phenomena of efflorescence: caused by the continuous presence of moisture, appearing as patches formed on surfaces of the walls, ceilings, floors etc. It may result in disintegration of the finishing layers off of the surface visible as well as structural deterioration due to the earthquake or damage/ detachment of the plaster finish, likely due to movement or as a result of external factors like impact or damp. Over time it has delaminated or become detached from the surface beneath.

- Concrete balconies that demonstrate the presence of the biological patina: the phenomena of the coloristic and chemical alteration of the building's external surfaces as a result of physico-chemical reactions caused by climatic factors and inorganic pollution.

Fig. 20: The facades' cladding materials, current condition

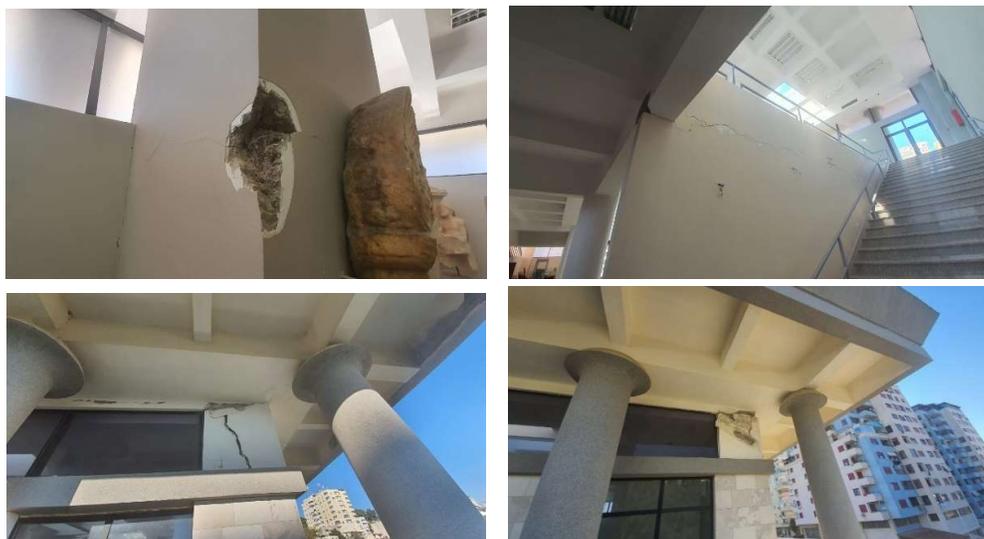
Fig. 22: Various deteriorations observed in the museum building, plaster cracks, damage to structural elements and plaster detachments.

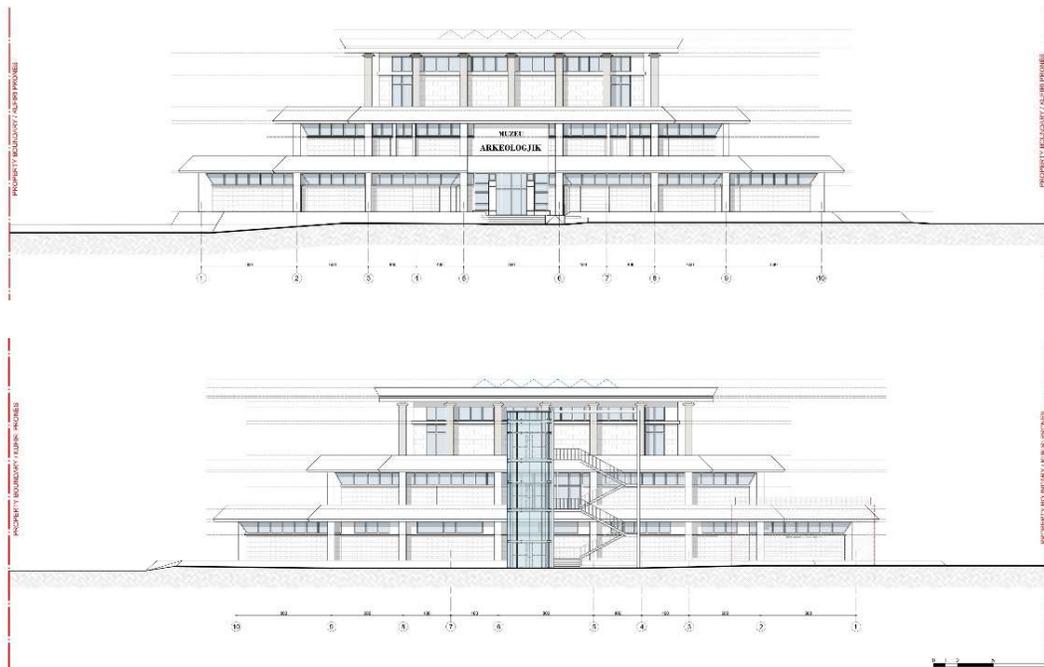
Fig. 45: Southwestern and Northeastern Facades, proposal of rehabilitation interventions.

- New construction of the gypsum wall on the ground floor. The wall separates the exhibition hall with the the fund and laboratories through a linear corridor. It has suffered cracks and fissures originating from the earthquake.
- Addition of a toilet for people with impairments next to the existing hydro-sanitary facilities.
- Mechanical cleaning of the vegetation in the front yard, as well as adding waterproof layer for protection and insulation and new finishing layers/tiles.
- Filling the floor with tiles wherever they are missing (eg of the floor right in front of the elevator doors in the ground floor).
- Replacement of the cracked glass in the façade windows.

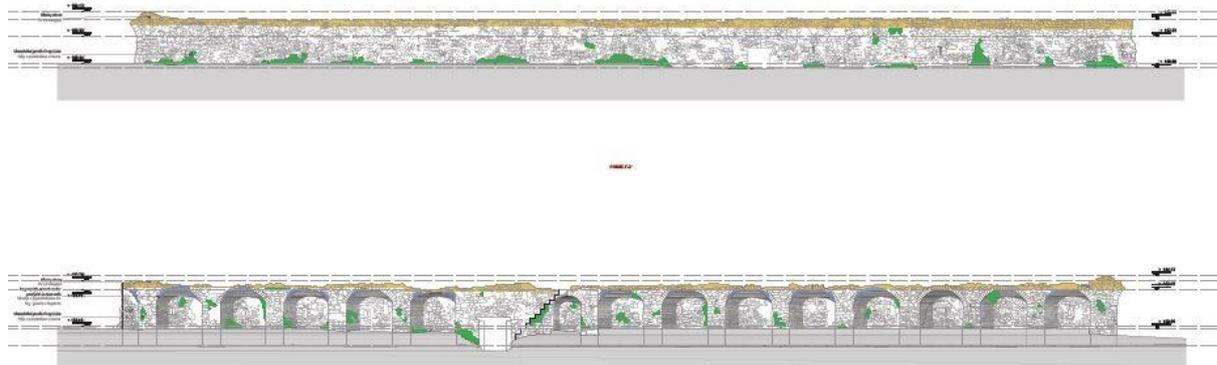
In the south-western façade, there are several damages noticed in the arches of the building, one of which is completely missing. At the entrance, the stone masonry has fallen masonry in its two final extremes. Moreover, there is moisture in the facade and the stairs have been deformed over time. The structure of the walls is completely missing in this facade. The head of the wall has deteriorated with time as well.

Fig. 18: The South-Western Wall (Current Condition)

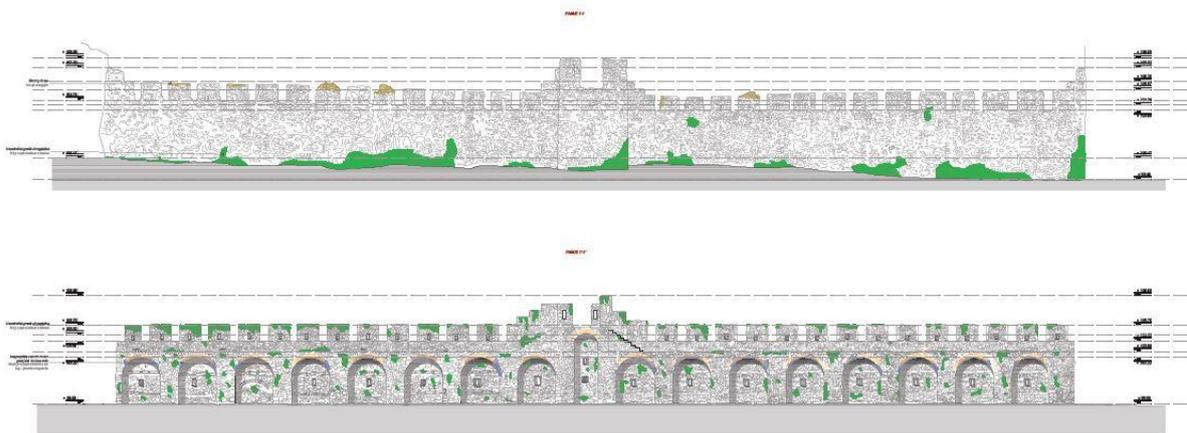
Në fasadën Veri-Lindore kati i dytë është i dëmtuar, ndërkohë që pjesa e parapetit sipër portes kryesore nuk ekziston. Shkallët janë po ashtu të dëmtuara. Përgjatë gjithë fasadës ka lagështi, ndërsa në pjesën e poshtme ka prani vegetacioni. Në brëndësi të harqeve ka mungesë të gurëve dhe dëmtim të materialit lidhës. Kreu i murit është i degraduar.

Fig. 20: The North-Eastern Wall (Current Condition)

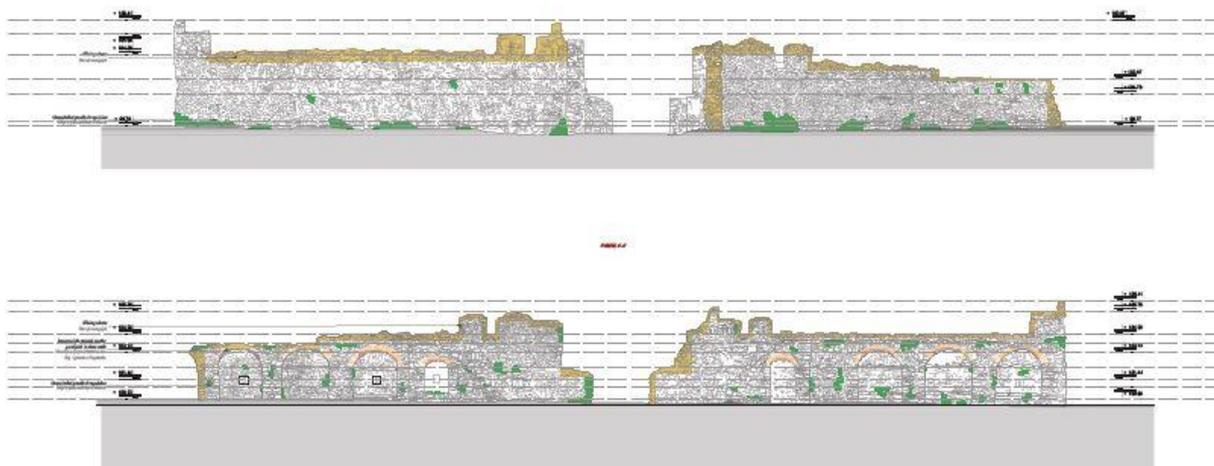
On the north-western interior façade, some of the arches are missing. Additionally, a considerable part of the masonry is detached from the walls' structure. There is moisture along the entire façade, while at the bottom, there is vegetation. The stairs that lead to battlements are damaged and in some cases there are no stairs, making it difficult to climb the walls. The battlements' structure is missing along the entire length of the walls. On the outside of the wall some structural cracks can be also noticed.

Fig. 22: The North-Western Wall (Current Condition)

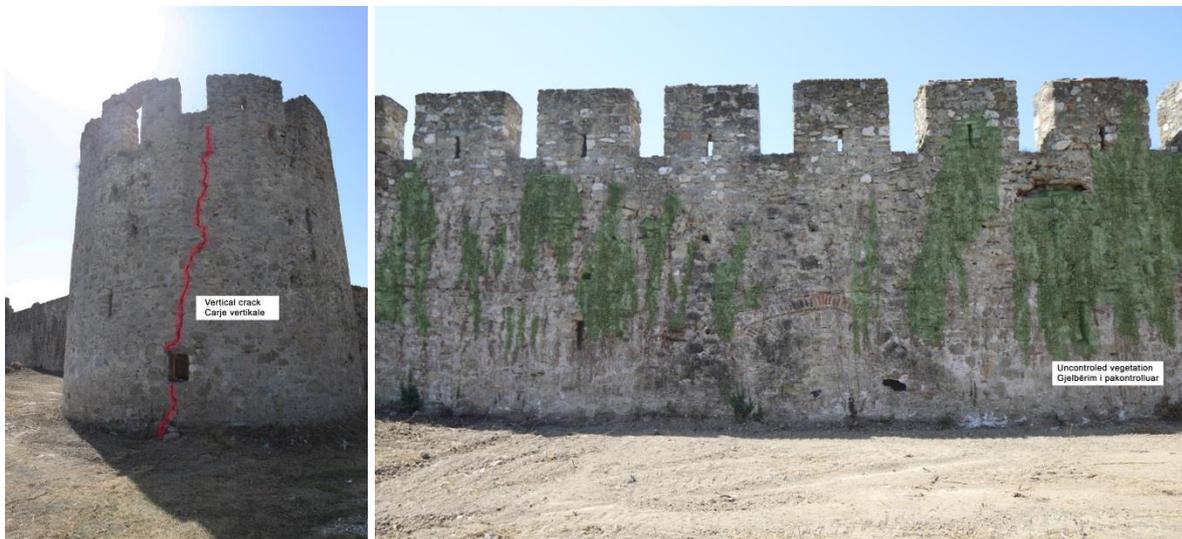
- Damage to the stone masonry
- Vertical, horizontal or diagonal cracks in the walls
- Inadequate filling with mortar - cement of the joints of the walls
- Uncontrolled growth of plants and biological patina.

Fig. 30: Different deteriorations on the walls of the Bashtova Castle

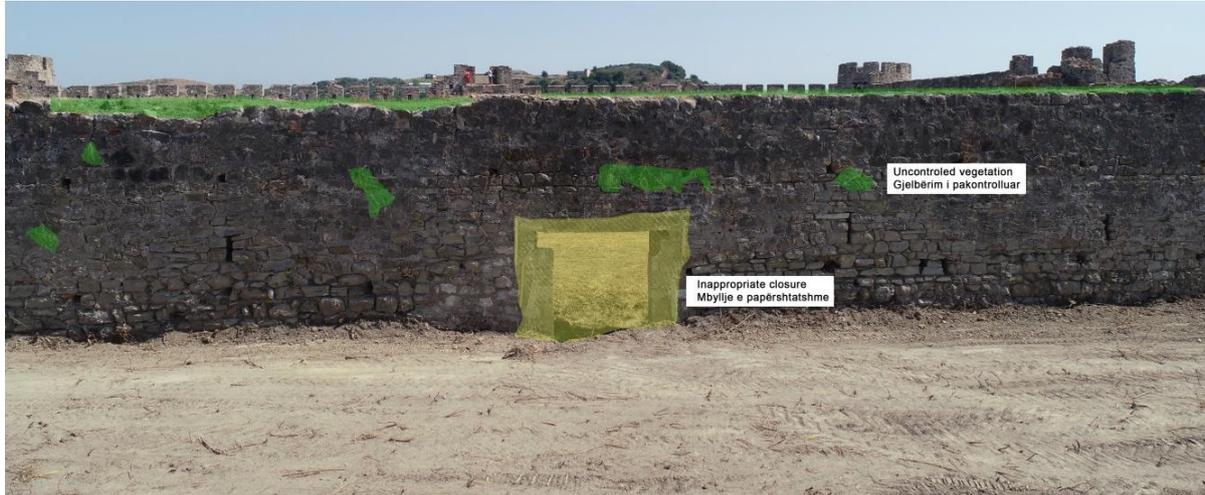
Fig. 31: Different deteriorations on the walls of the Bashtova Castle

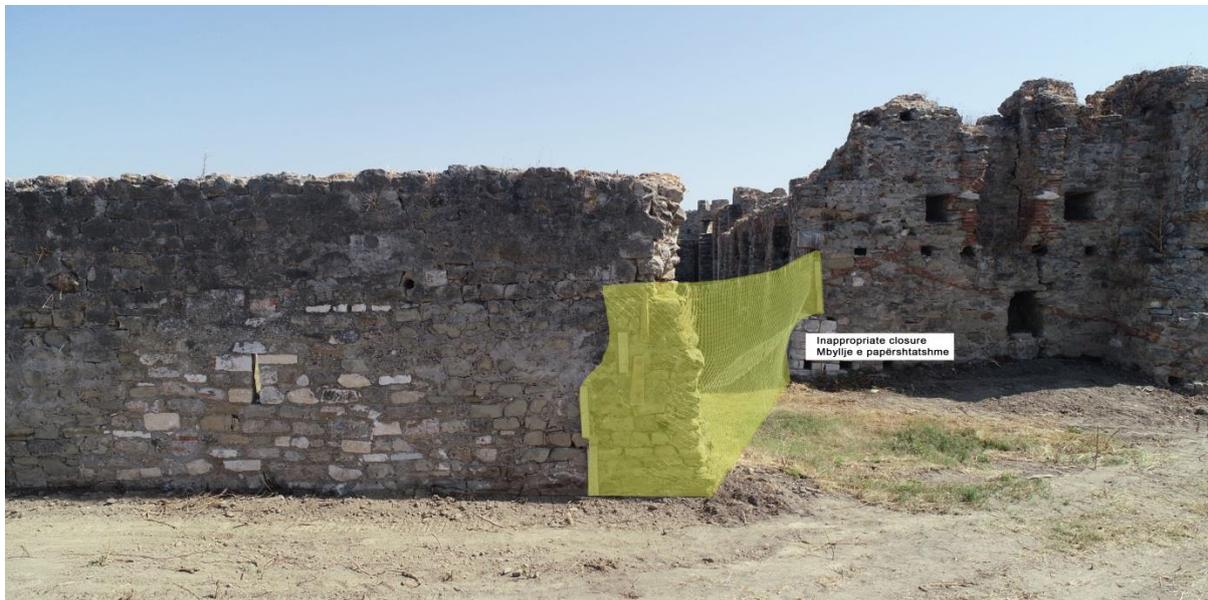
Fig. 32: Different deteriorations on the walls of the Bashtova Castle

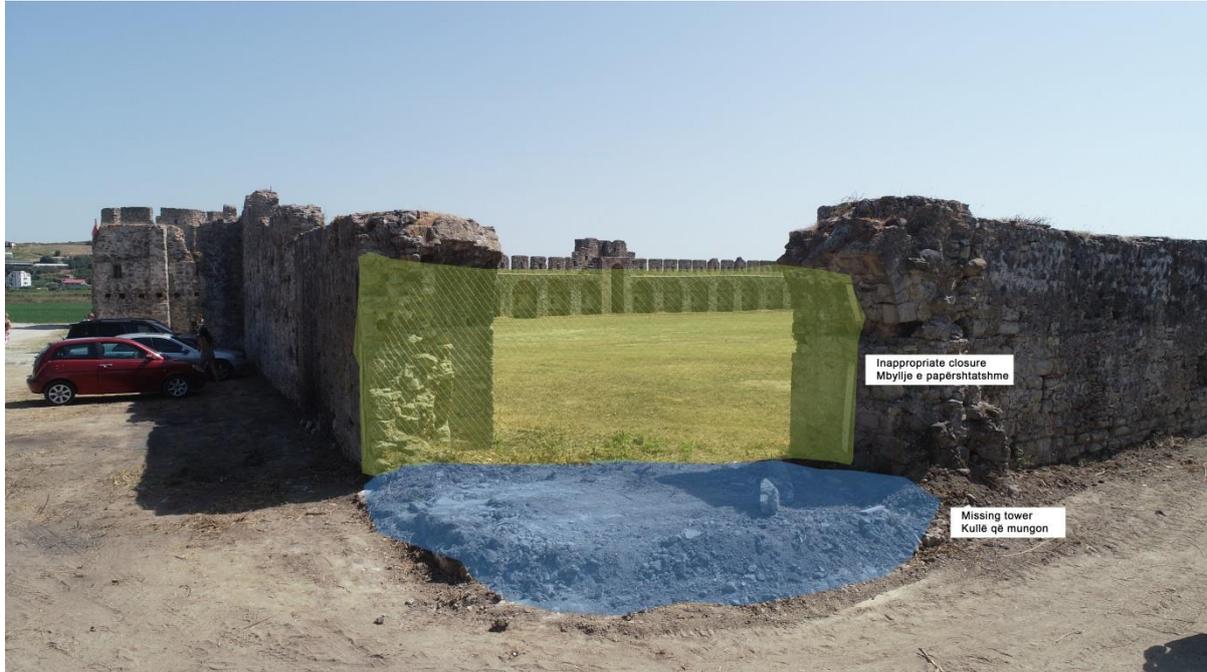
Fig. 33: Different deteriorations on the walls of the Bashtova Castle
