Annex E - Yatta Assessment Report

Yatta Water Supply Project (YWSP) Phase 1

Technical Assessment Report

Universal Group for Engineering and Consulting
Main Office: Nablus
Tel.: +972 (09) 238 3281/2
Fax: +972 (09) 238 3280

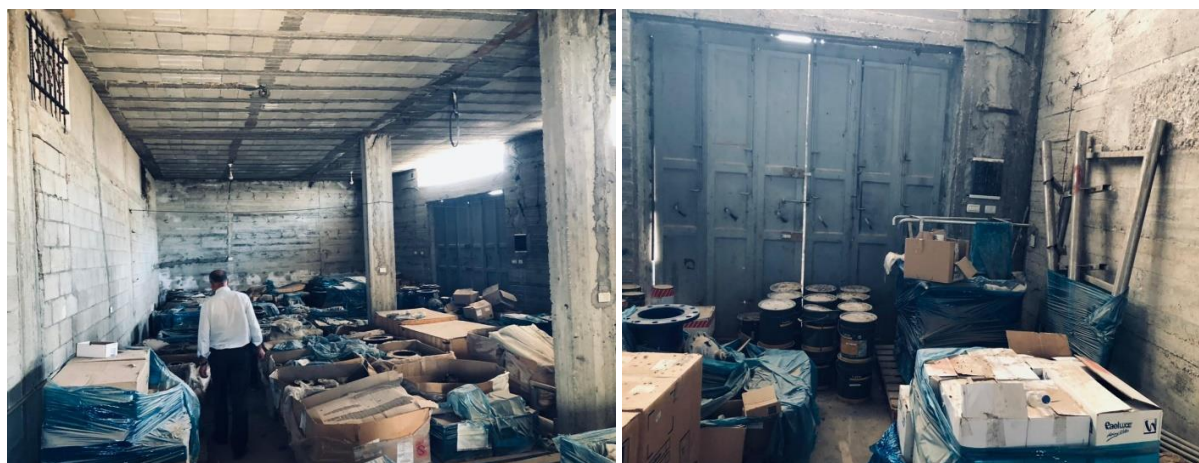
Figure 1: Materials Storage area No.1

The materials and equipment's were stored in two locations. The first location is a closed storehouse which includes the materials that can be affected by weather conditions such as electrical materials, electromagnetic Flow Meters, SCADA equipment's etc. Figure (1) shows a general view of the closed storehouse. Most of the materials were stored on the ground inside boxes.

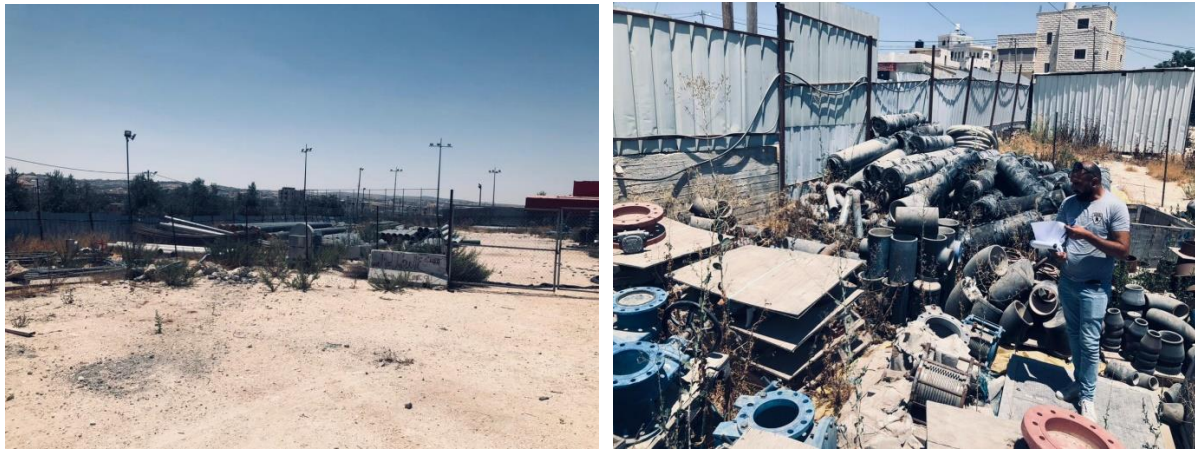
Figure 2: Materials Storage area No.2

The second location is an open space storage area. The main material stored are steel pipes, valves, manhole covers, elbows etc. Most of the materials were stored directly on the ground. Figure 2 shows a general view of the open space storehouse.

The materials in the closed storage are subject to humidity and internal heat as the ventilation is minimum. The materials in the open storage are subject to weather conditions of rain and sunshine. Both materials have to be cleansed from dust and dirt and tested before being installed.

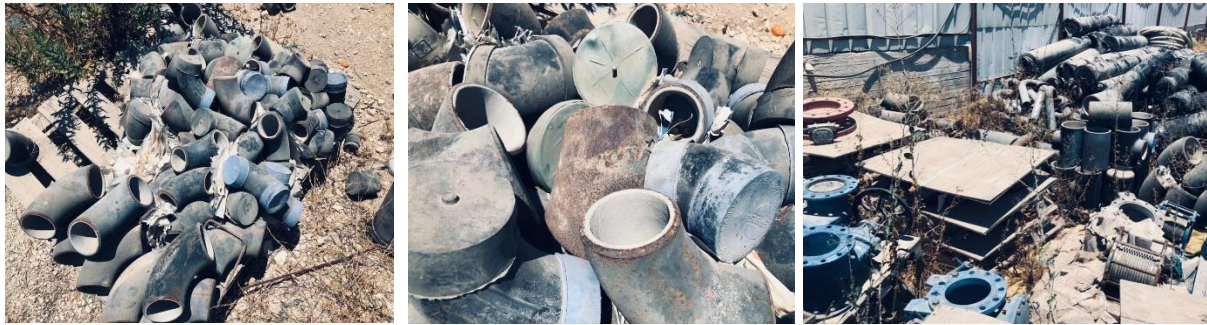
- 7) The pipe quantities are less than the list of materials provided by PWA. Mainly, the missing pipes are from 4-inch and 3-inch pipes. However, those missing pipes are from the spare parts material list. It might have been used for other activities by YM or PWA.
- 8) All electrical valves and equipment have unused batteries inside. These needs to be replaced.
- 9) All materials (except the SCADA components) are full in dirt and dust. However, this does not have any direct impact on the materials.
- 10) The current condition of the open space storehouse is very bad. Except for the pipes and manhole covers. The materials are badly stored. see self-explanatory photos.

1. A detailed storage management plan shall be prepared. This shall cover the storage area, location, condition, tag system, material Input and output mechanism before implementation. This shall also include separation between

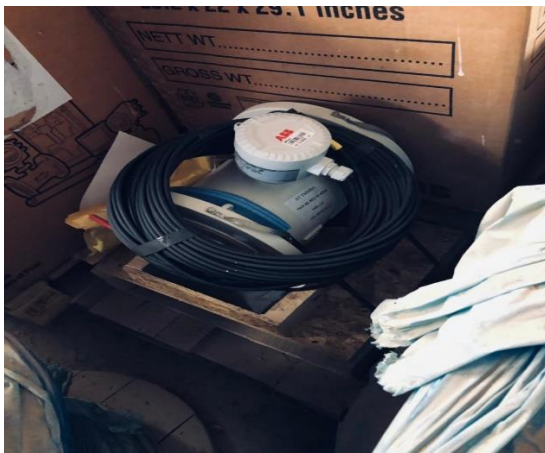
Brand Electromagnetic Flow Meter in very good conditions.

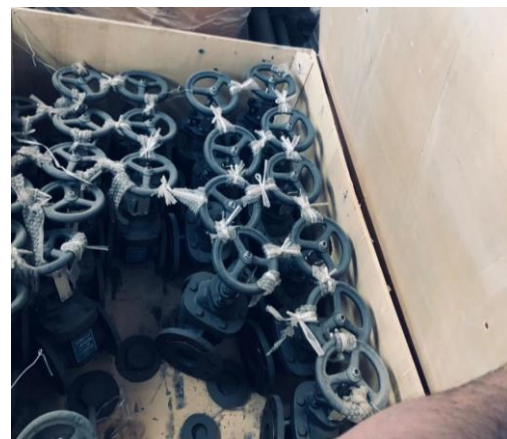
Brand Gate Valves in very good conditions.

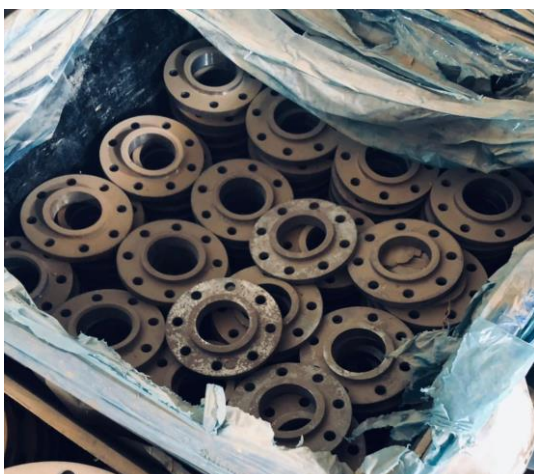
Flanges need cleaning using sand blasting

2. General cleaning for all materials from dust and dirt.
3. Sand Blasting shall be used to clean all the rusts on the flanges. This shall be added in the BOQ of the completion project.

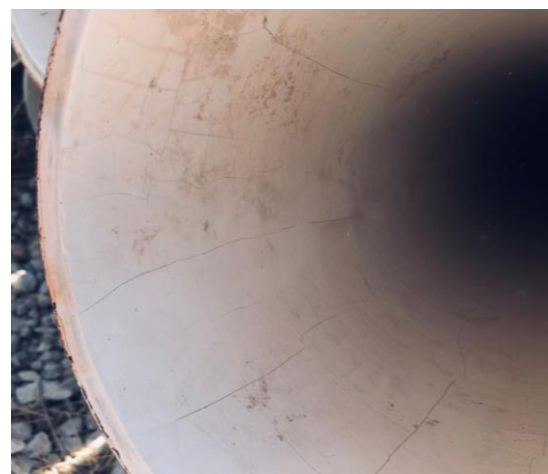
- 4) Except for the Electromagnetic Flow Meter, the materials were not tagged with special code or number.
- 5) Around 20% of the steel pipes have cracks in the internal cement lining. These pipes shall not be used in the project. these are observed in the 3 Inch, 4 Inch, 6 Inch and 8 Inch Pipes. This will not have impact on the project as most of the works related to those diameters are completed and these are from the spare parts.

Steel Pipes. The pipes with cracks in the cement lining must be excluded, less than 20%

7. All steel pipes which have cracks in the cement lining shall not be used.

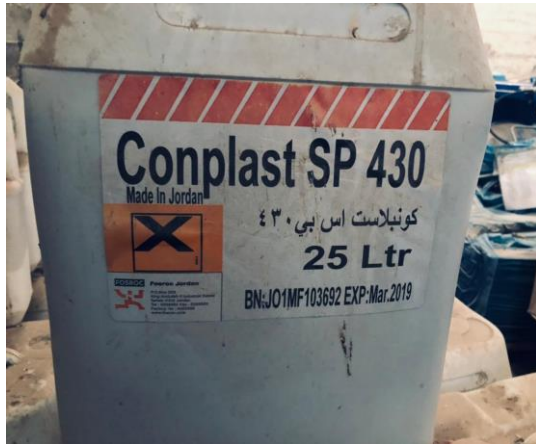
- 6) All materials which have validity dates are expired. These materials are concrete additives and concrete repair materials such as Rendroc FC, Nitocote EPSW, Nito Marter etc.

Expired admixture materials.

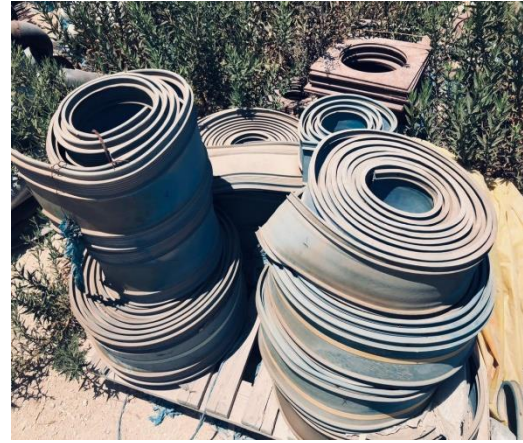
Damaged Water Stop. Has nothing to do with the remaining works.

4. Remove all the damaged materials which will not be used such as water stop, geotextile, shrinkable sheets, shrinkable tapes, reinforced steel etc. and as indicated in the list presented in Appendix 1.

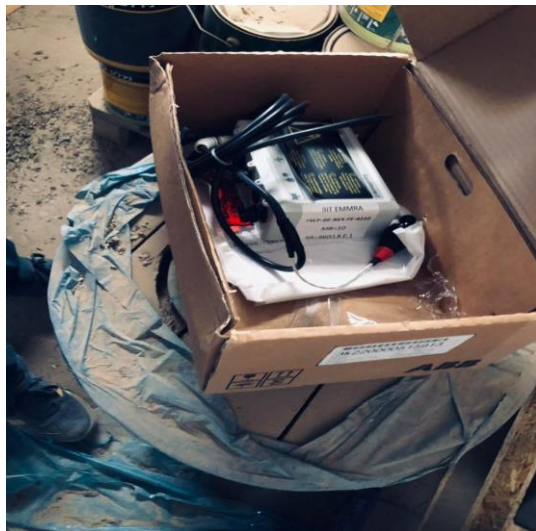
Brand Electromagnetic Flow Meter in very good condition.

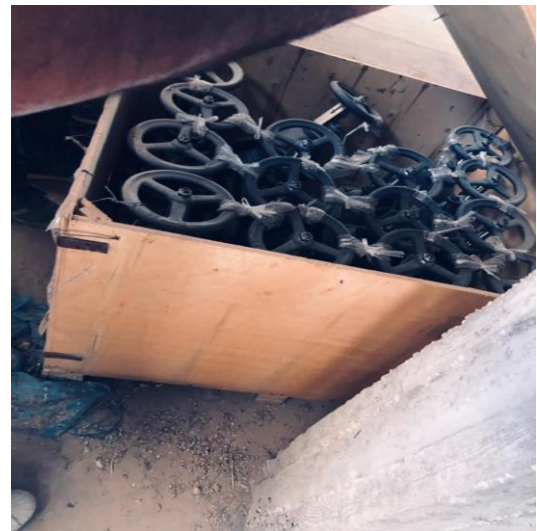
Brand Gate Valves in very good condition.

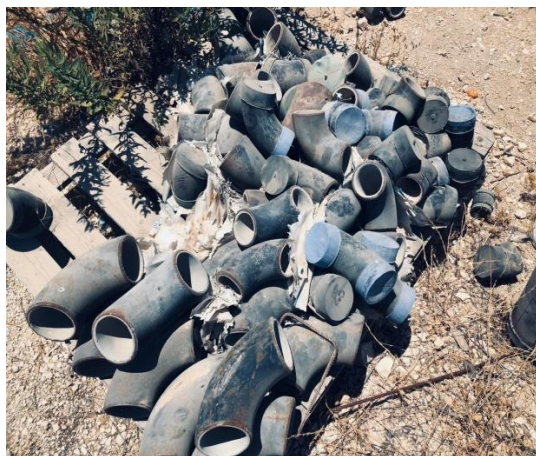
Bends and Elbows need cleaning and insulation. The damaged ones have to be excluded.

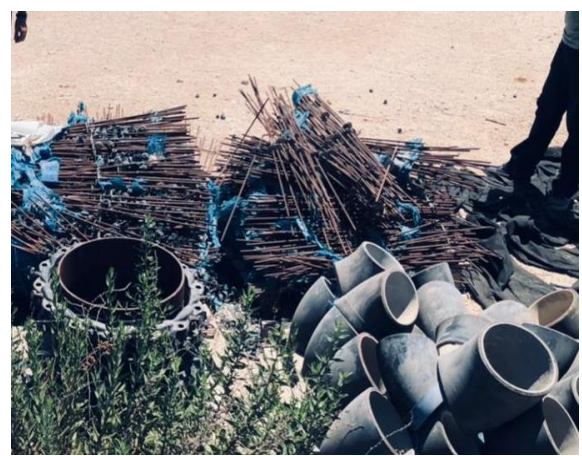
Rusted Reinforced Steel shall not be used in the project.

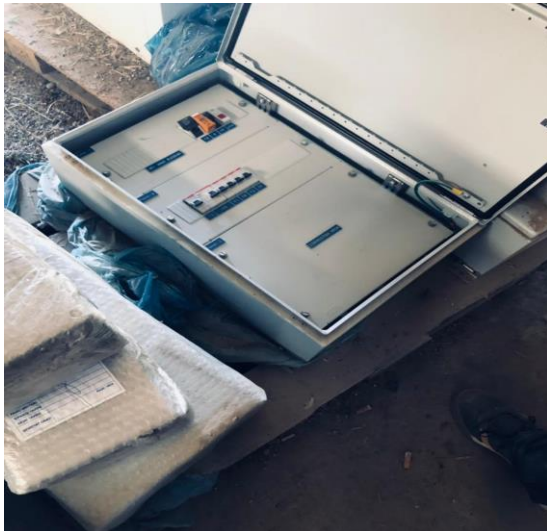
SCADA equipment are in Good Conditions.

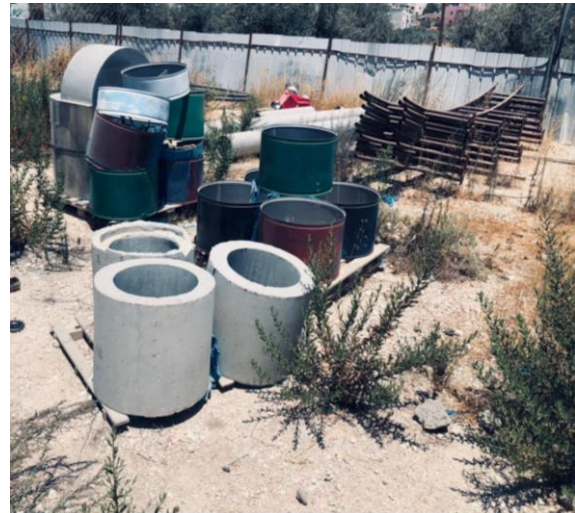
Manholes are in good Conditions

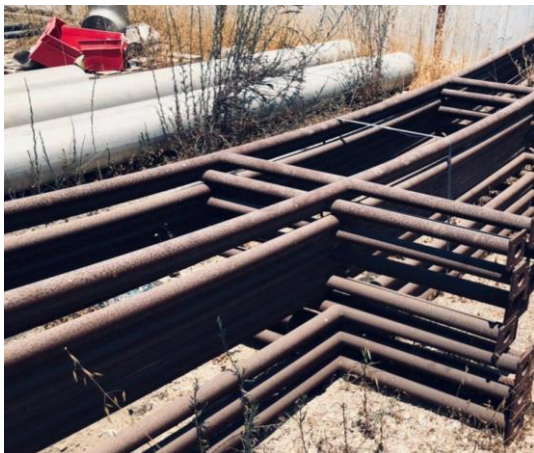
Handrails for Reservoir in bad condition but can be used

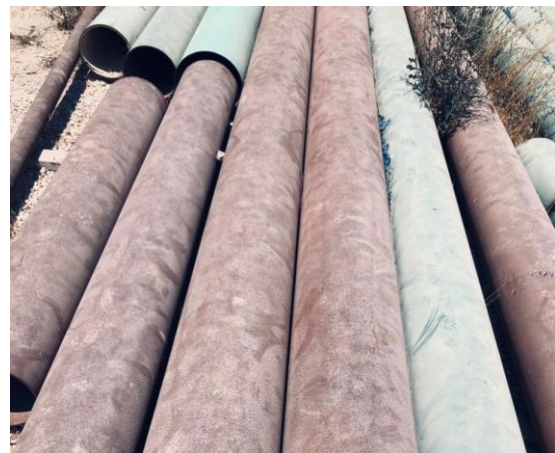
Pipes in bad conditions

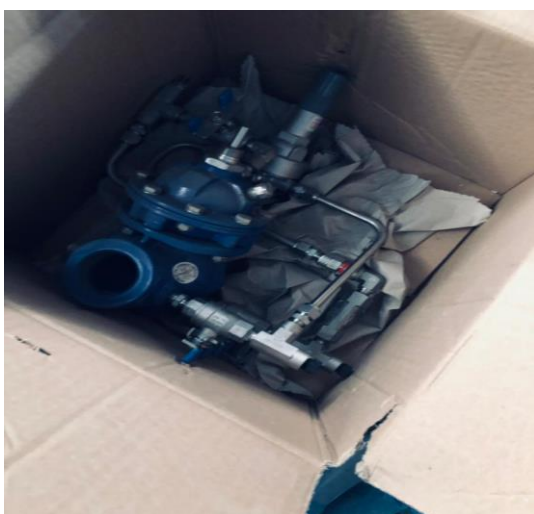
PRV in Good Conditions.

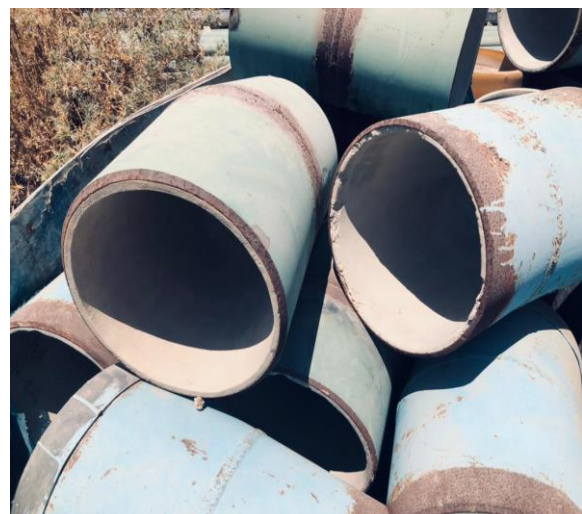
Will need some repair and insulation before use

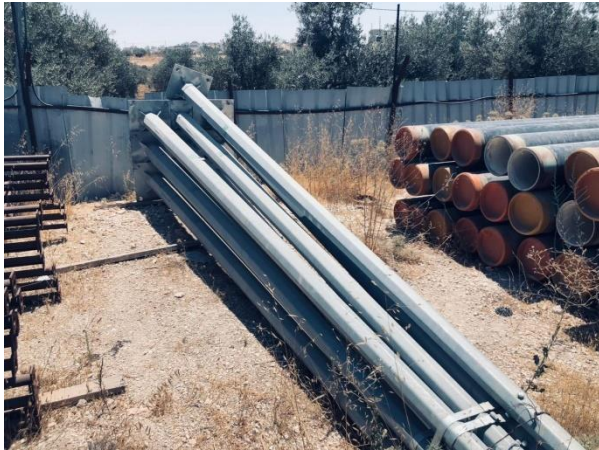
Electrical Poles are in Good Conditions.

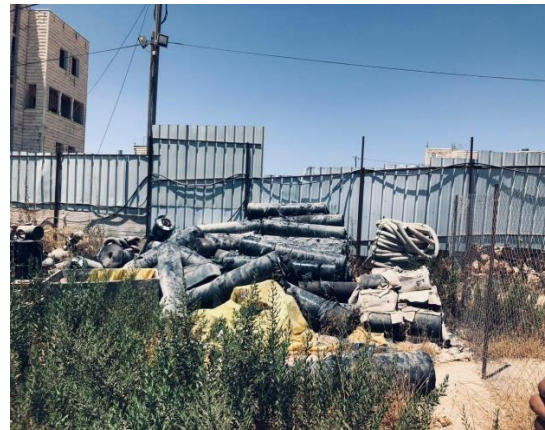
Geotextile in bad conditions

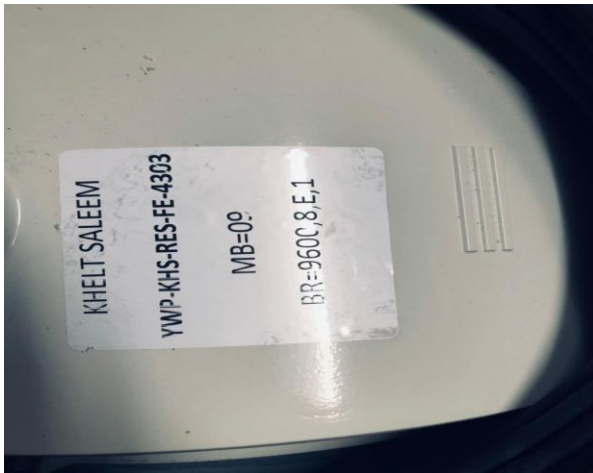
Tags are only on the EM flow Meters

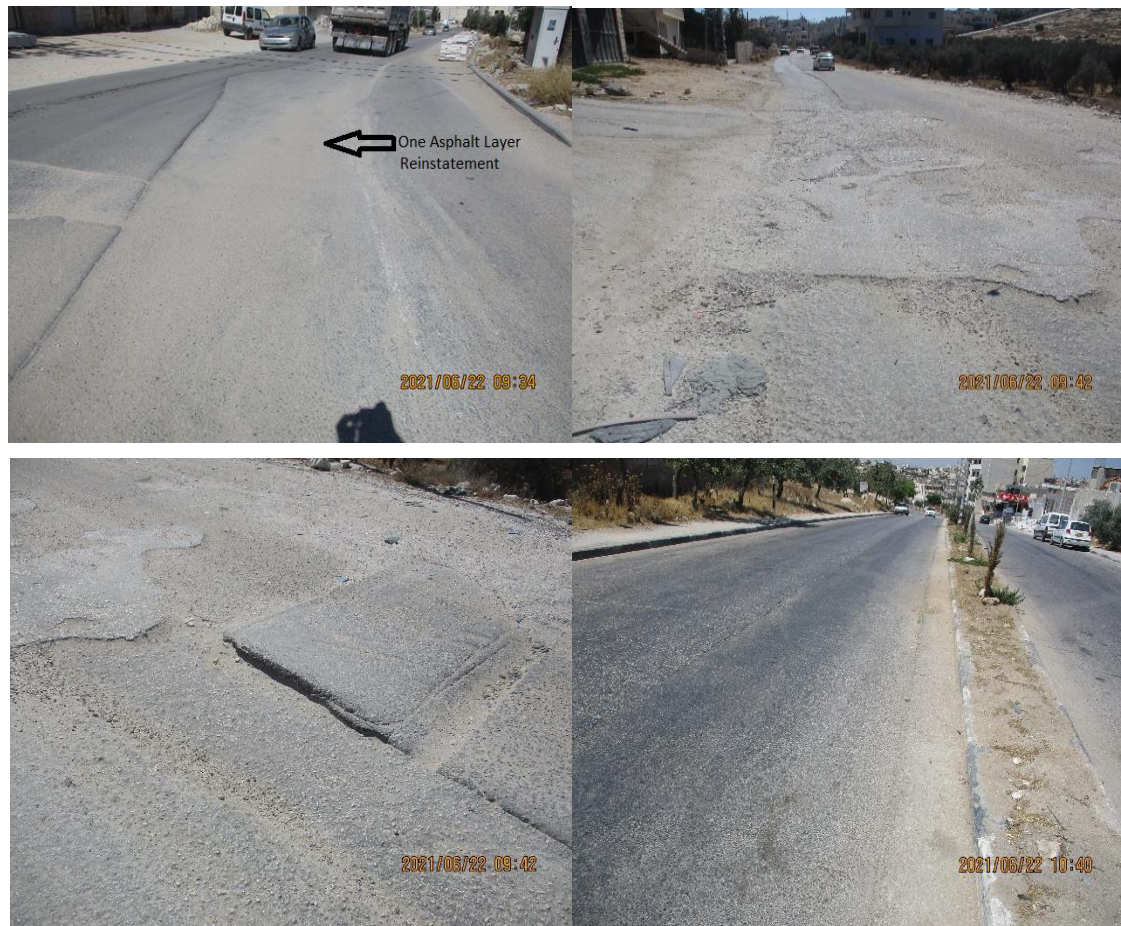
Figure 3. Current Reinstatement Condition in Yatta

- 1) The degree of Compaction for the 30 sample were ranging between 97% and 99.7%. These arranges are acceptable if we take into consideration that only one layer of asphalt reinstatement was implemented.
- 2) The thickness of the 30 asphalt samples were ranging between 4 cm and 11.1 cm. 6 samples were less than 5 cm which shall be the minimum for the first layer of asphalt reinstatement. The additional layer has to be implemented in order to have a minimum of 10 cm thickness for both asphalt layers.
- 3) The asphalt reinstatement condition is bad and must be supported with one additional layer. Figure 3 shows some locations which will need a second layer of asphalt reinstatement.

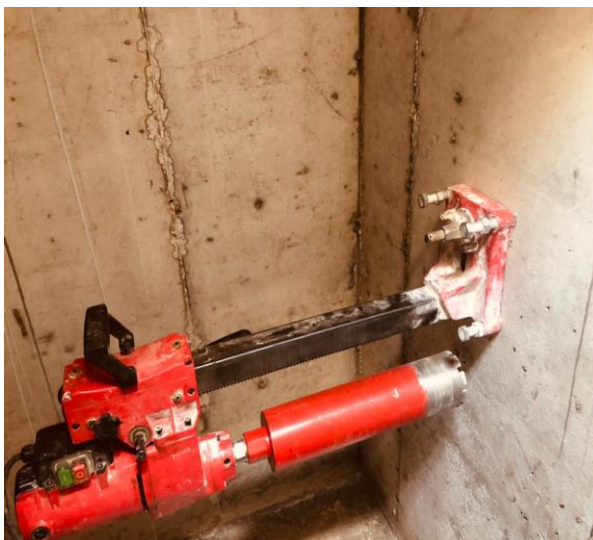
Core Test for Concrete Chamber #1

The walls, slab and floor of the chambers were observed to be generally in good condition. Our team did not observe any serious cracks or deviations.

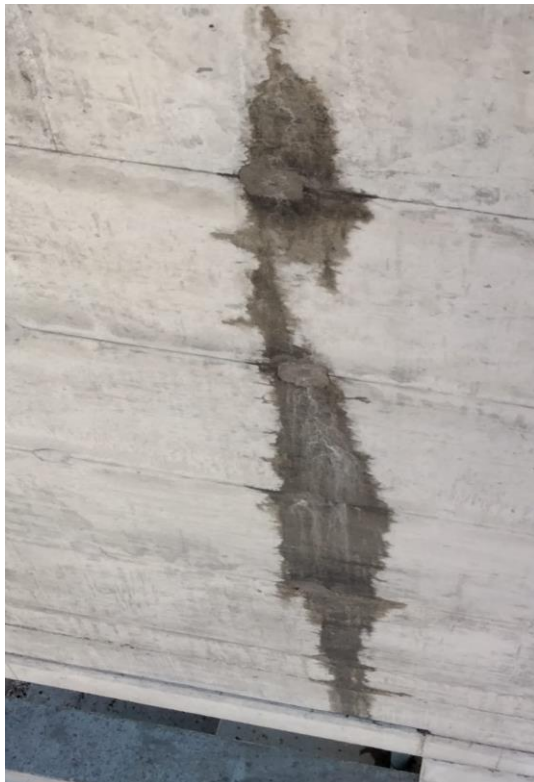
The leakage started at western walls of the tank. Then additional two locations were observed near the slab of the tank. Below are some photos showing the leakage spots.

Beit Ammra leakage Spot #1

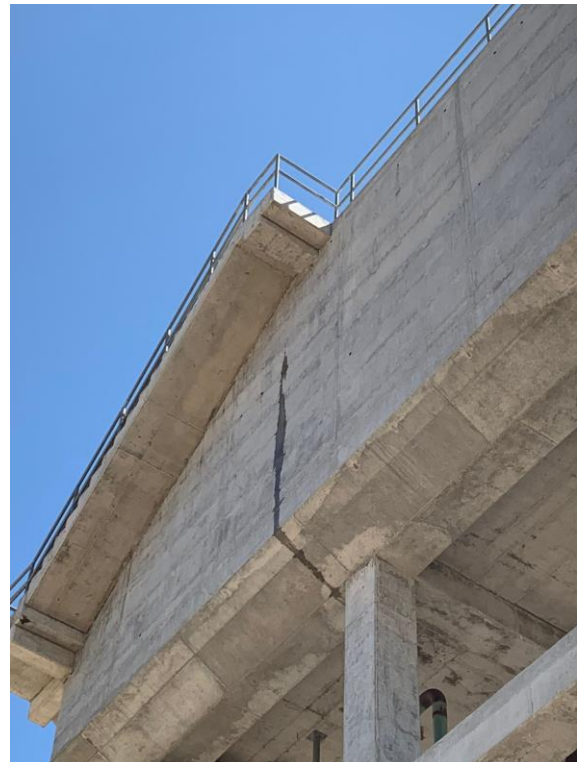
Beit Ammra leakage Spot #1

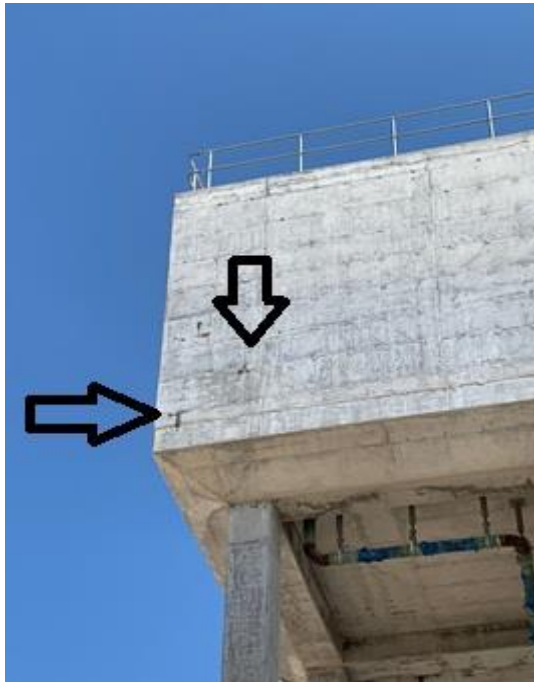
Beit Ammra leakage Spot #2 and #3

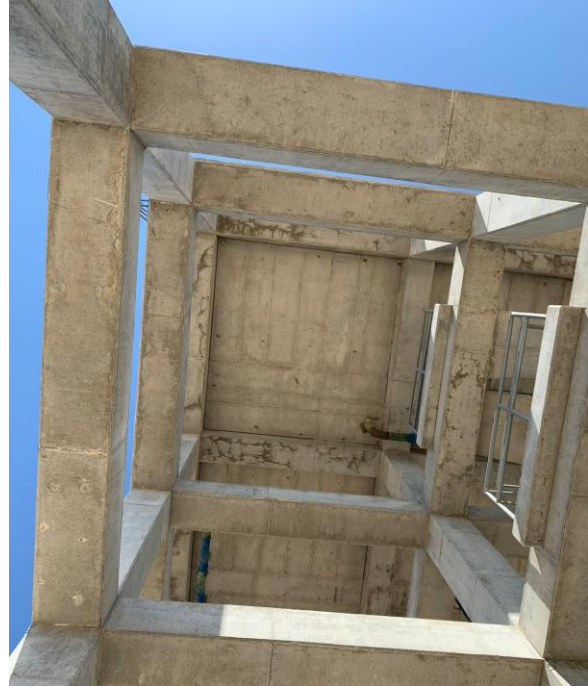
Nothing was observed from the bottom

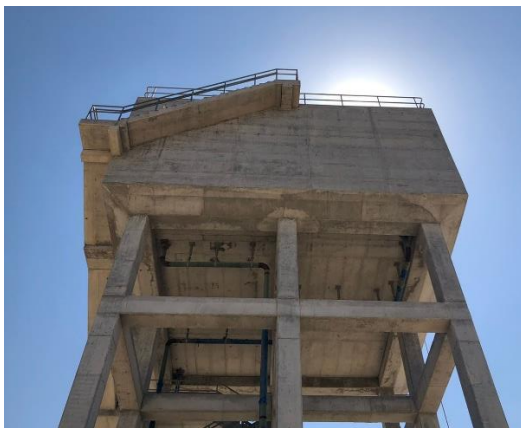
Tank during the filling- 25% filled. No Water leakage through floors, walls, or wall-floor joints.

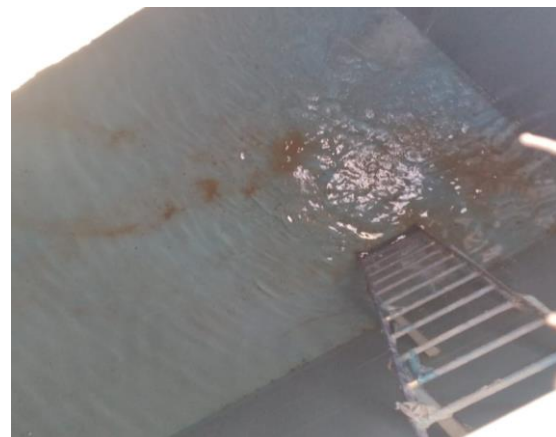
Tank during the filling- 25% filled. No Water leakage through floors, walls, or wall-floor joints.

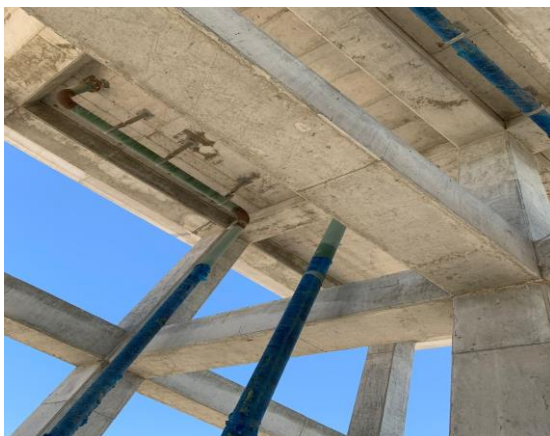
Tank during the filling- 50% filled. No Water leakage through floors, walls, or wall-floor joints.

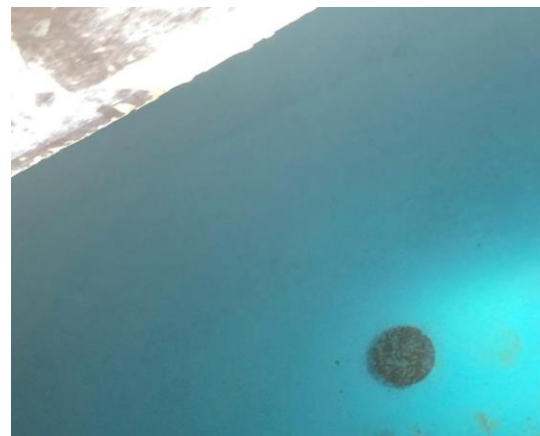
Tank during the filling- 50% filled. No Water leakage through floors, walls, or wall-floor joints.

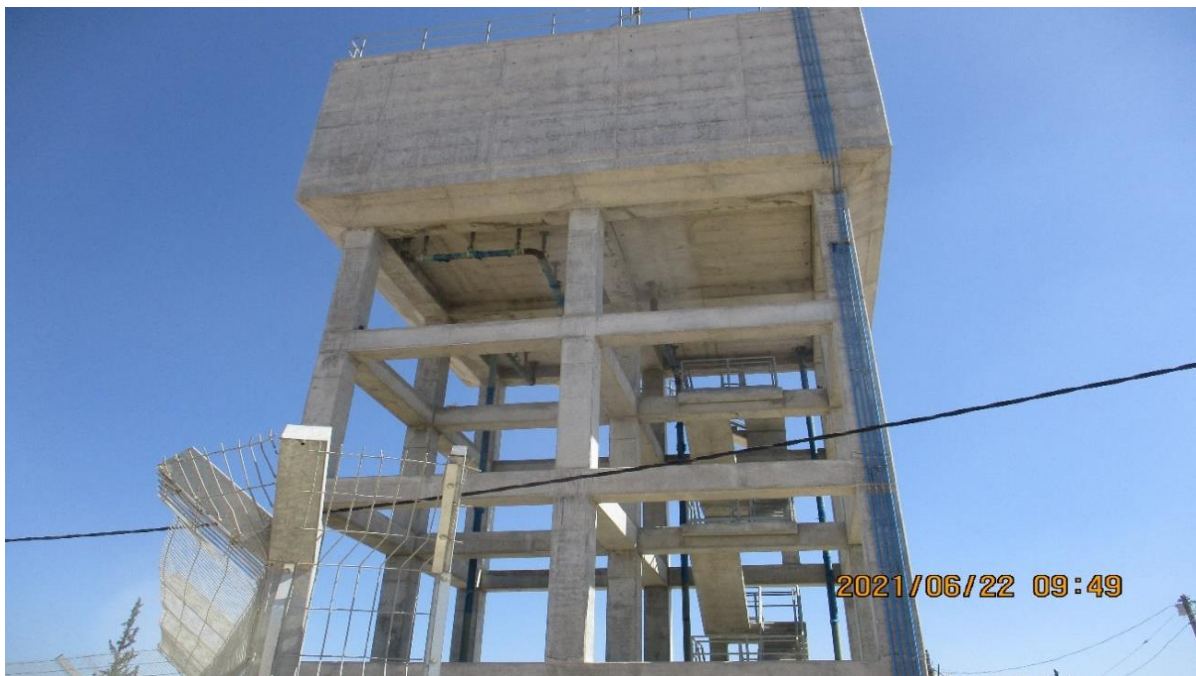
Figure 4. Beit Amra Elevated Water Tank

The Reservoir is a 500m³ elevated tank with 20.4m height (from base level to roof level). The body of the tank is reinforced concrete wall perimeter and thickness of 30 cm. The dimensions are (11.5X11.5X 5.0m). The foundations are reinforced concrete continuous footing with 1.2m thickness.

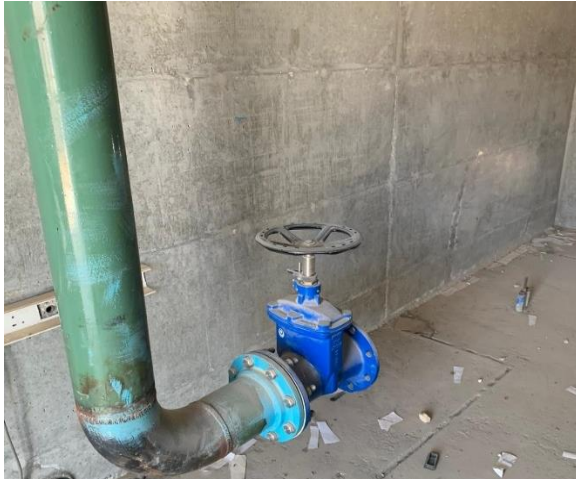
Inlet and Outlet Pipes must be treated from rust and insulated.

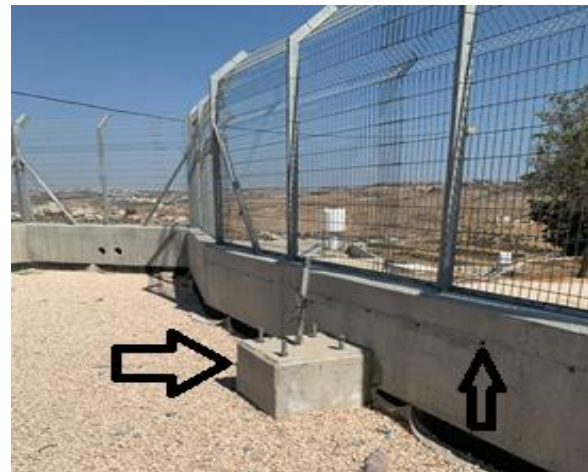
Tie rods locations must be filled. Electrical poles are not fixed

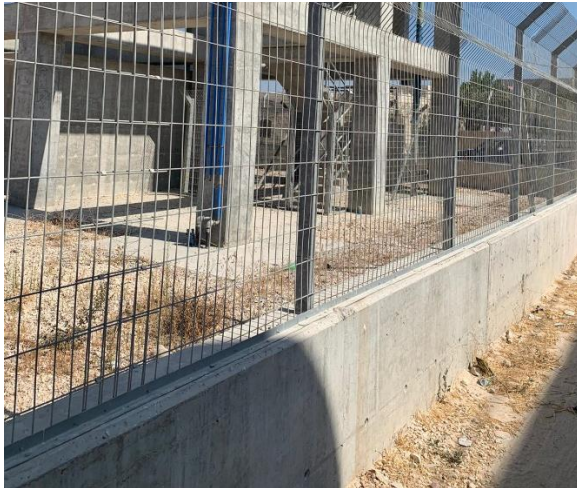
Boundary wall and fence are in good conditions

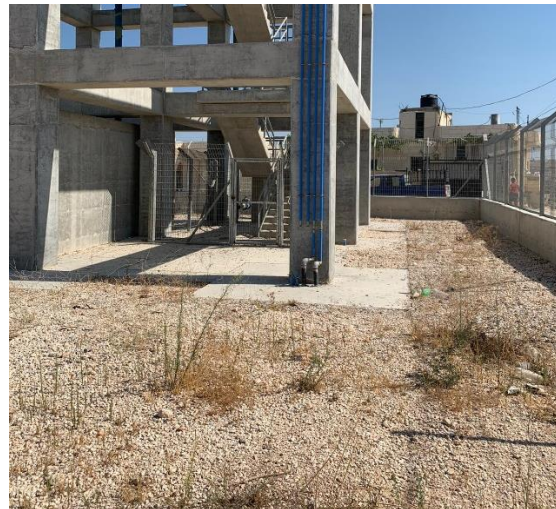
The yard must to be asphalted.

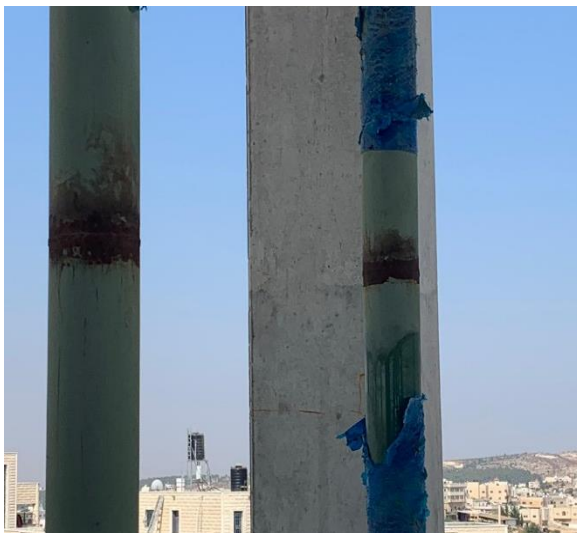
Inlet and Outlet Pipes must be treated from rust and get insulated

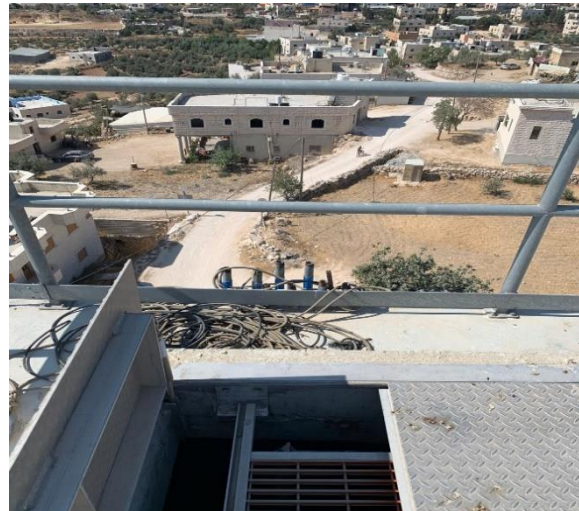
Earthing, lightening and red lamp are not completed.

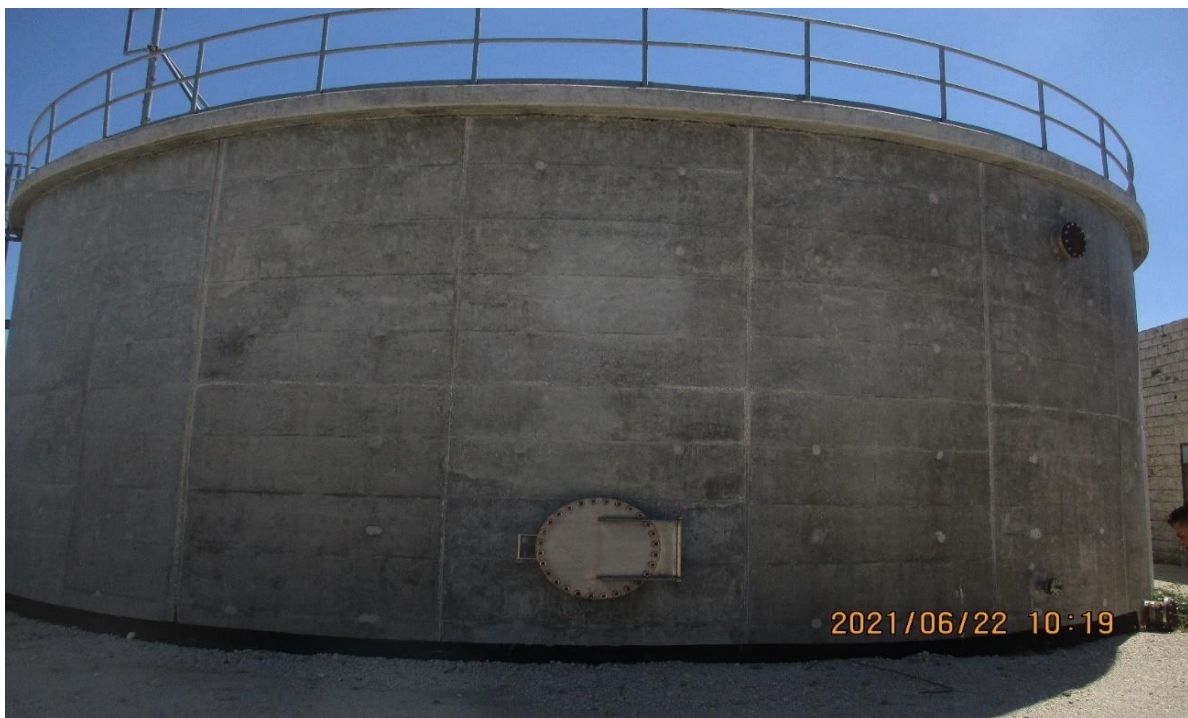
Figure 5. Schools Reservoir

Similar to Beit Amra water tank, the civil works are 100% completed and the remaining works are related to mechanical and electrical works, SCADA, miscellaneous, disinfection and commissioning. **Figure 5** shows the 1000 m³ schools' reservoir.

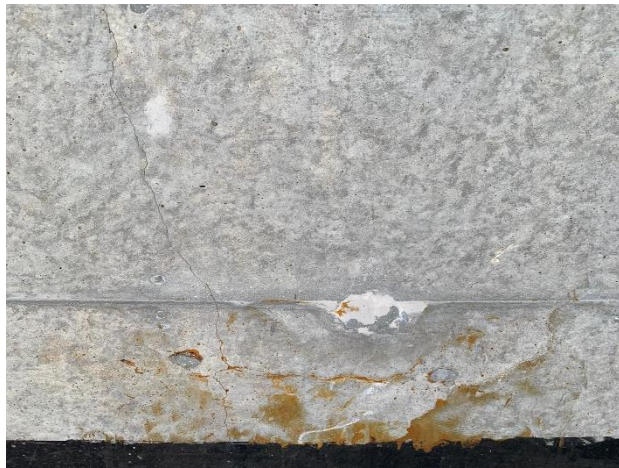
General repair for concrete surface

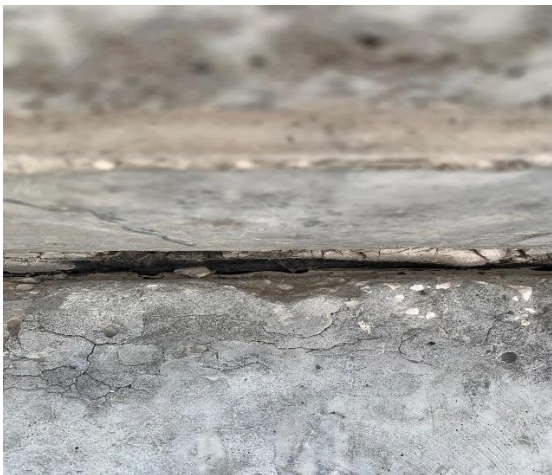
General repair for concrete surface

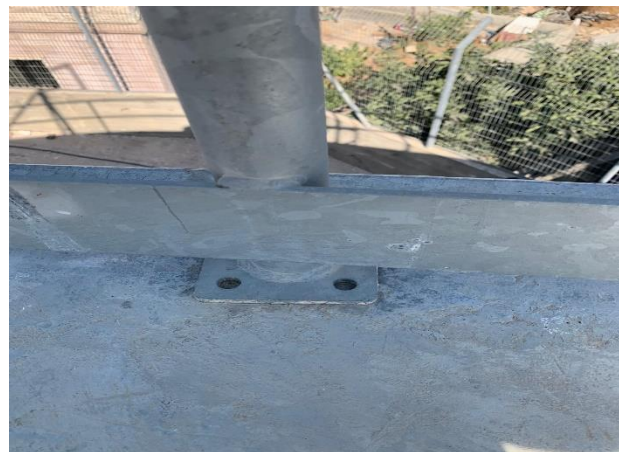
Some miscellaneous works are required

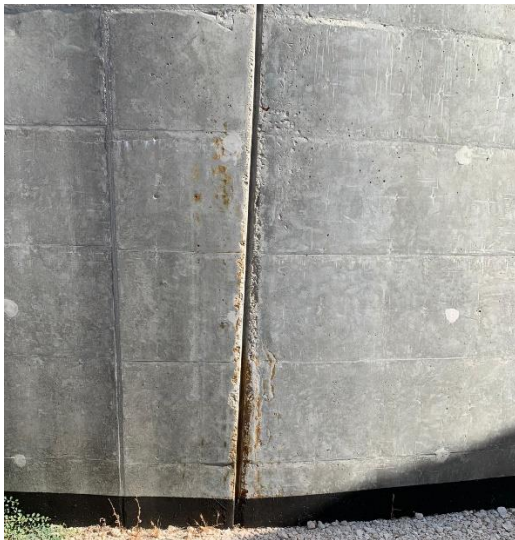
General repair for concrete surface

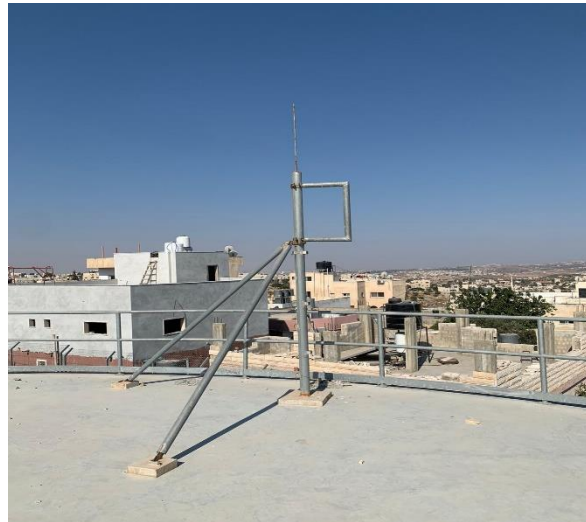
lightening is installed.

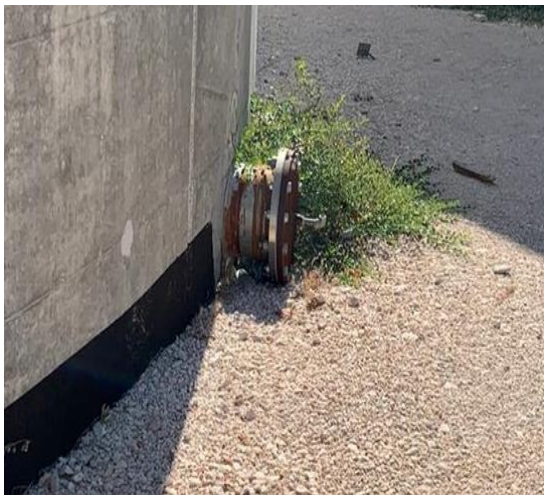
Rusted flanges have to be treated and insulated

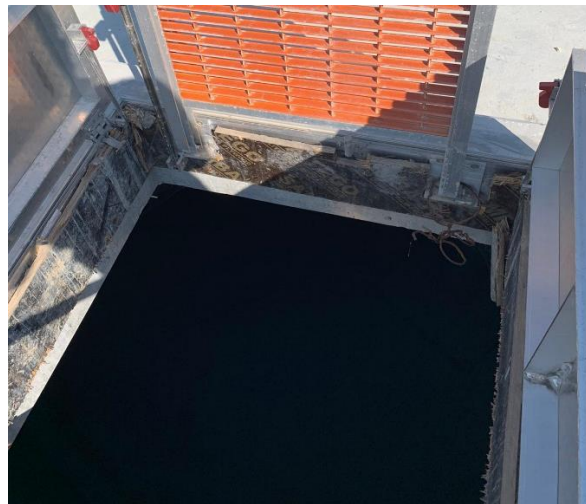
Remove some formwork remnants

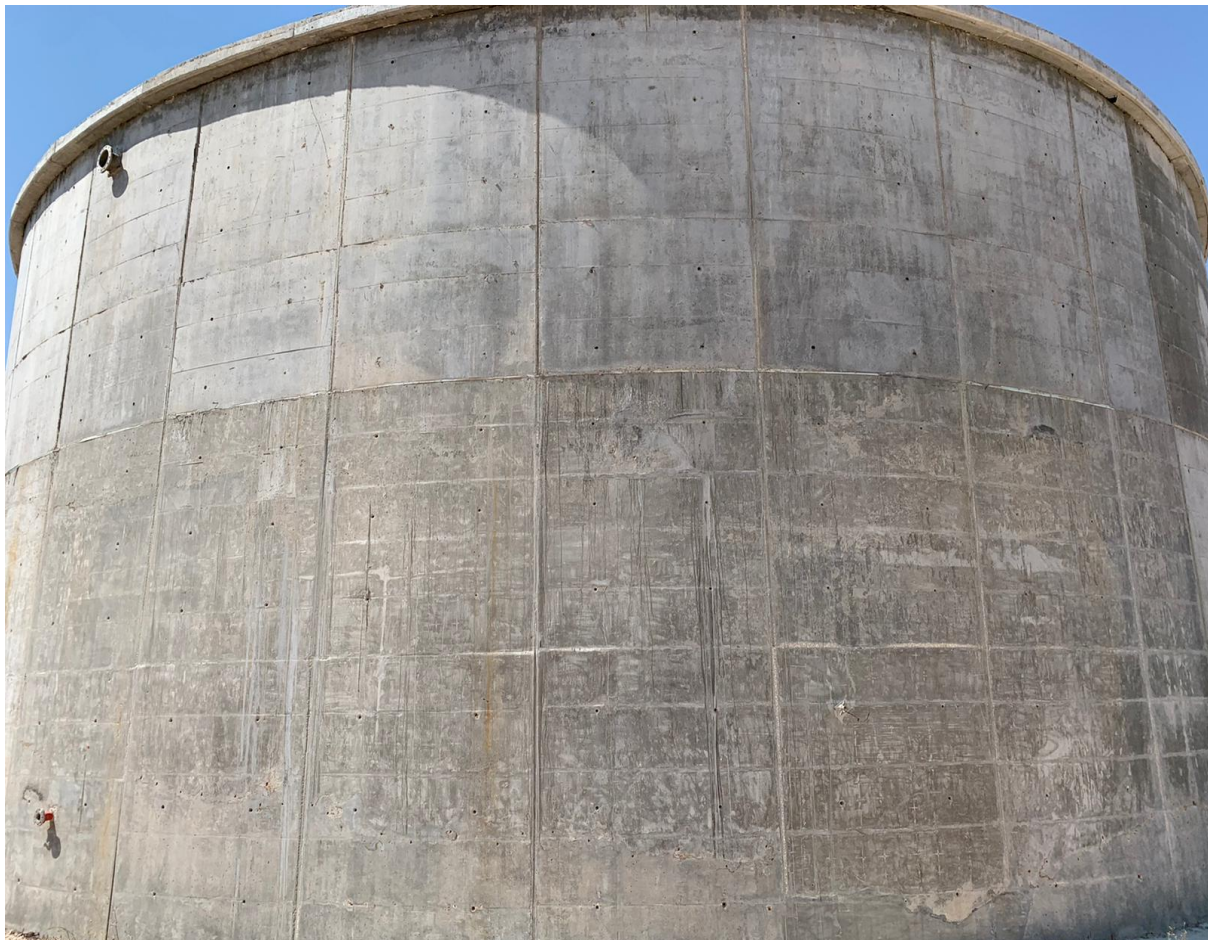
Figure 6. Khalet Salem Reservoir

Unlike the other two water reservoirs, the civil works is not completed. But the most of the remaining works are related to mechanical and electrical works, SCADA, miscellaneous, disinfection and commissioning. **Figure 6** shows the 5000 m³ Khalet Salem reservoir.

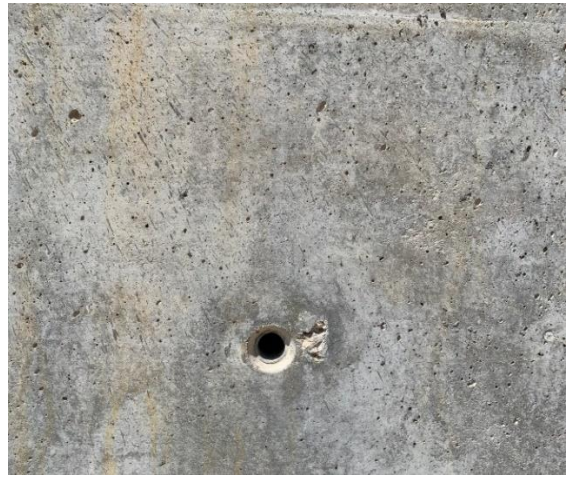
Tie rod holes must be repaired and filled

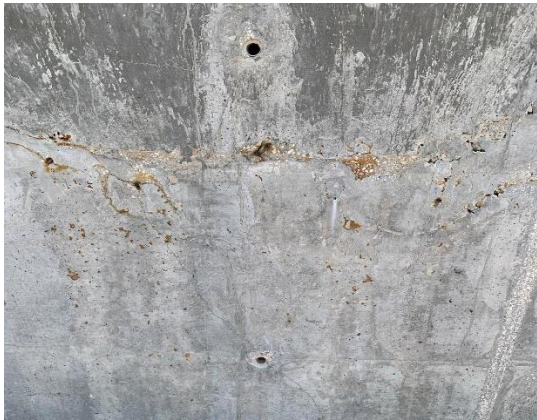
General repair for concrete surface

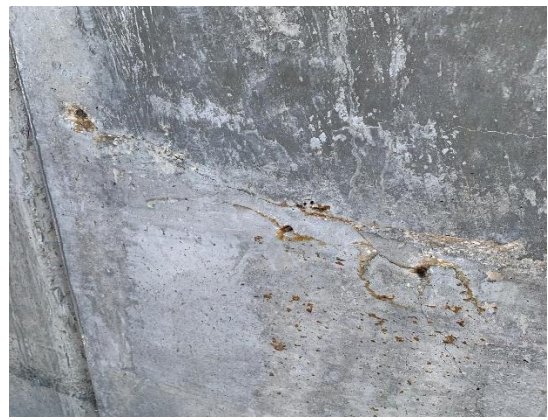
General repair for concrete surface

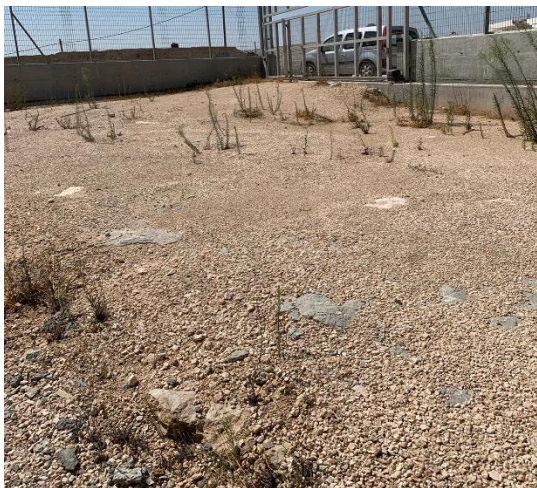
Reservoir yard level is not reached. Additional layers are required

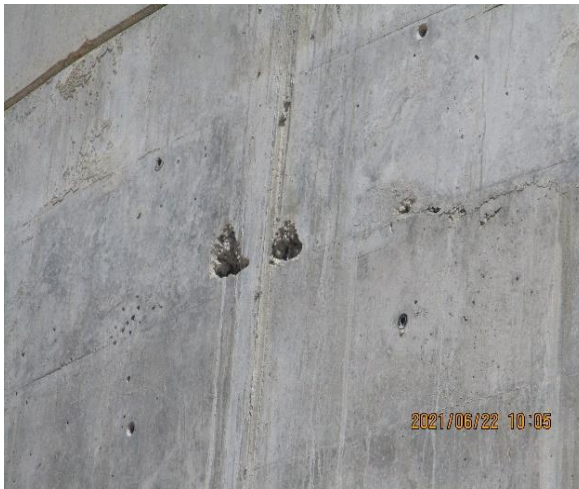
General repair for concrete surface

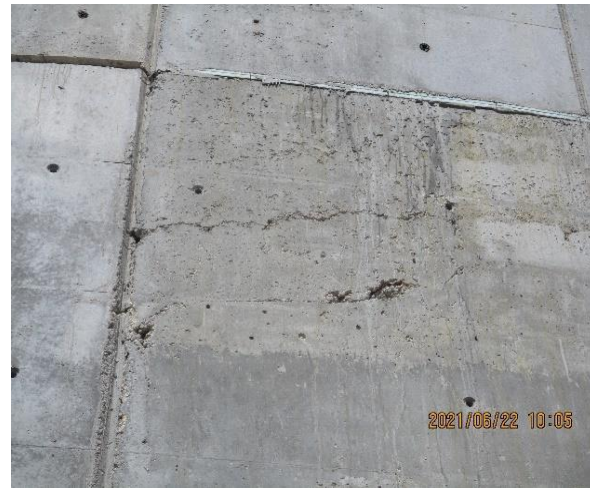
General repair for concrete surface

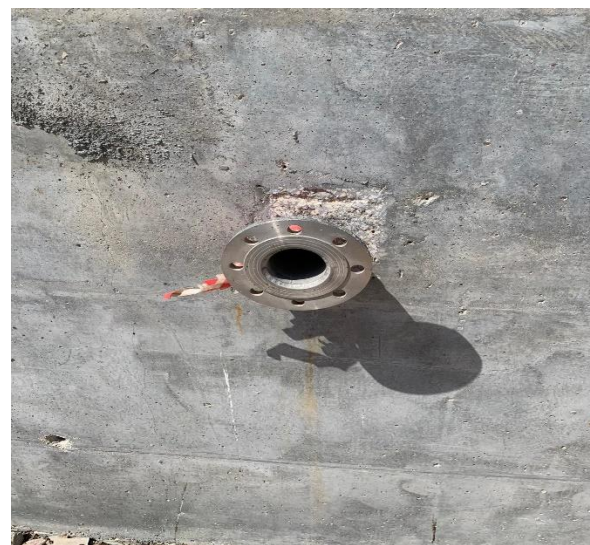
General repair for concrete surface and inlet/ outlet

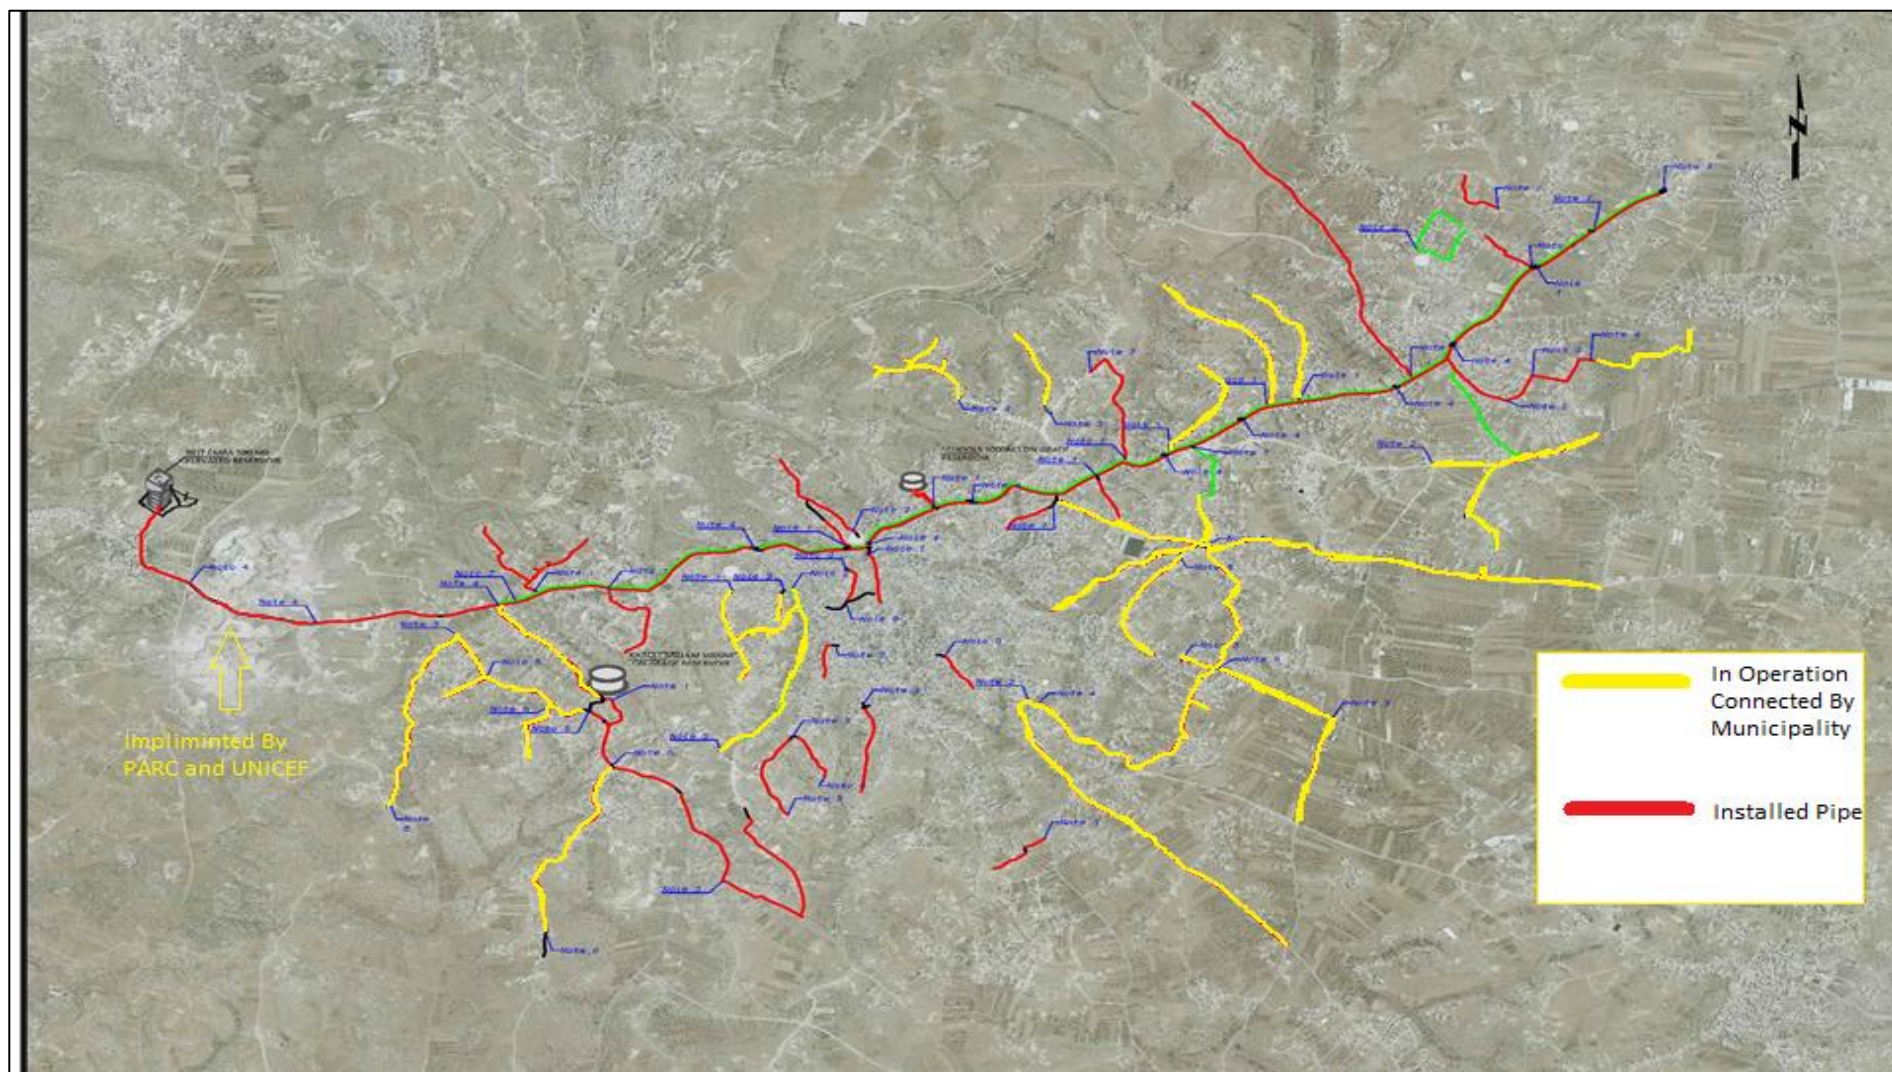
Figure 12. Installed Pipes after being connected and put in operation by Yatta municipality

The main observation is related to the works done by the municipality. Yatta Municipality reconnected some customers by integrating the old network with the new network. This has to be considered in tender document of the completion project to reconnect those houses with the new network only.
