Annex E - Yatta Assessment Report

Yatta Water Supply Project (YWSP) Phase 1

Technical Assessment Report

Universal Group for Engineering and Consulting
Main Office: Nablus
Tel.: +972 (09) 238 3281/2
Fax: +972 (09) 238 3280

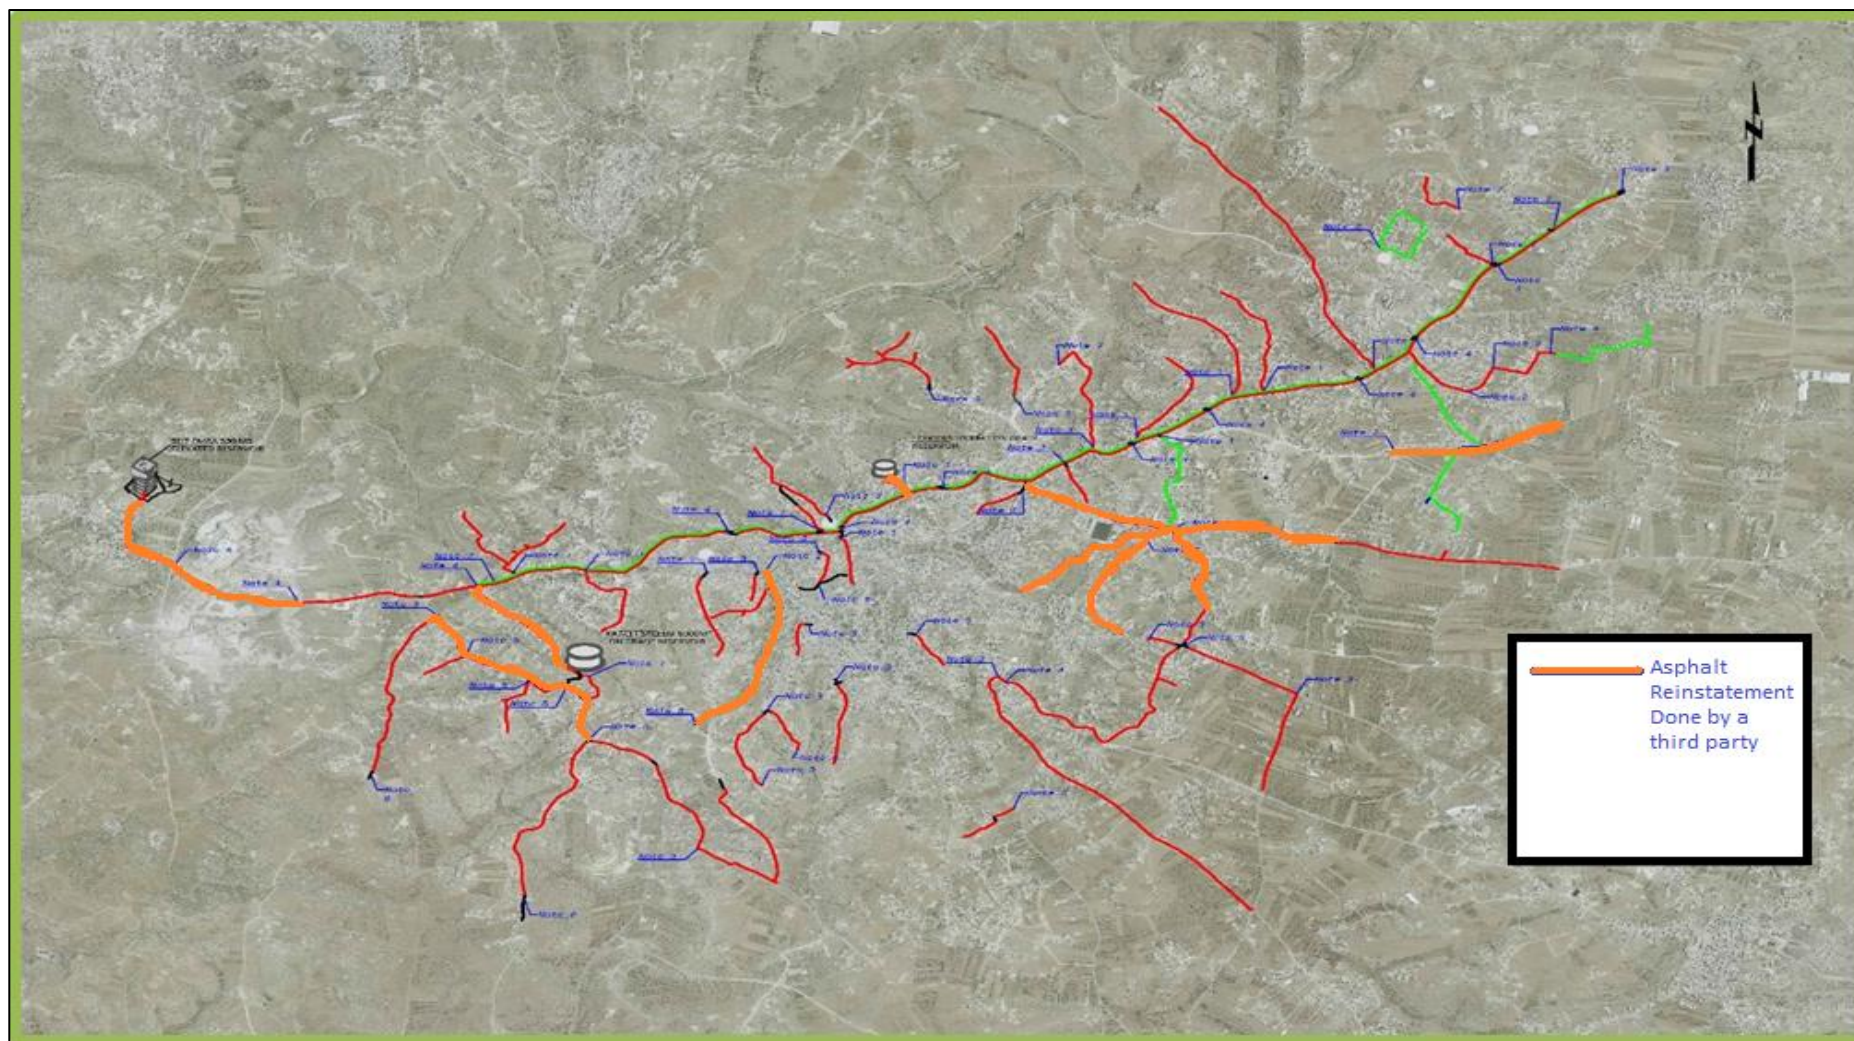
Figure 13. The Reinstatement works done by Yatta municipality and other parties

The works done by third parties were done in accordance with PWA specification, MoPW specification and the best practice of International Standard.
