TECHNICAL ASSESSMENT REPORT NATIONAL MUSEUM OF HISTORY

4.1 General Description

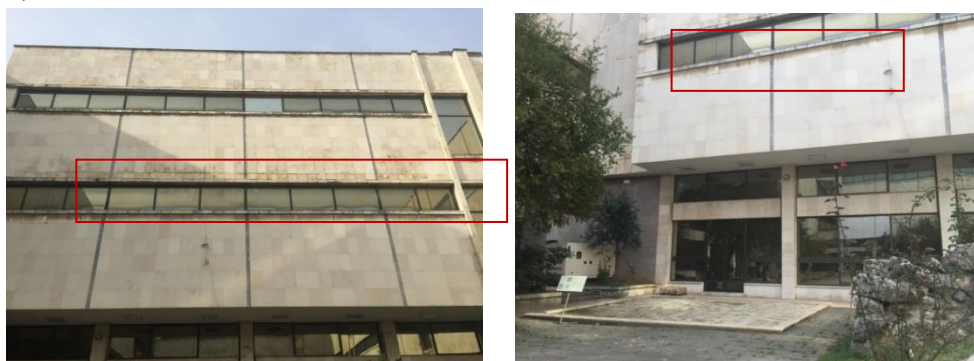
Fig. 5 Impurity on the facade by atmospheric agents

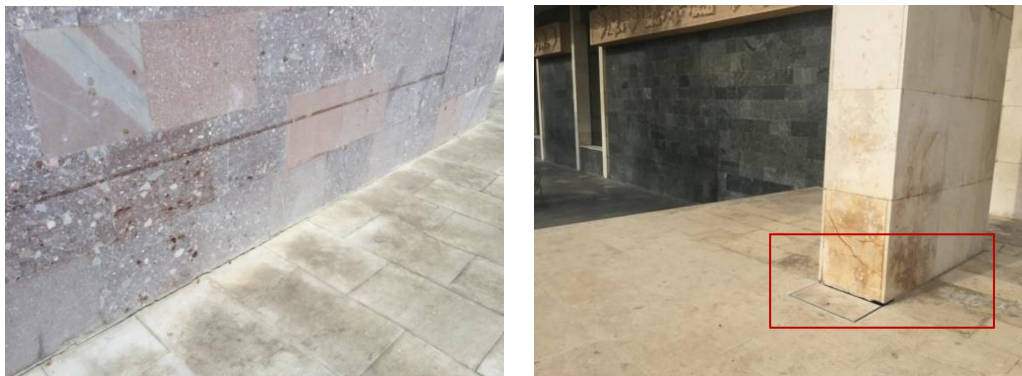
Fig. 6 Tile removal from the floor

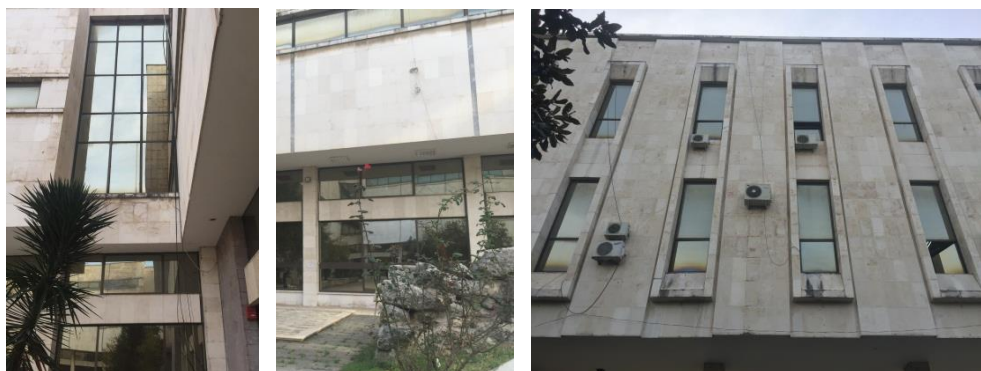
Fig. 7 Cables, installations and air conditioners on the facade

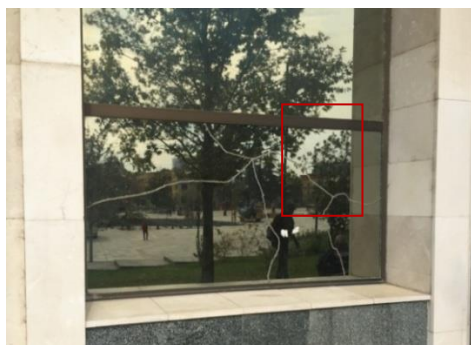
Fig. 8 Broken glass

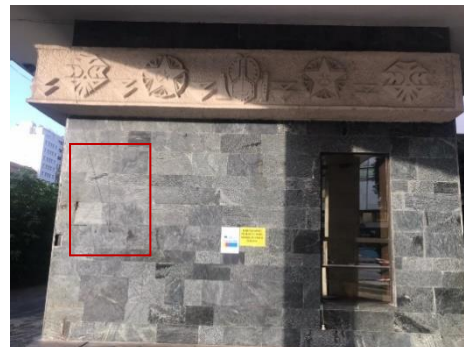
Fig. 9 Broken tiles

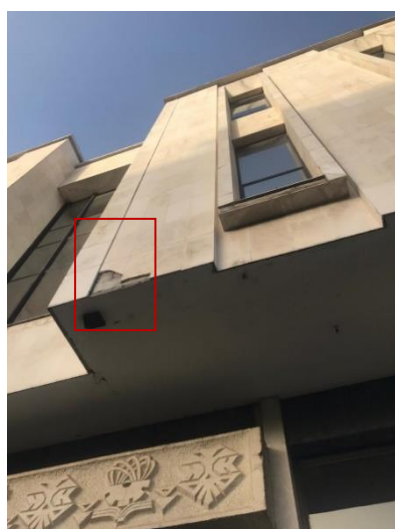
Fig. 10 Detached tiles

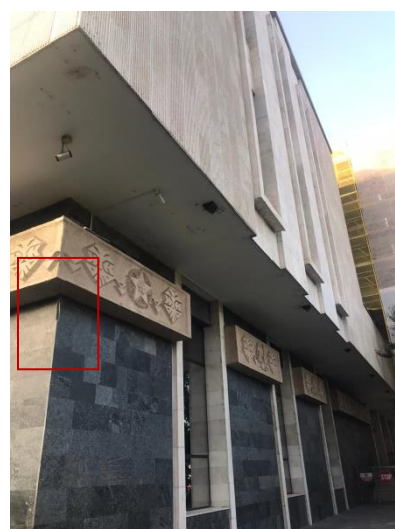
Fig. 11 Cracked tiles on facade

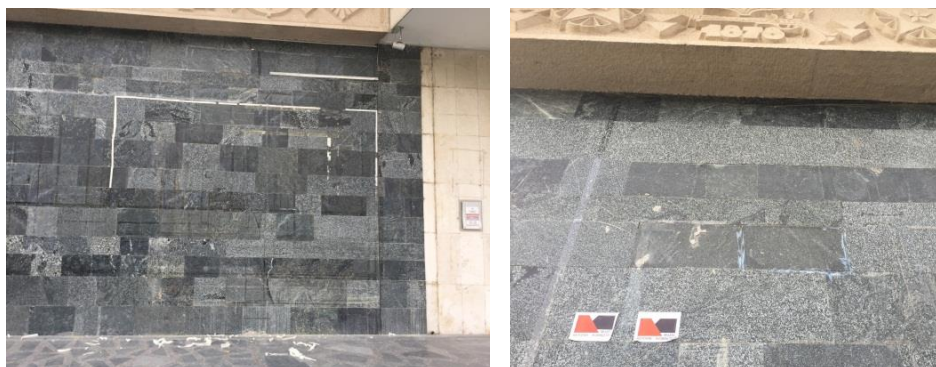
Fig. 12 Impurity on the face from the sticking posters

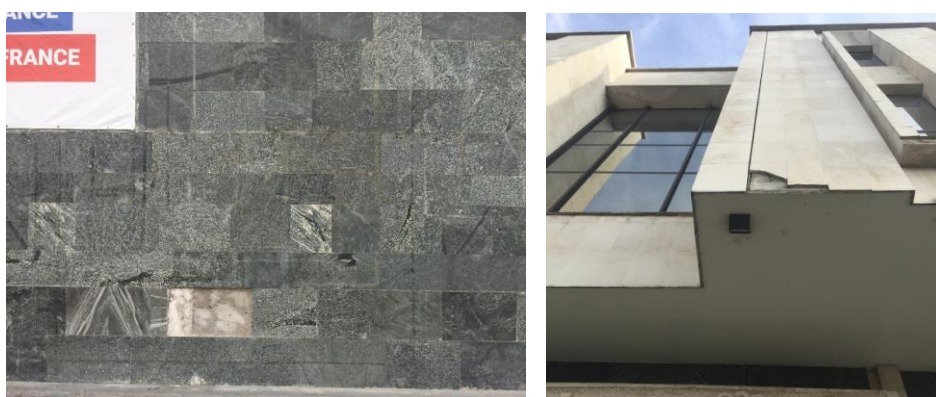
Fig.13: Damage to tiles and finishes

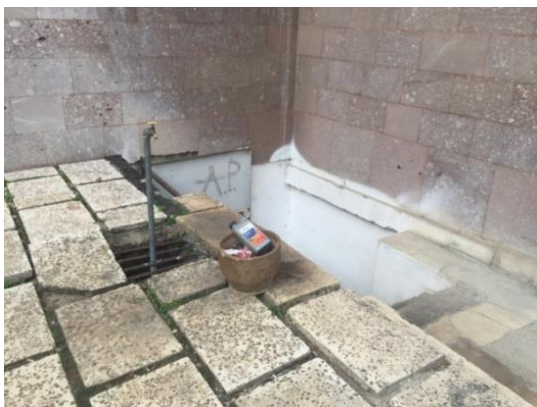
Fig. 14 Damaged floor tiles

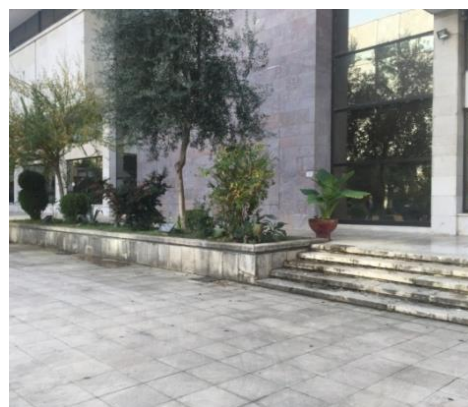
Fig. 15. Damaged stairs treads

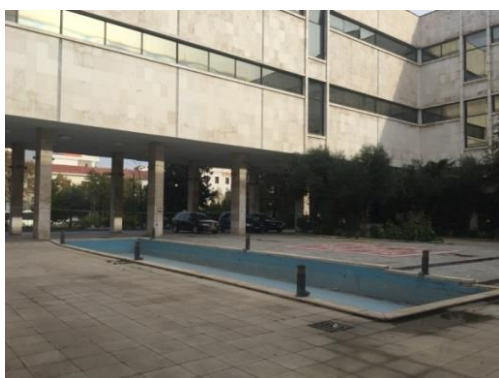
Fig. 16 Amortized and non-functional fountain

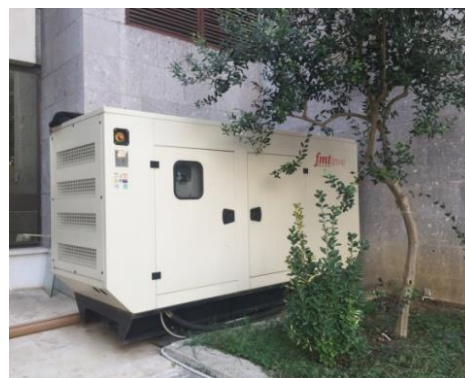
Fig. 8 Technical equipment exhibited in the yard
