ELECTRICAL TECHNICAL REPORT

NATIONAL MUSEUM OF HISTORY

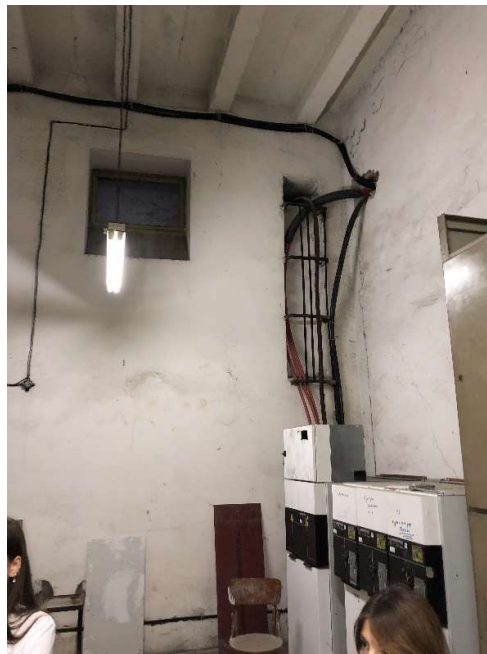
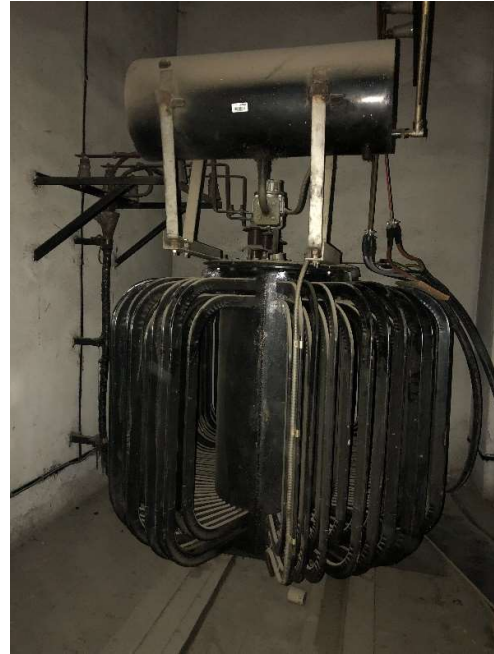
The technical spaces dedicated to the supply of electricity are sufficient and with surfaces which are considerable, but the equipment and their configuration in these premises is not in accordance with the requirements of the facility. The medium voltage switches 20 kV and the transformers were in operation, but they are oil transformers, installed in the basement which are unsuitable for working in these enclosed underground environments.

Medium voltage boards that were in use at the time of construction are also in condition in these facilities although most of them are out of function.

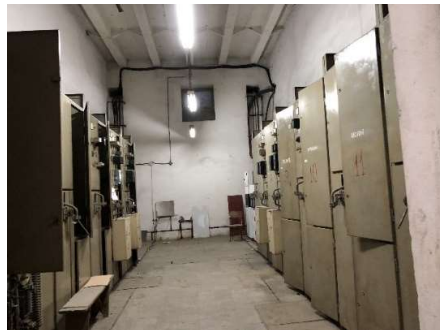
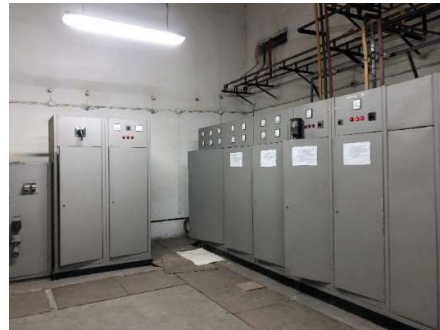
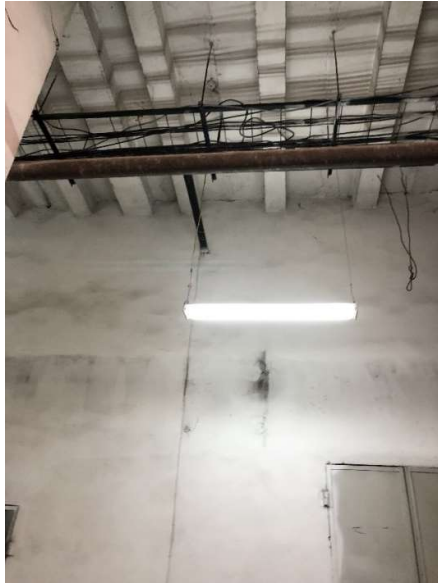
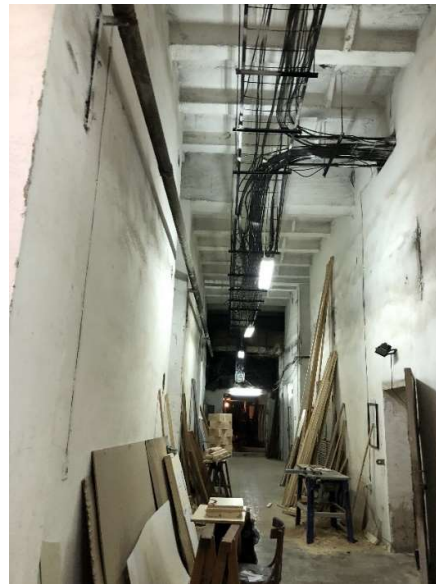
The main low voltage network is conceived according to the initial design with copper busbars installed in the walls to supply the main low voltage electrical boards and the distribution is made with electrical cables with PVC insulation protection with different dimensions.

The crossings of the power lines are chosen mainly in corridors or at the poles designated for these services, through the metal infrastructure realized by hanging from the ceiling.

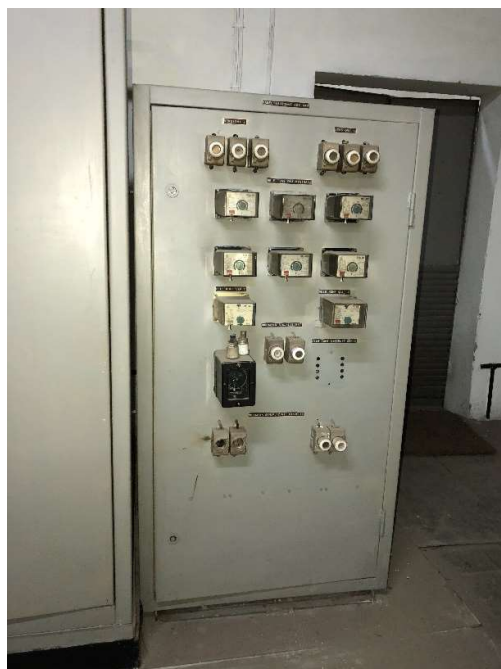
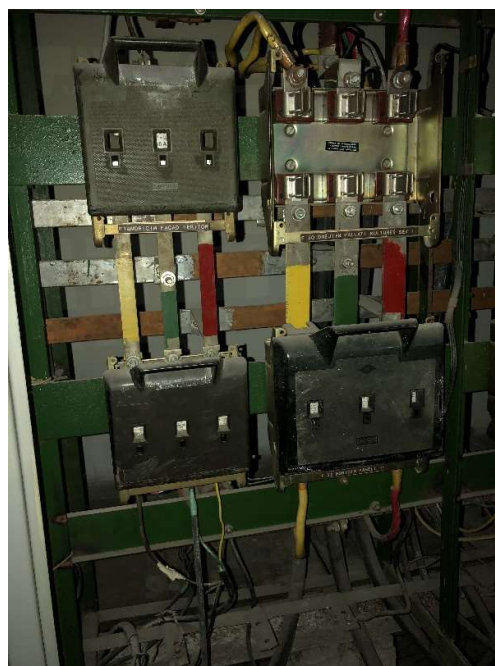
Low voltage boards are also built with protective devices with fuses, which have been in use at the time of construction, although in some cases they have been replaced with circuit breaker, the condition of these boards leaves much to be desired. They are no longer able to protect existing power lines and consumers and are no longer considered to adapt to new installations.

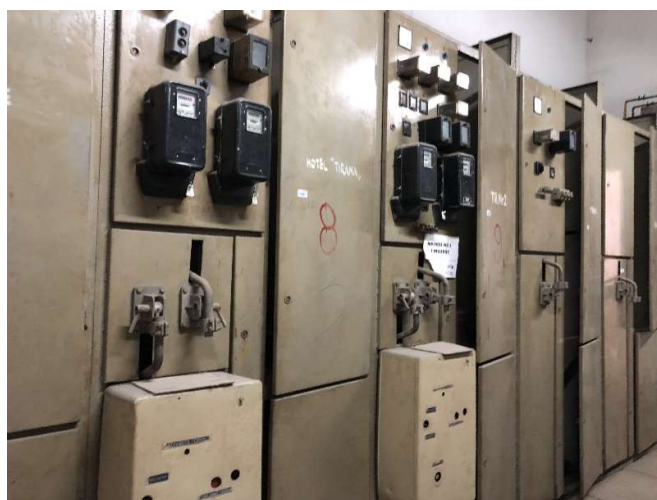
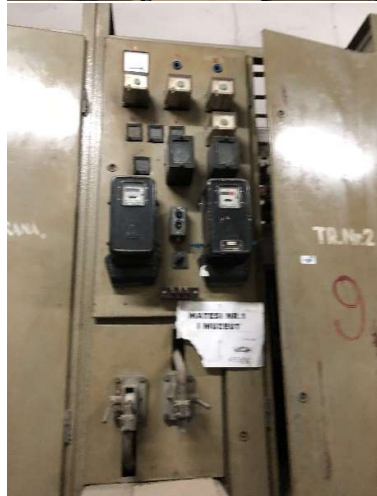
The measurement of electricity is done at low voltage, since the network was conceived for other users, and in recent years there has been an increase in consumers who receive electricity from this area. It is very important to identify all consumers and their respective contracts that are supplied with electricity from these facilities as the intervention in the electricity network of the reconstruction will be complete and in cases when these are private customers, should be reviewed the possibility of the power supply be done by the museum cabinet.

Based on the above information and considering the interventions that have been made over the years in the electricity network both in medium and low voltage, it is necessary to collect information from OSHEE for the interventions realized by OSHEE or if projects of recent years for intervention carried out by the institution itself, are available, in order not to carry technical problems and to find the appropriate technical solution.

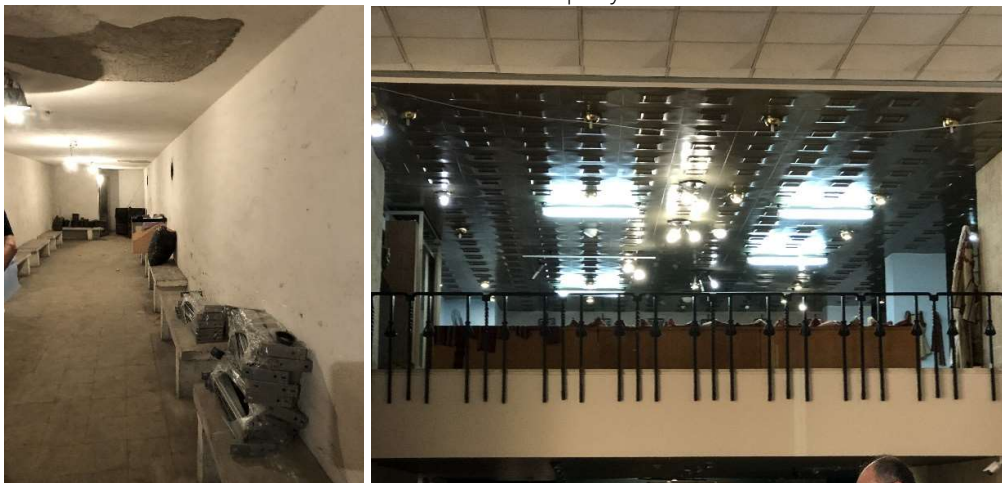
The interior lighting is realized with 40 w luminaires for the underground floor premises, but it is not in accordance with the requirements and lighting norms. Also, the lighting of the exhibition floors has been partially modified in recent years in accordance with the changes that these premises have undergone and replacements have been made of lighting fixtures and lighting lamps. The lighting is mainly with halogen lamps, fluorescent and in some cases even LED but not in accordance with the requirements and technical standards required for a museum institution.

The way of distribution, type of lighting, positioning, etc., must be adapted to the environment where they are used, as currently they do not meet the technical requirements for lighting based on illuminotechnical calculations that must accompany the technical solution of these installations.

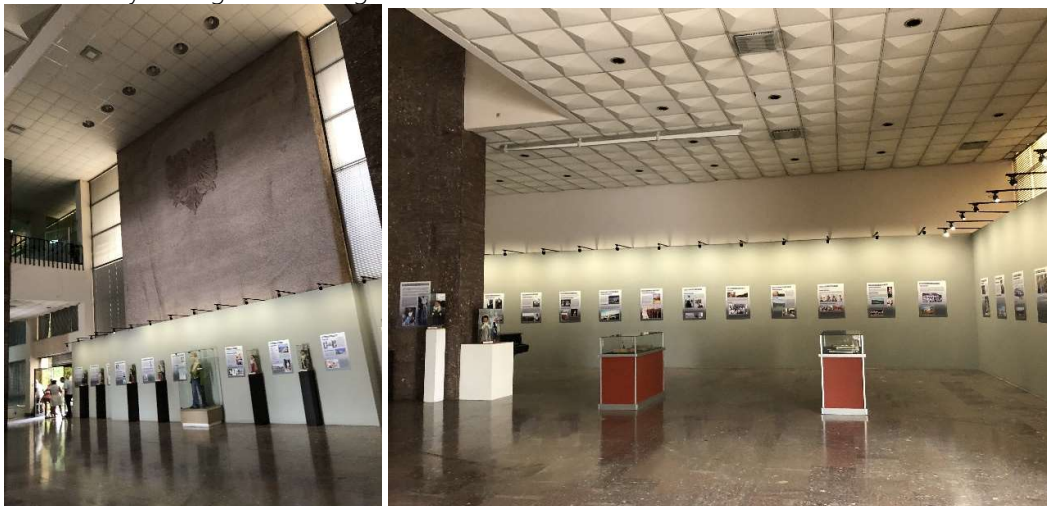
Emergency and evacuation lighting leaves much to be desired as it can not be evaluated as a system studied and in accordance with the requirements, and technical norms of installation given that in many settings it is lacking.

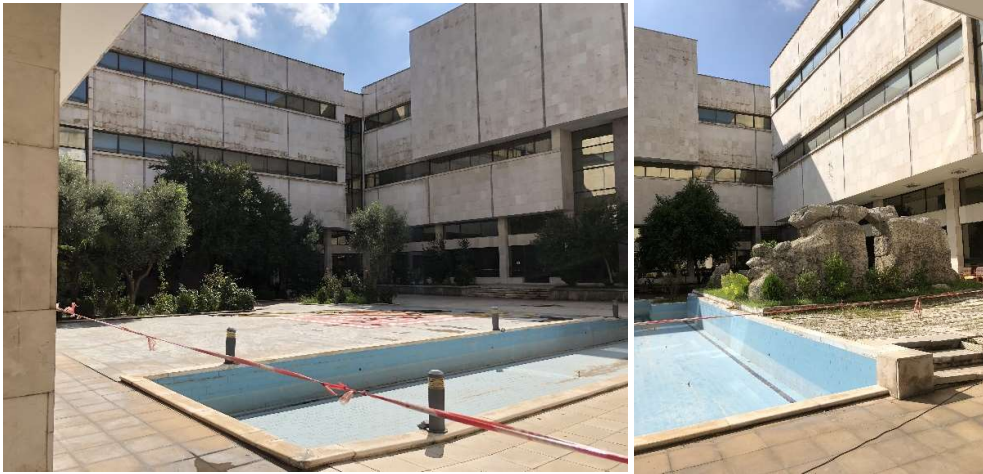
The outdoor lighting network is also realized with different lighting according to the interventions that have been realized during the last years through the lighting of the facade and also of the inner yard which are in some cases also out of service.

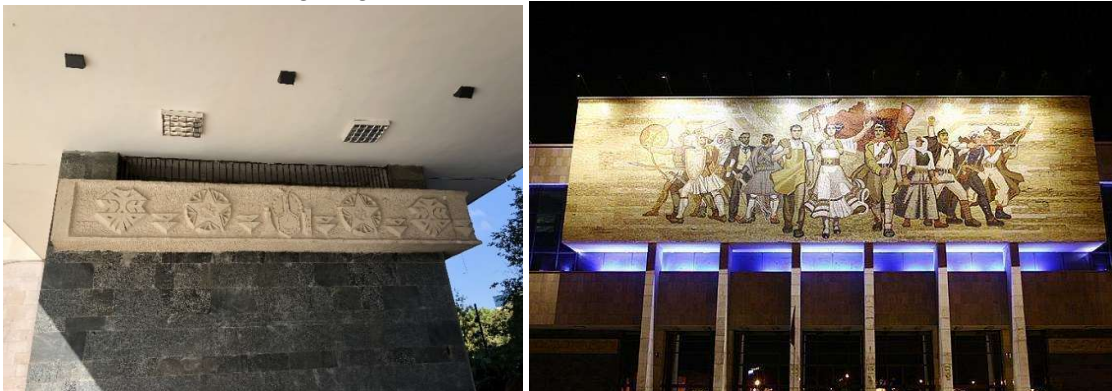
The lighting of the facade is also not complete and in accordance with the requirements and aesthetic criteria of lighting, appreciating the importance of this building, its position and the cultural values that it carries as an object protected by IMK. The visible part of the square is somewhat brighter, but on the inside the other facades leave much to be desired, as they are not treated at all in terms of lighting.

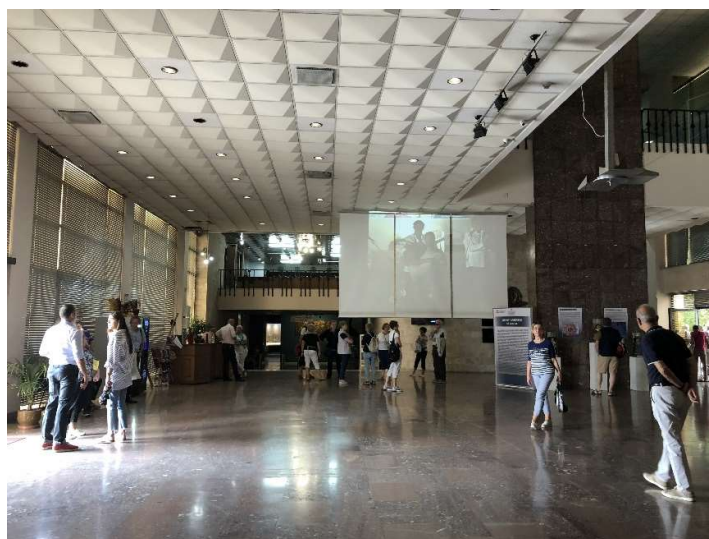
In the interventions that have been made in recent years, a system of internal cameras has been installed, mainly thin, and external in certain areas but which do not cover all the premises of the Museum, are not in accordance with the requirements of the Museum and will have to be

reviewed. compliance with the internal technical organization of the Building. The quality of the view, recording, configuration and monitoring of the CCTV system must be in accordance with the norms and technical standards of surveillance for Museum objects.
