TECHNICAL ASSESSMENT REPORT AND INTERVENTIONS "PARTIAL NORTHERN WALL OF LEZHA CASTLE"

HT Construction (High Tech Construction)"shpk
Nr. Liç. N.6886/3
Ing. Hydajet TOTA
Ing. Lavdie BIRBO

Tetor 2022

22644-001_ALB_EU4C_RFP_01 - "Provision of Consultancy for Design services for EU4CULTURE Project - Support for revitalization of cultural heritage sites and monuments affected by Earthquake in Albania."

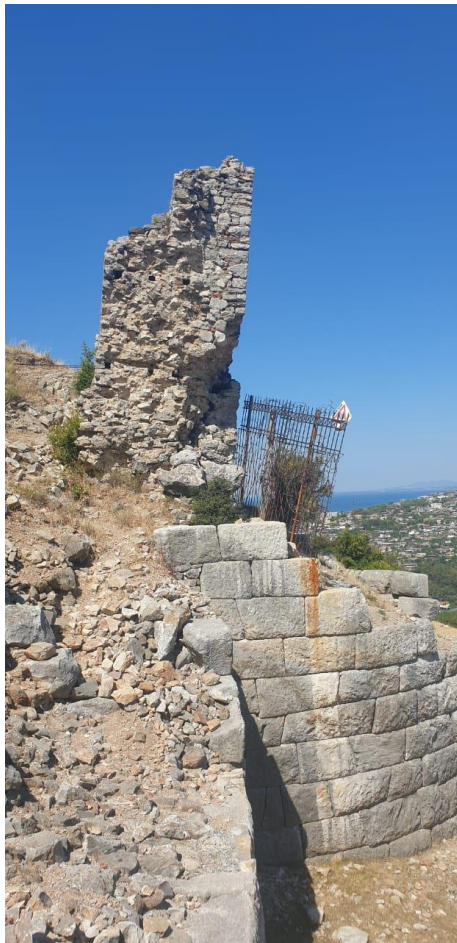
From the careful observations in the field, it is noticed that the wall has problems related to its stability since the wall has acquired a slope which causes it to be eccentric in the action of the normal force, a reason which can cause it to collapse and be destroyed.

Also, a problem that is easily noticed is the crack in the wall at its end or even along the perimeter of the wall, which causes a loss of its bearing capacity.

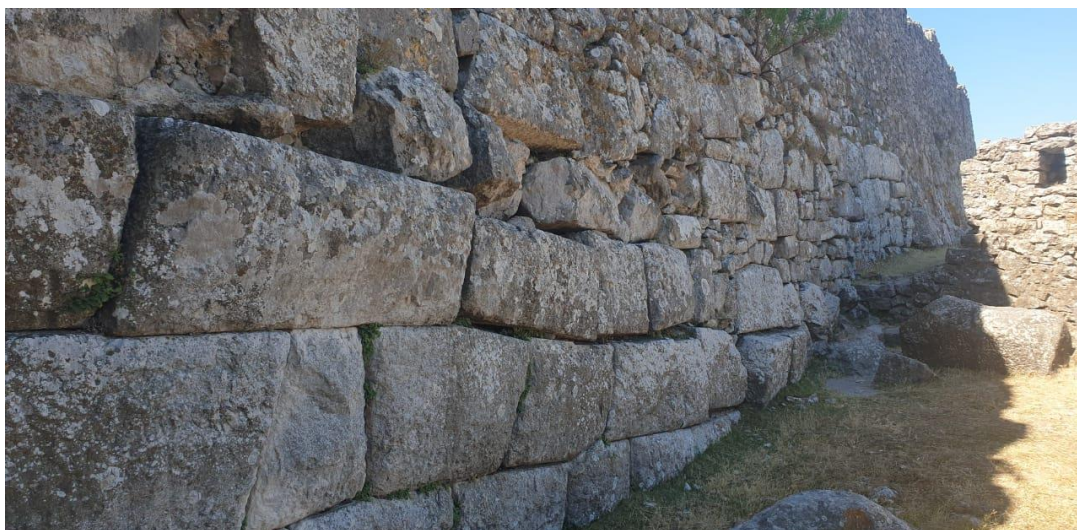
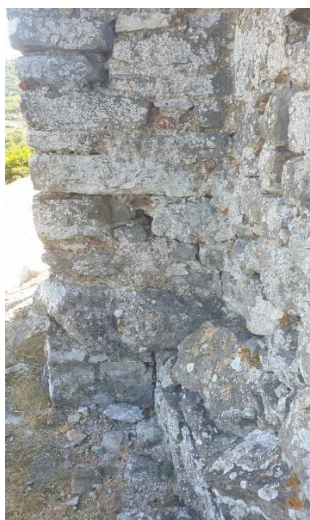
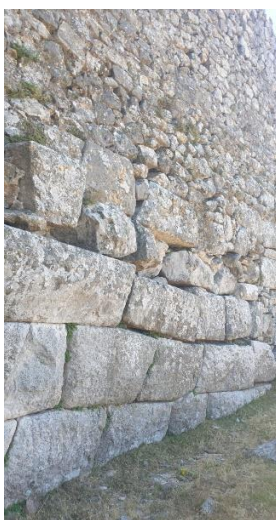
1. We are dealing with an old wall which dates back to the 4th century, with frequent interventions. The wall is exposed to atmospheric agents, causing a decrease in the bearing capacity of the wall itself. Its composition is wall built with different sections in different periods..

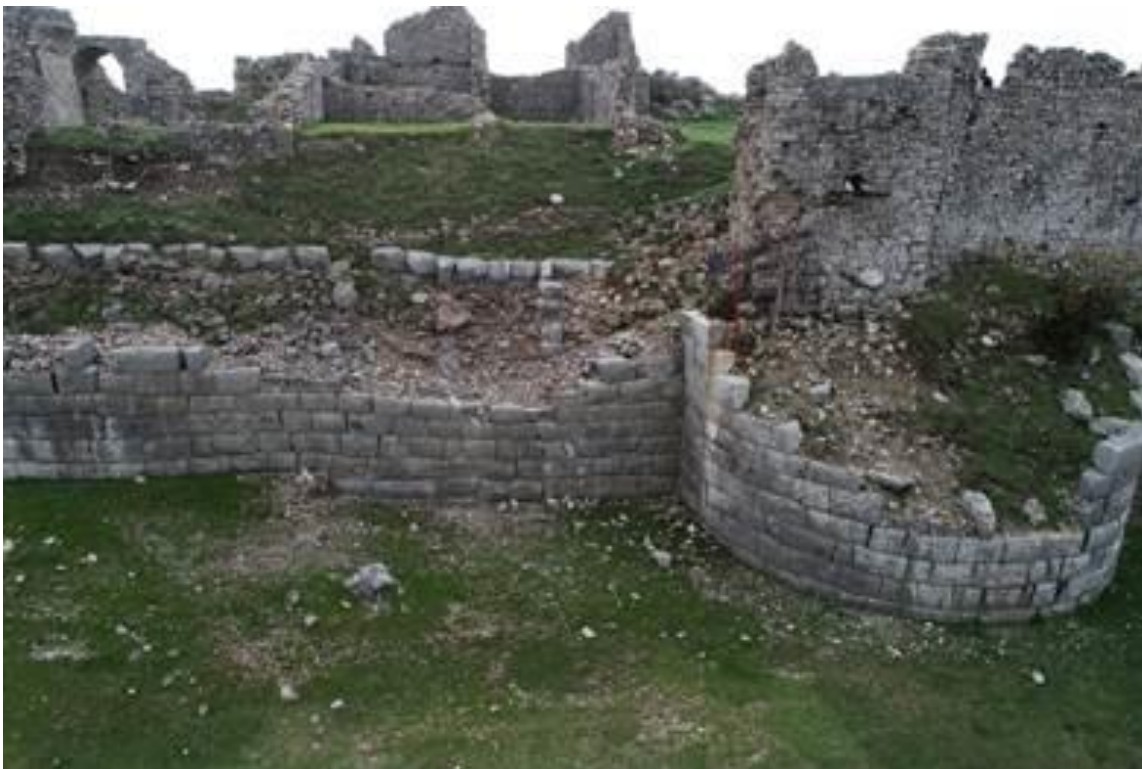
2. From the field visit, it is noticed that the wall being studied is part of a continuous wall, which has been destroyed in different parts of it. This has led to the loss of its structural connection. In our opinion, this is one of the main reasons why this wall is heading towards destruction.

Below with photos we present a part of the destroyed wall and the damaged wall, with two topologies. These are arguments that it was the same wall as the one missing in the photo below.

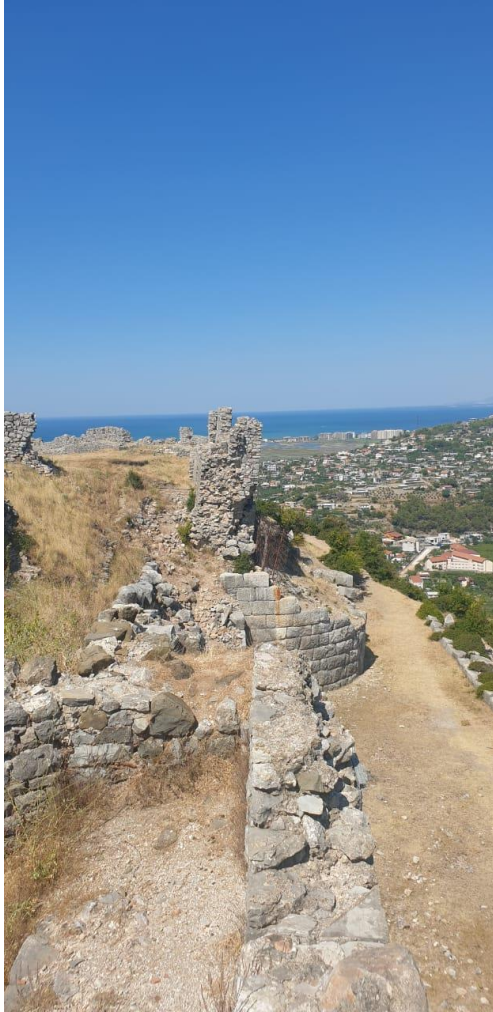
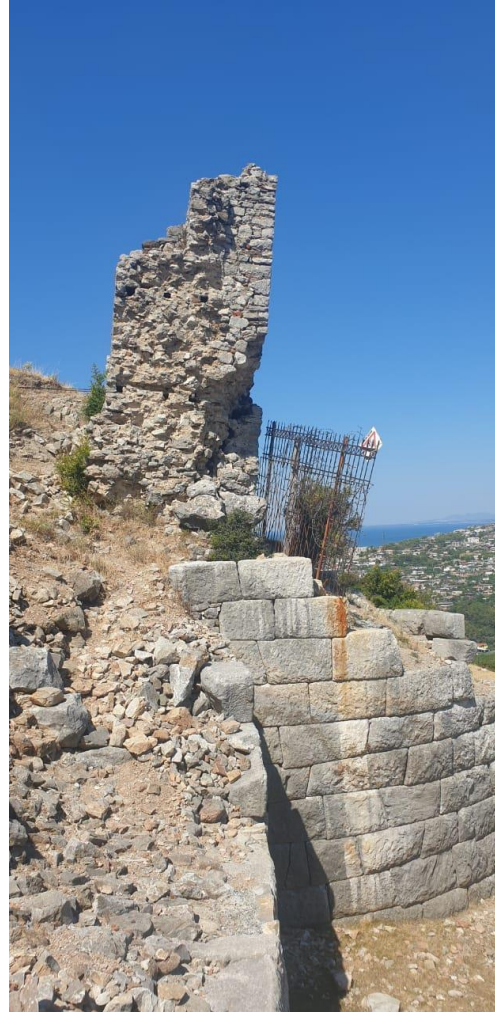
3. The increase of the soil level behind the wall over time, due to the movement of soils as a result of atmospheric agents, and not only. Since the wall in this area was the end part, it also served as a place for depositing soil. The increase in earth pressure on the wall has exceeded the bearing capacity of the wall, leading to its damage.

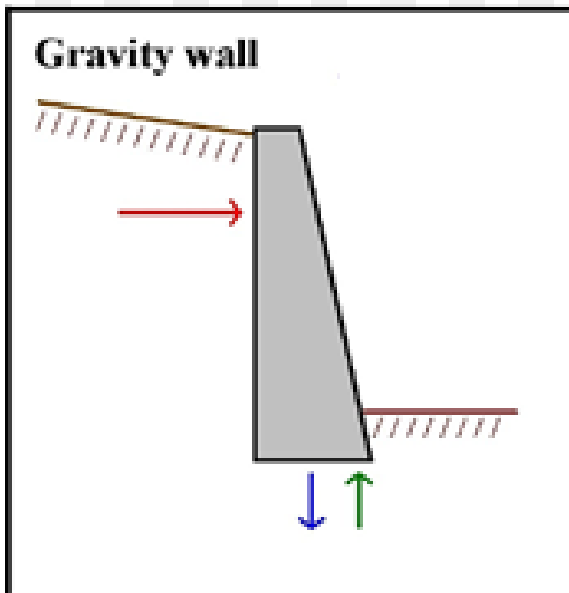
The schematic below shows the soil pressure before it fails..

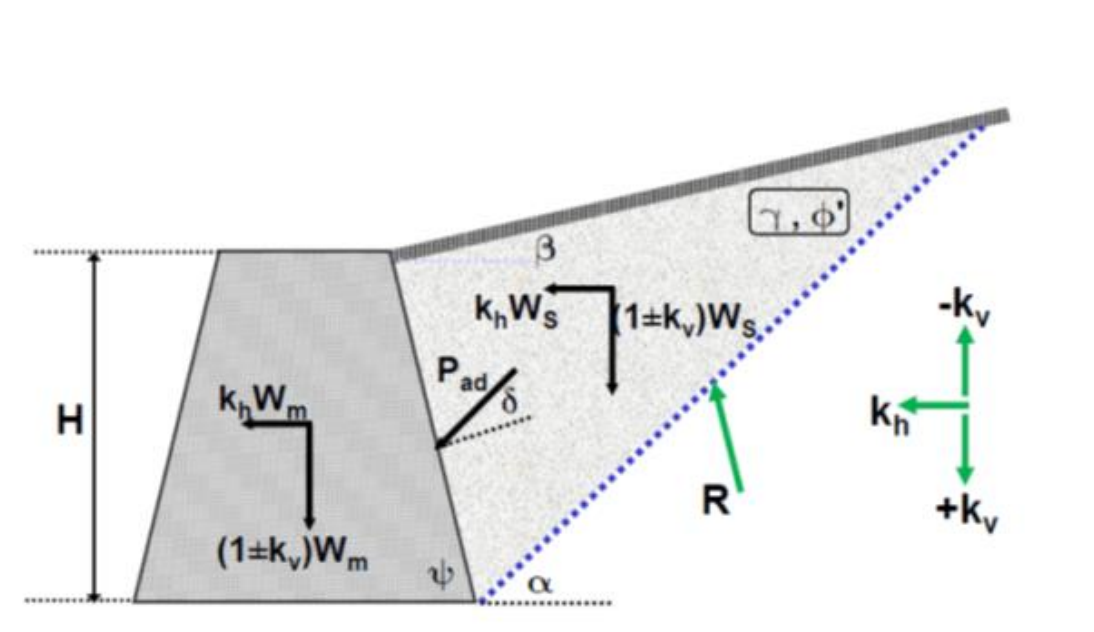
According to Eurocode 8.5 chapter 7 "Earth Retaining Structures", in case of a seismic situation, we have an increase in soil pressure due to the seismic situation. Below is a schematic presentation of the pressure in the seismic situation:

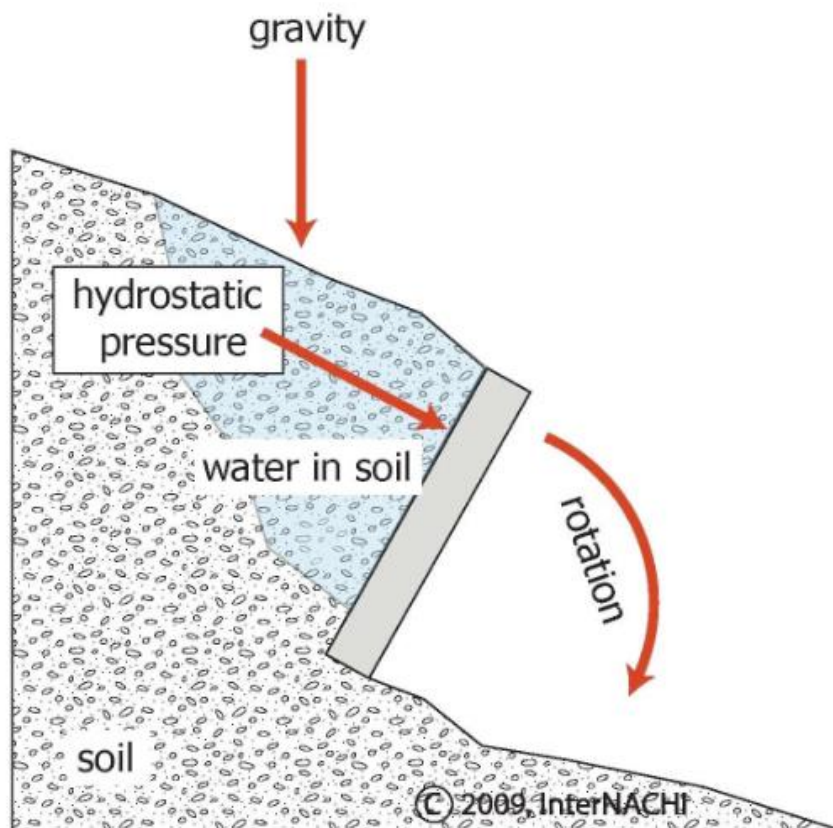
5. Non-drainage or malfunction of the existing drainage behind the retaining wall has resulted in increased pressure from the ground in the presence of water.

Below is a schematic of the pressure that may have resulted from the malfunction of the wall drain.

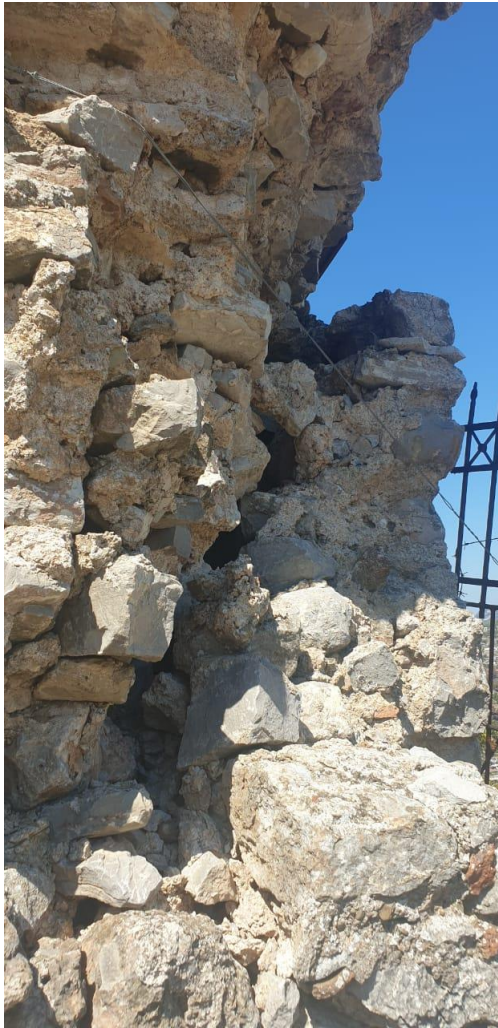
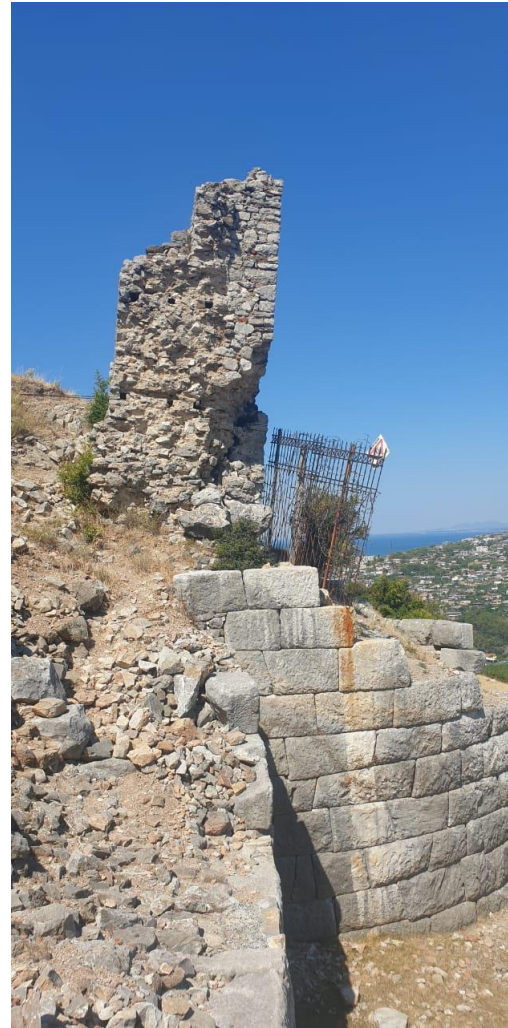
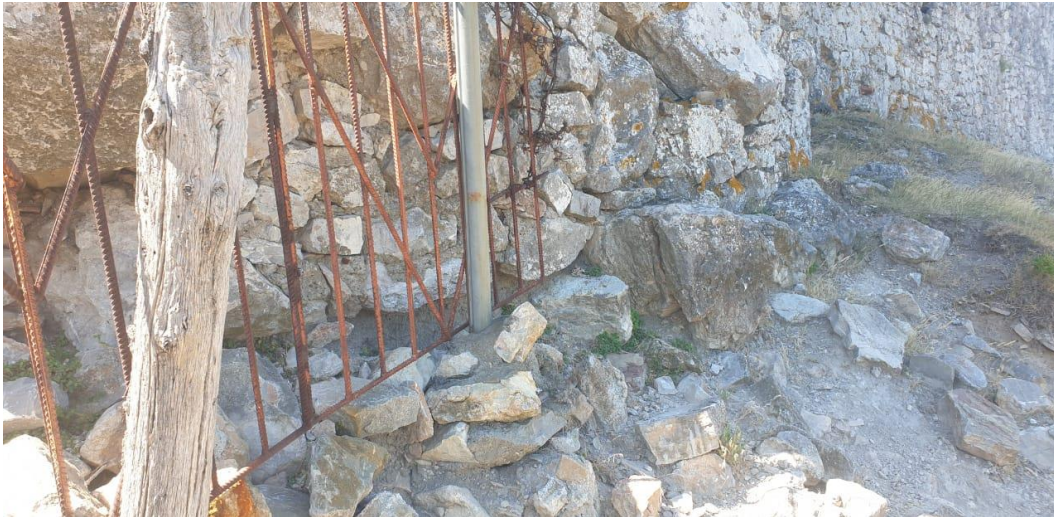
6. Loss of the bearing capacity at the base of the foundation, regardless of the fact that the exposed area may not be the true base of the retaining wall, there is a loss of the bearing capacity of this area, this is also reflected in local damage to the retaining wall near the foundation, something that has put the entire retaining wall in more difficult conditions and may be the main reason for the advancement of the further movement of this part of the wall.

3. Injection of grouting in the part of the base of the wall that risks collapse. This kind of intervention is done to increase the foundation stability soil of the wall and to give a positive impact to the bearing capacity of the wall.

4. Removal of the damaged wall in the foundation(bottom) part and its repair.

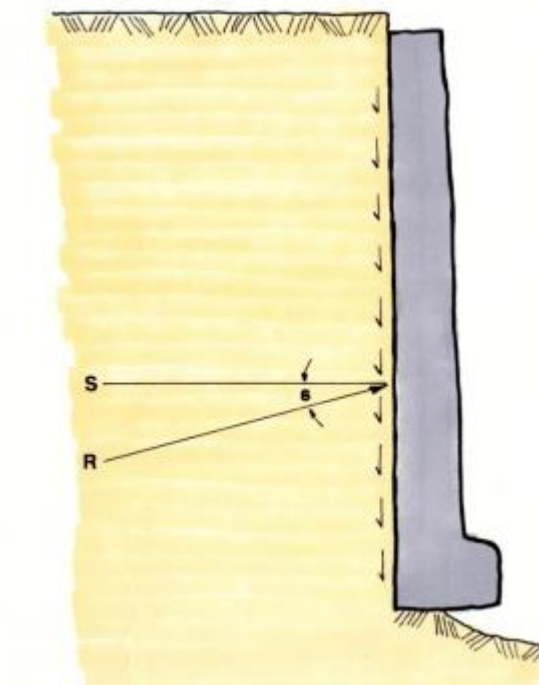
In a schematic way in photo below, we are presenting the loss of stability of the base of the foundation:
