GUIDANCE FOR IMPLEMENTATION OF WORKS AND MAINTENANCE PROGRAM AND PLAN "EMERGENCY CONSOLIDATION OF THE NORTHERN WALL PORTION OF THE CASTLE OF LEZHA"

22644-001_ALB_EU4C_RFP_01 - "Provision of Consultancy for Design services for EU4CULTURE Project - Support for revitalization of cultural heritage sites and monuments affected by Earthquake in Albania."

3.1 EXISTING CONDITION OF THE STRUCTURE

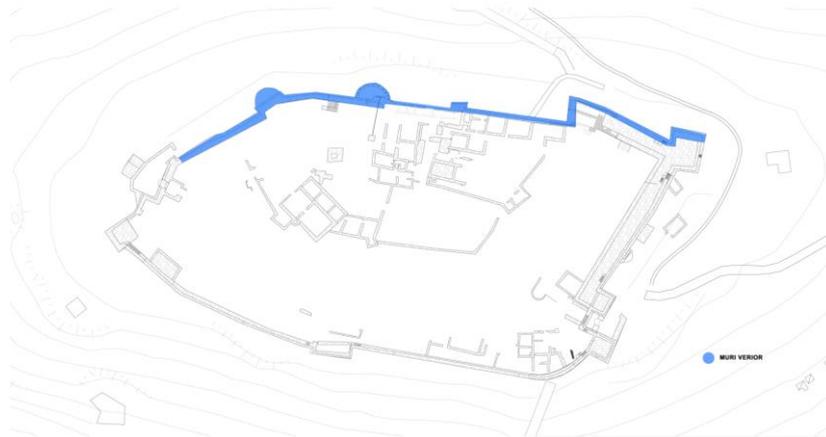
Northern Wall

This area presents the biggest structural problems. It is noted that on the northern wall near the tower circular with polygonal stones, there is a deep crack in the entire height of the wall and its inclination. This has also led to the tilting of the tower over the circular tower. This area has always been problematic, for this reason, the square tower is reinforced with metal vaults from an old intervention from the staff of the Institute of Monuments.

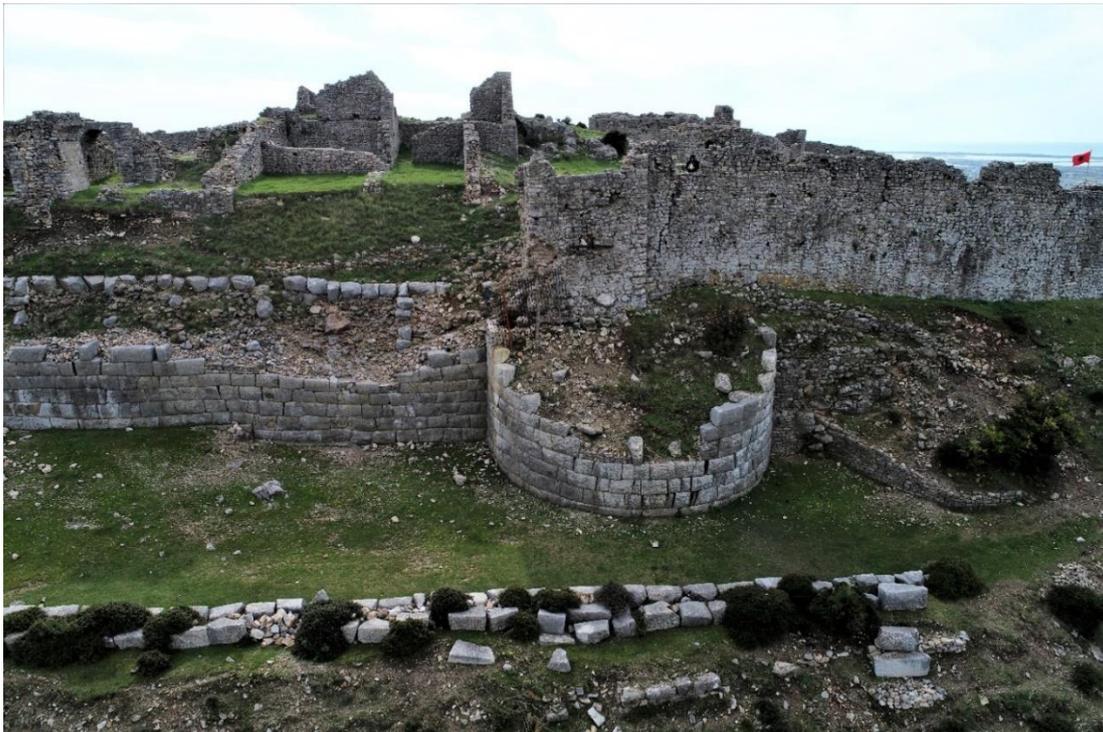
After the earthquake of 26.11.2019, the castle suffered a partial collapse of the stone masonry and ancient blocks. There is also a loss from the verticality of the stone wall in the northern part. Its structural elements have suffered significant damage.

Current condition; Northern Wall

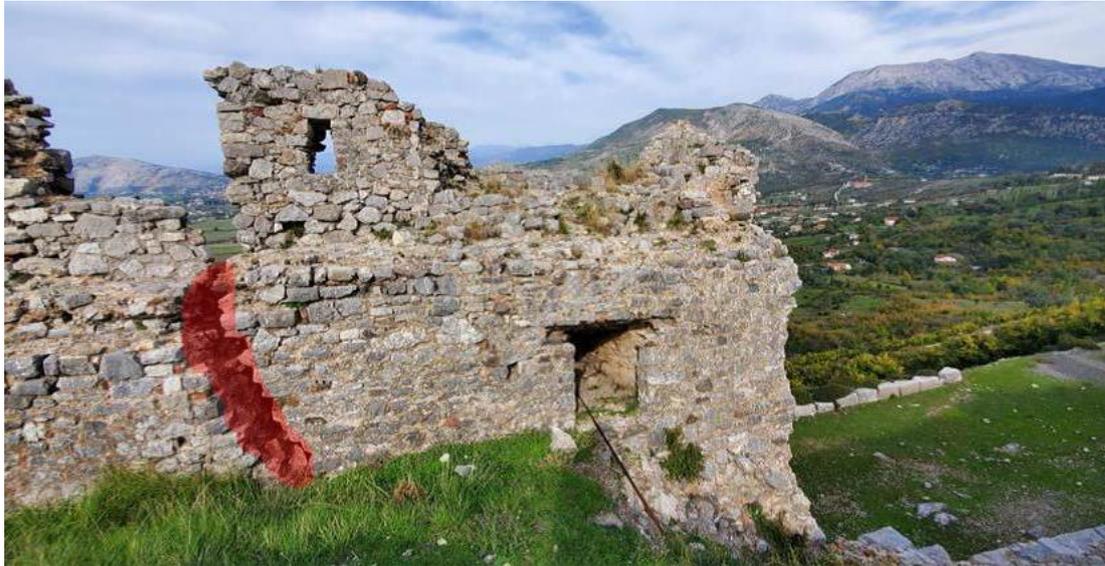
Structural Wall crack

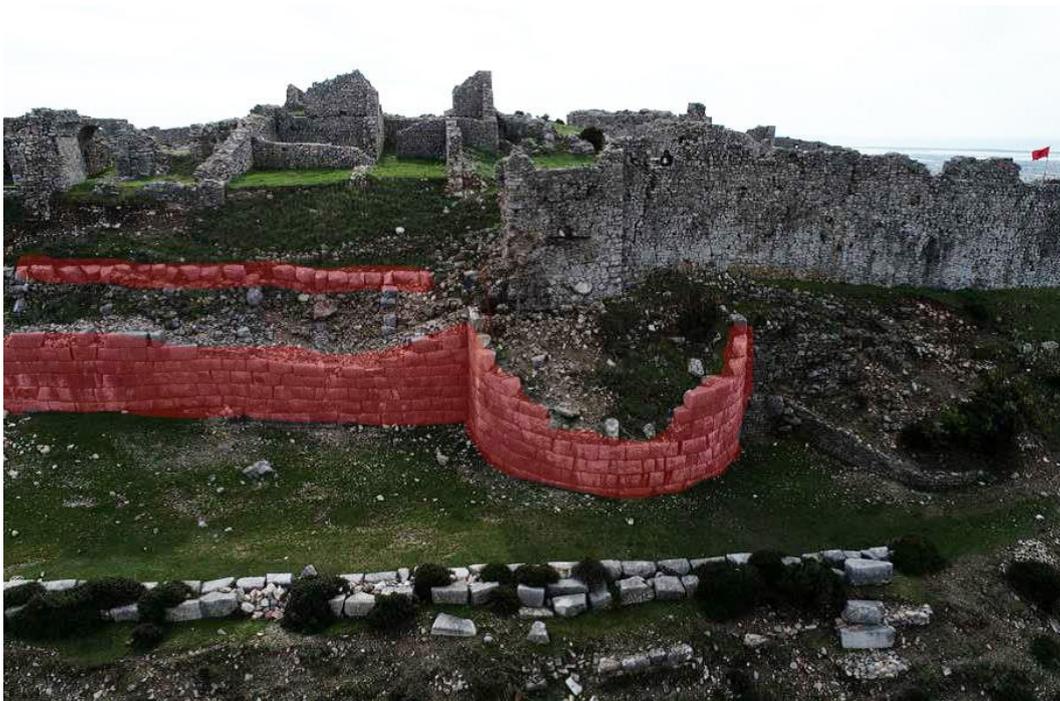
Damage to the lower part of the stone masonry

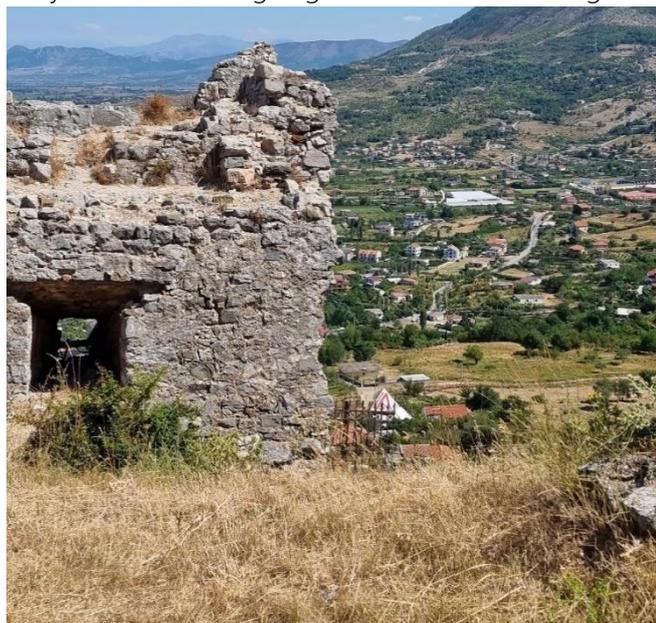
Near the north wall there is no fire hazard from man-made elements. The stones of the Castle itself are non-combustible material, but if touched by fire they may crack; break and have a total structural collapse in the event of a major fire.

Greenery surrounding the wall; summertime

peratures do not damage the structure. We recommend not allowing the grass to grow to a significant height because in high temperatures during the dry season, together with human carelessness, pose a risk. We also recommend that an inspection for exposed electrical installations be carried out during the works phase; and if there is then rearrange to reduce the risk of fire.
