## GEOLOGICAL REPORT

# "NORTHERN WALL SECTION OF THE LEZHA CASTLE"

**22644-001\_ALB\_EU4C\_RFP\_01 - "Provision of Consultancy for Design services for EU4CULTURE Project - Support for revitalization of cultural heritage sites and monuments affected by Earthquake in Albania."**

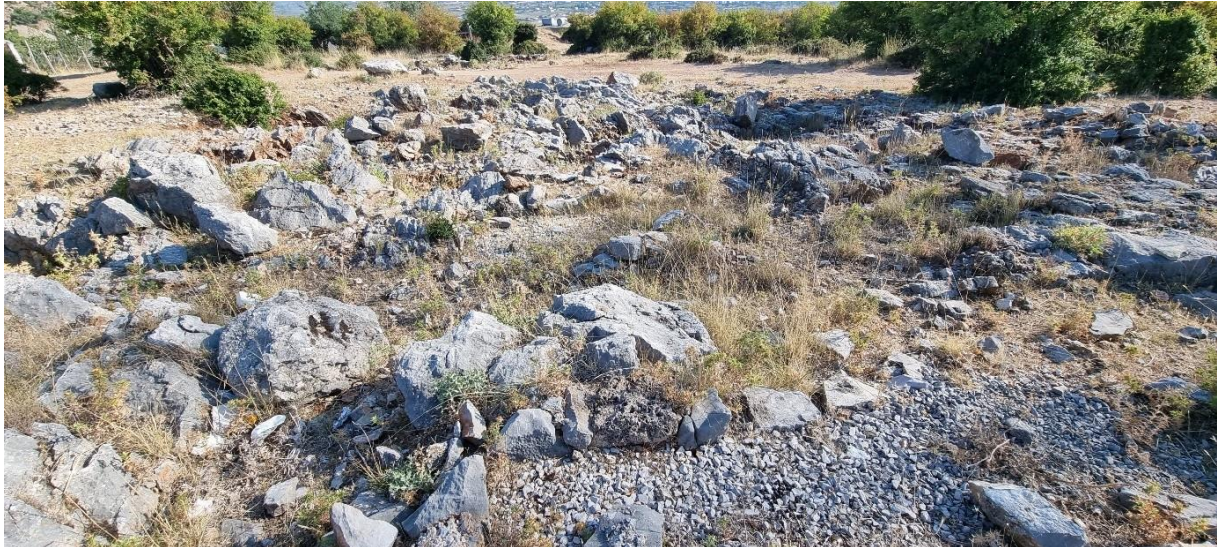
*Fig. 4: View of limestone rocks Upper Cretaceous.*

The phenomenon of weathering in our construction site is noticed, but in a non-alarming form for the stability of the site, since we mainly have limestone rocks, quite compact. This phenomenon is observed only on the surface of the rocks in the form of cracks that do not go deep.

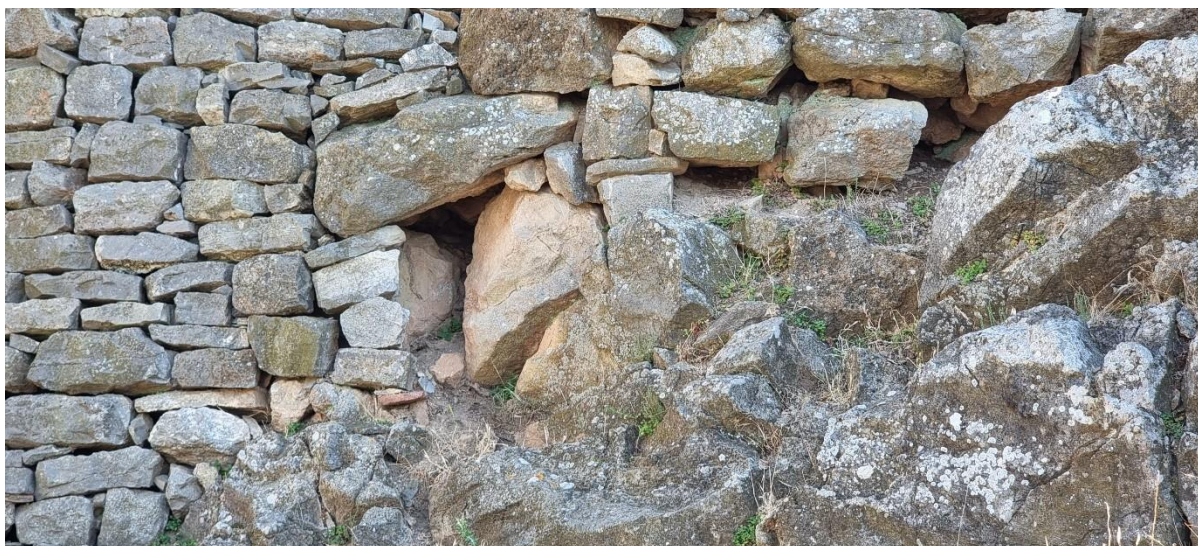
- No cracks have been detected due to the effect of drought or swelling.
- From the reconnaissance carried out, it results that the foundations of the fortress wall are based on limestone rock with very good geotechnical properties.

*Fig. 5: The wall of the castle located in the rock, in the northern part*

- If it will be excavated for a new foundation, before filling, the geologist should be present on site for the corresponding report and record.

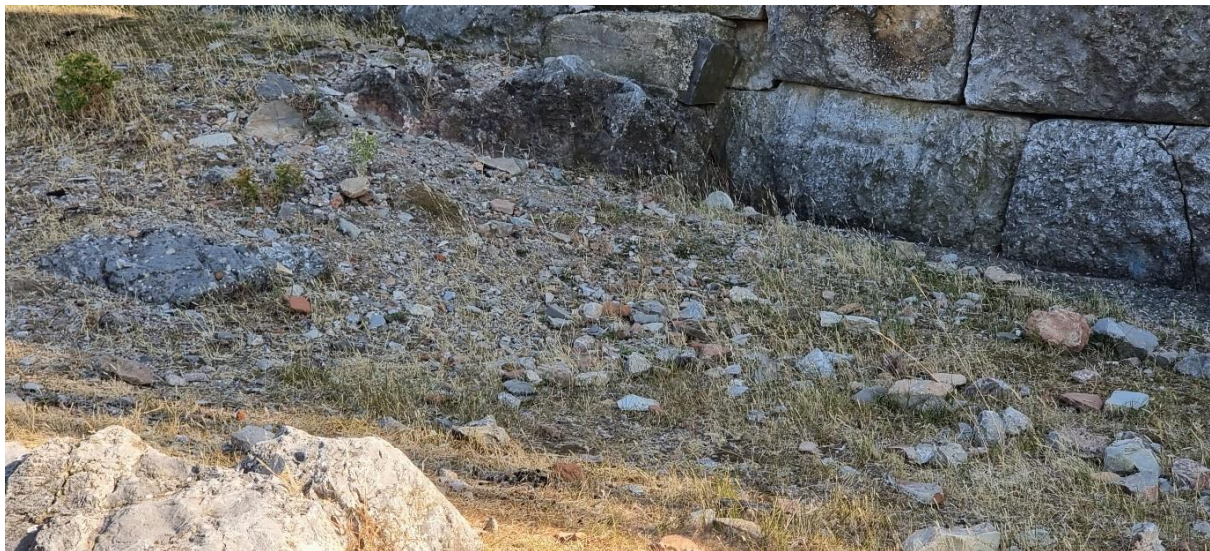
*Fig. 6: The rock that come to the surface near the wall (northern part).*
