The Monastery Church Rubik

The conservation design for the wall painting

Tirana, March 2022

Anex 1: Monastery Church, RUBIK

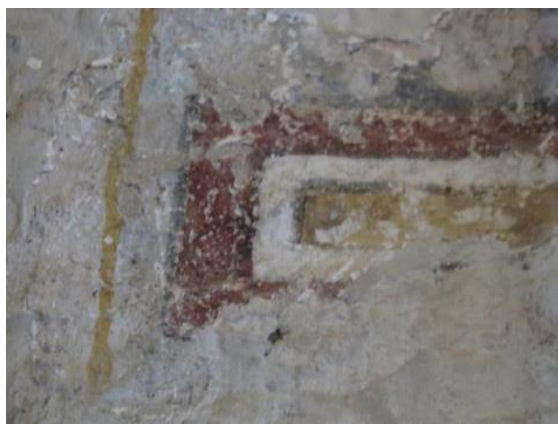
Fig. 7 Decoration above the southern section

as if they were dancing. The drawing shows all elements as in movement, as if feet are stepping, and as if hands are opening in embrace and if the heads are bowing according to the music including the drapes of traditional clothes showcased in a number of moving felts¹¹. As for the announcement scene, it is divided into two scenes on both sides of the conch. Today this scene is not visible any longer, while its iconography is confirmed only through historical documentation of Dh. Dhamo (fig. 5, fig.6). Painted plaster surfaces can be seen on both side walls of the apse (north and south). Although fragmented, the colors contained as well as the geometric motifs presented are clearly discernible. A good part of them are covered with different layers of plaster, placed carelessly and irregularly (fig. 7, fig. 8).

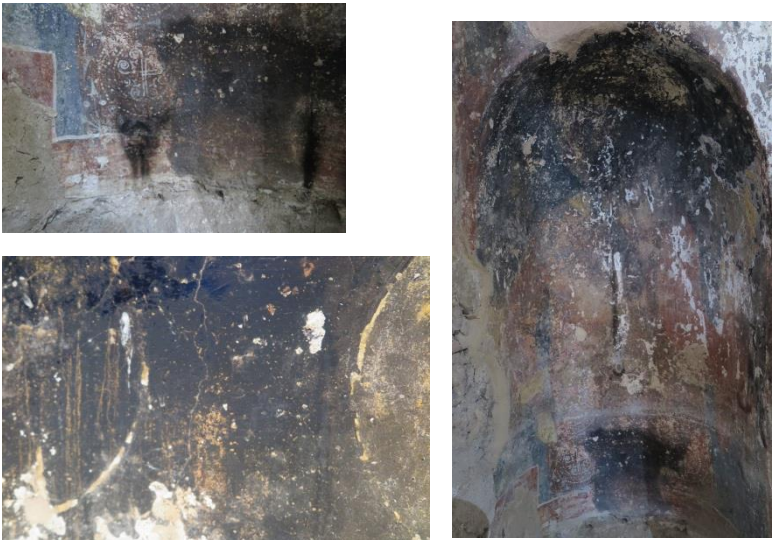
NR	PATHOLOGIES	PHOTO
1	Darkening of the painted surfaces

Darkening of painting surfaces will be treated with Tween 20 - neutral non-ionic surfactant derived from ethylene oxide. Tween 20 is soluble in water, alcohol (ethyl, methyl, isopropyl), ethylene and propylene glycol.

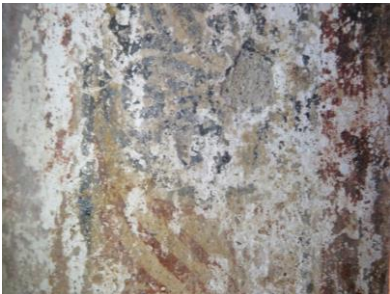
2	Abrasion of the wall painting surface

The consolidation process should also aim at consolidating the base layers from abrasion and decomposition. For the specific case, which is related to the pathologies of abrasion and decomposition of the base layers and painted layers, - Nanorestore is suggested to be used. It is important that the materials used in the consolidation operation do not change the chemical and physical characteristics of the original materials and constitute a cause of chemical degradation of the original material, neither at the time of injection nor in the subsequent stages. Based on the conversion of hydroxide to calcium carbonate by the action of atmospheric carbon dioxide, Nanorestor is the "par excellence" consolidator compatible with frescoes but also with other materials with a carbonate based material mixture. As such, Nanorestor has excellent permeability to water vapor, does not imply chromatic variations or glossy effects, and maintains hydrophilicity and the absence of hydrophobic surface films.

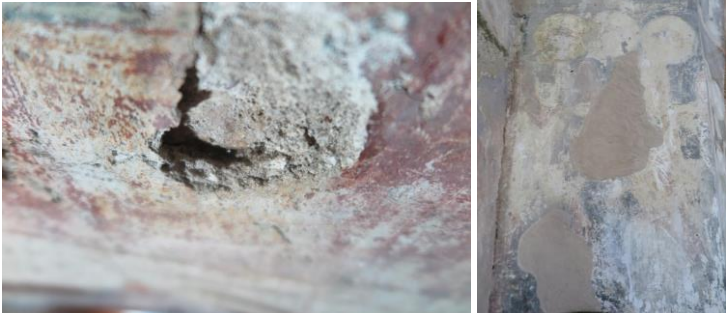
3	Recent addition of plaster

After stabilizing the surface through consolidation, as well as after cleaning of the surface, the necessary filling of lacunae and voids shall be undertaken. As currently observed the different stages of restoration have brought a number of different interventions and materials to appear on the surface. The removal of old plasters and the infills of gaps and surfaces with a new plaster similar to the original plaster shall be undertaken. Removing the old infills shall secure the structural stability of remains of the wall painting and will make the surface more readable.

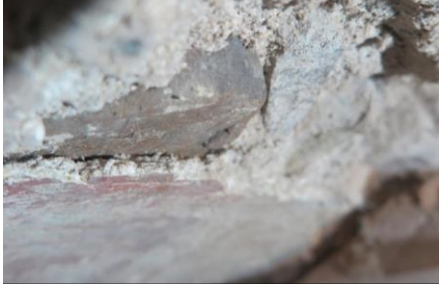
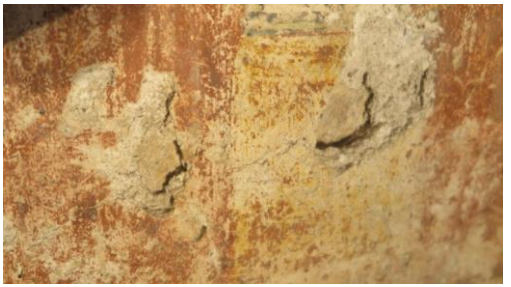
4	Collapse of base layers

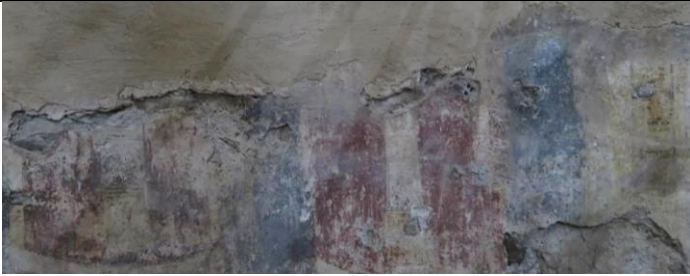
5	Disconnection of base layers

This process should continue with the appropriate fixing and adhesion of the base layers to the support. In this case, the adhesion between the base layers must be evaluated with a non-invasive study (acoustic survey) which allows the assessment and localization of the "gaps" corresponding to the points of detachment both between the base layers and the masonry. Consolidation consists of performing localized micro-injections of a consolidator selected on the basis of compatibility with the component

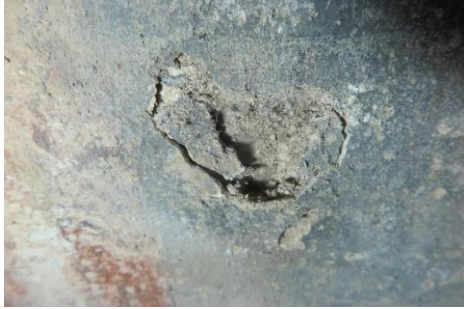
6	Cracking of base layers

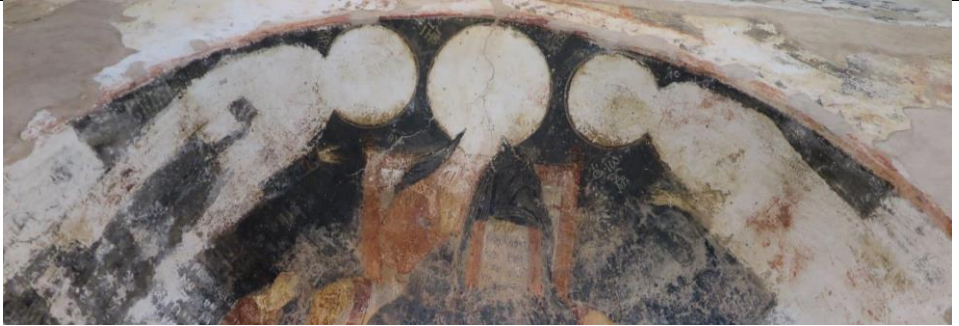
7	Collapse of painted layers

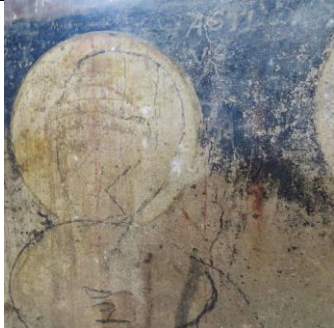
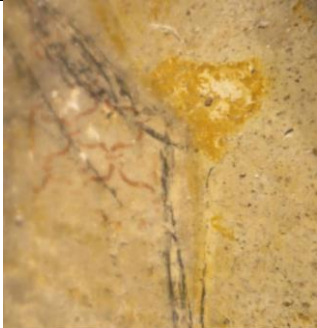
8	Re-painting efforts

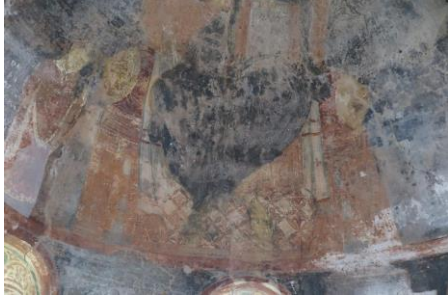
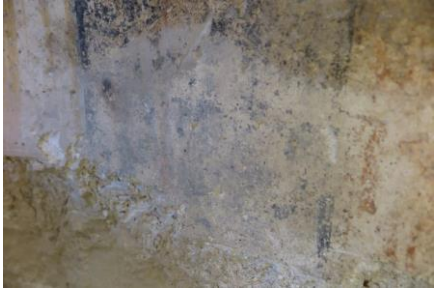
9	Salts/efflorescence

Biological deposits as well as numerous salt deposits evident on the surface are meant to be treated with the solid homogenized gel obtained from the double baking of AgarArt (Nevek) usually used for cleaning of the surface of the fresco in this case. Nevek in this case can also be mixed with suitable solutions such as ammonium carbonate in different percentages (according to the situation on site). Nevek strongly retains water and can be used to absorb dirt even from moisture-sensitive surfaces.

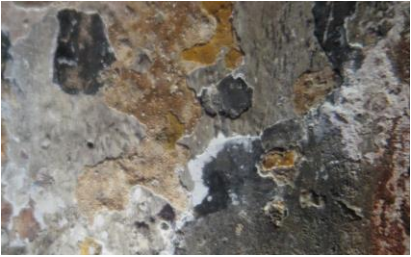
10	Remains of the lime over the painted surfaces

Cleaning is a very special and delicate process as it is an irreversible intervention, and must be evaluated very carefully on a case-by-case basis. The cleaning intervention shall be directed at removing the foreign substances, without affecting the original material and while respecting the historical patina of the painting. Therefore, the removal of unstable inadequate surface materials will be done with soft brushes. The removal of materials firmly attached to the surface (layers of lime or superimposed plaster) will be carried out mechanically using spatulas and scalpels.

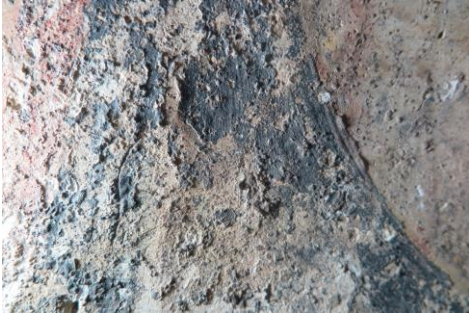
11	Detachment of painted layers

For the first stage of consolidation, the pigmented layer which is separated from the base is fixed by applying acrylic resin Acryl 33 diluted in distilled water. Mowital B 60HH could be a good option as well, since it responds very well regarding reversibility, resistance to time and aging, transparency and quick application. Further to this, Mowital B 60HH as well secures minimal shrinking. Mowital B 60HH can be applied as diluted with alcohol in a multiple ratio, depending on application. Mowital B 60HH can be reversed by alcohol and acetone. Melinex, when added, should further secure stabilization of the painted layer within its original place.

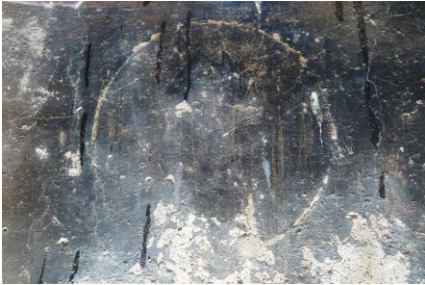
12	Drops and dirt over the painting

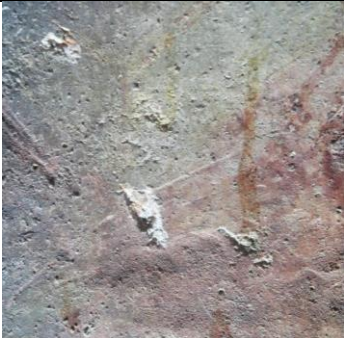
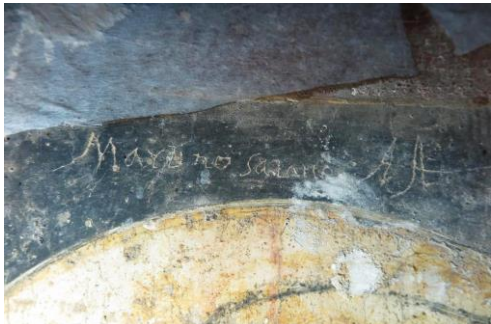
Mechanical damage is present on the wall paintings and those appear to be the result of carelessness and engravings resulting from attempts to repaint the portion of the painting. In the lower portion of the painting, the mechanical damage was most likely done deliberately after 1968. And as a result it damaged three remaining portraits in the lower portion of the painting as well the one on the north side of the apse. Areas of fallen sections of painting are also identified. (Attached annex 1 shows illustrated pathologies of degradations).

13	Mechanical damages

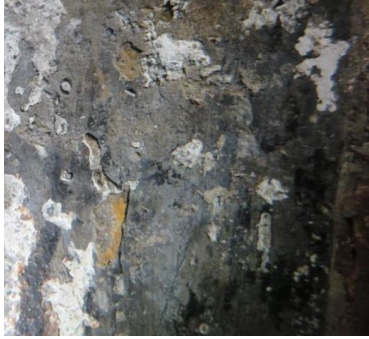
14	Drops of wax (from candles)
