“Full design preparation of façade mosaic restoration of Albania’s National Museum of History”

Technical Report of the Detailed Design / Implementation Bill of Quantities / Prices analysis
Raport Teknik i Projektit të Zbatimit / Preventiv total i Investimit / Analiza e çmimeve

C36576 - D - R - 00

Date / Data August 2019 / Gusht 2019

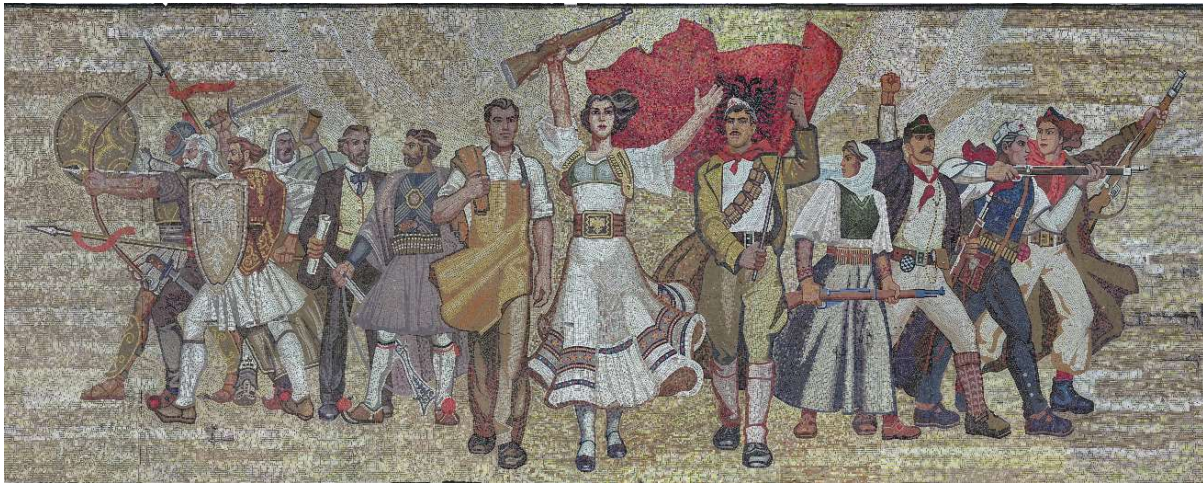
Fig. 2 – Full frame of the mosaic in the Facade of the Historical National Museum

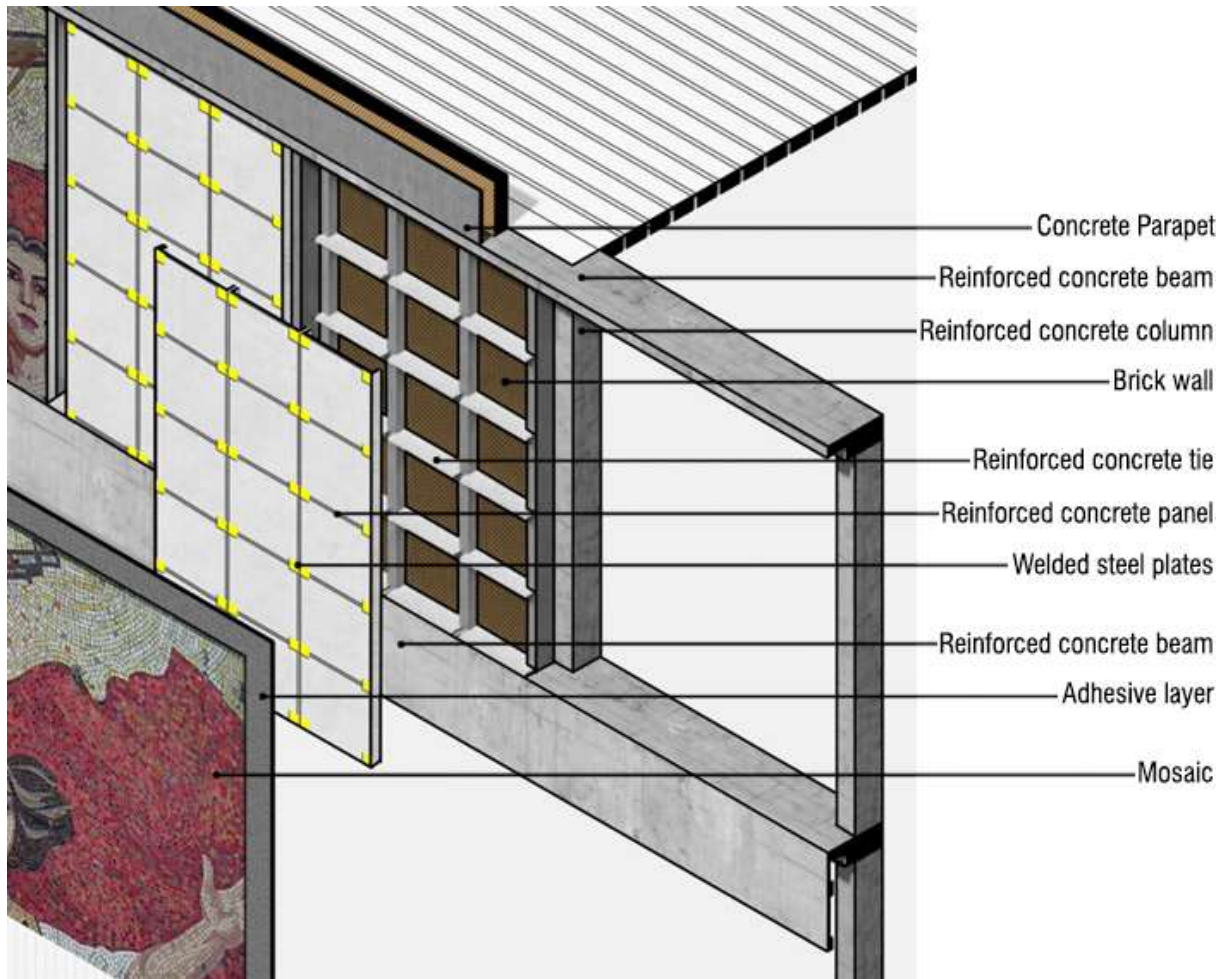
Fig. 4 – Illustration of mosaic construction layers

At the upper part of the columns of the southern facade colonnade, starting from the highest level, 21.30m and going down toward the ground level, there are mounted the armed concrete panels, which would serve as the main support of the mosaic. There are 15 concrete panels, 11x2.5x0.2 m large. These panels have been preliminarily produced at the "Josif Pashko" construction factory, in Tirana, and from there they have been transported to be mounted in the Historical National Museum facade. They are mounted at the HNM facade by welding them at some specific points (metallic tiles), the position of which had been preliminarily designated spots at the columns of the southern facade colonnade. After the installation of each concrete panel, there had been applied a flattening layer of cement +river sand plaster. This layer filled the joint gaps between every two panels and also made possible a flat surface, over which latter would be placed the Mosaic.

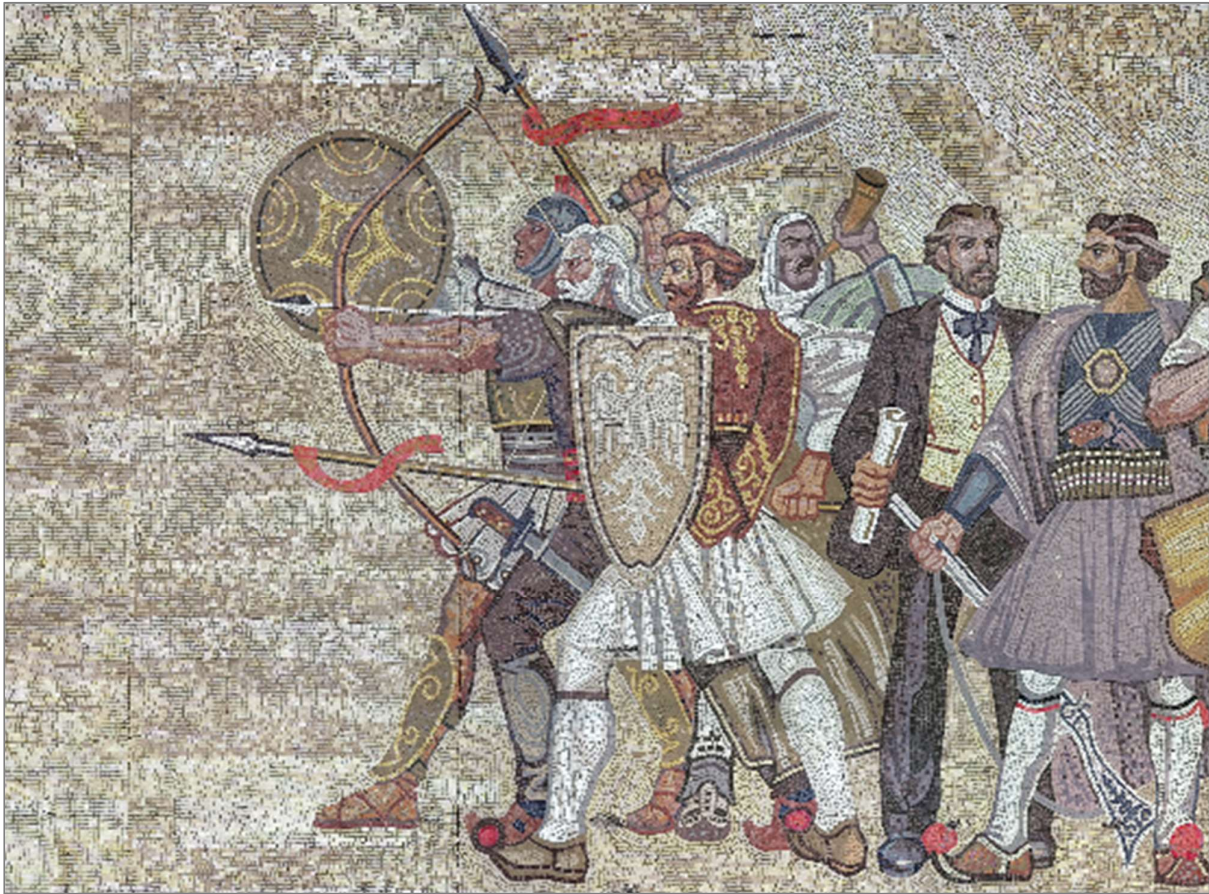
Fig. 5 – The left fragment of the Mosaic, the scene which represents different historical period, from Illyrian until the national renaissance

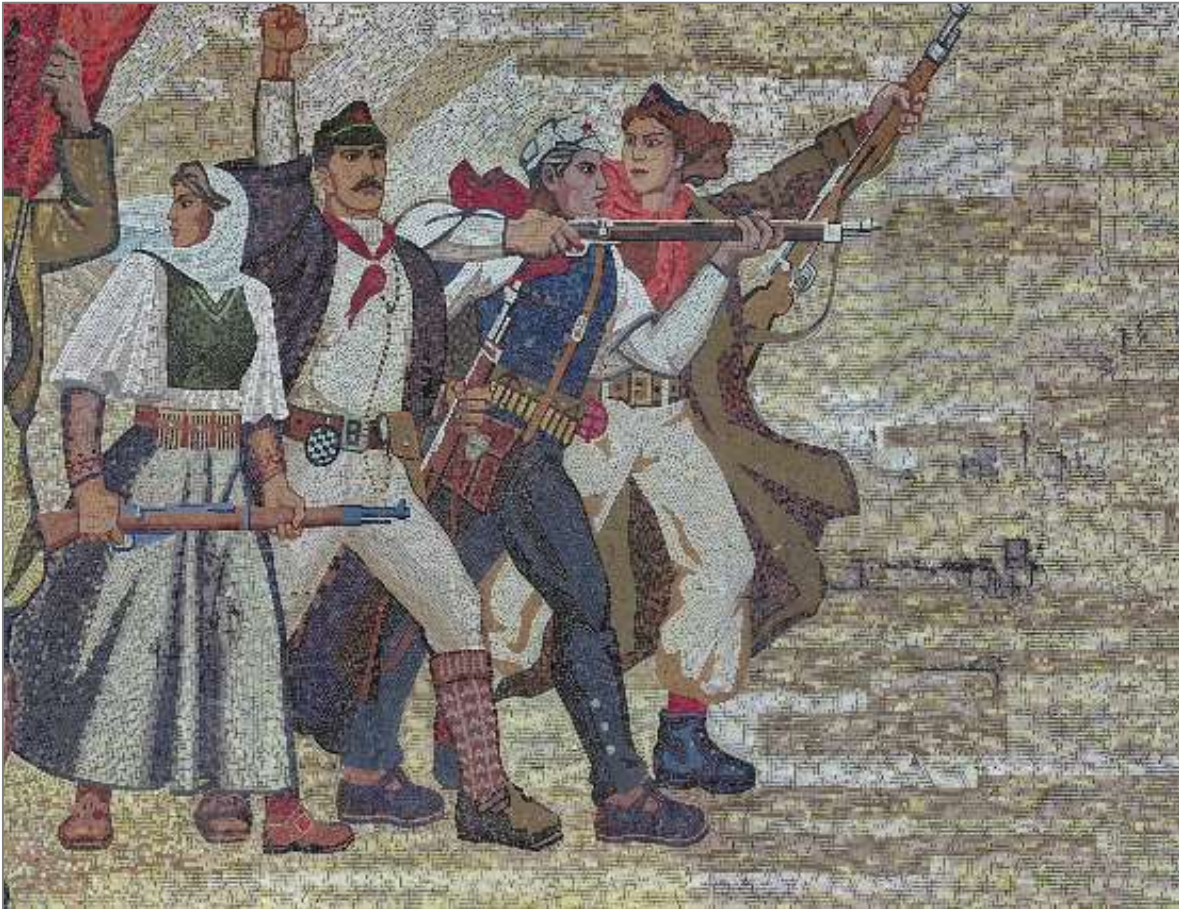
The right half of the mosaic has been dedicated to the National partisan war for the Albania deliverance, during the world wars. This period is represented in the mosaic by 4 different people figures, standing at the right part of the mosaic.

Fig. 6 – The right fragment, the scene that represents the national partisan war

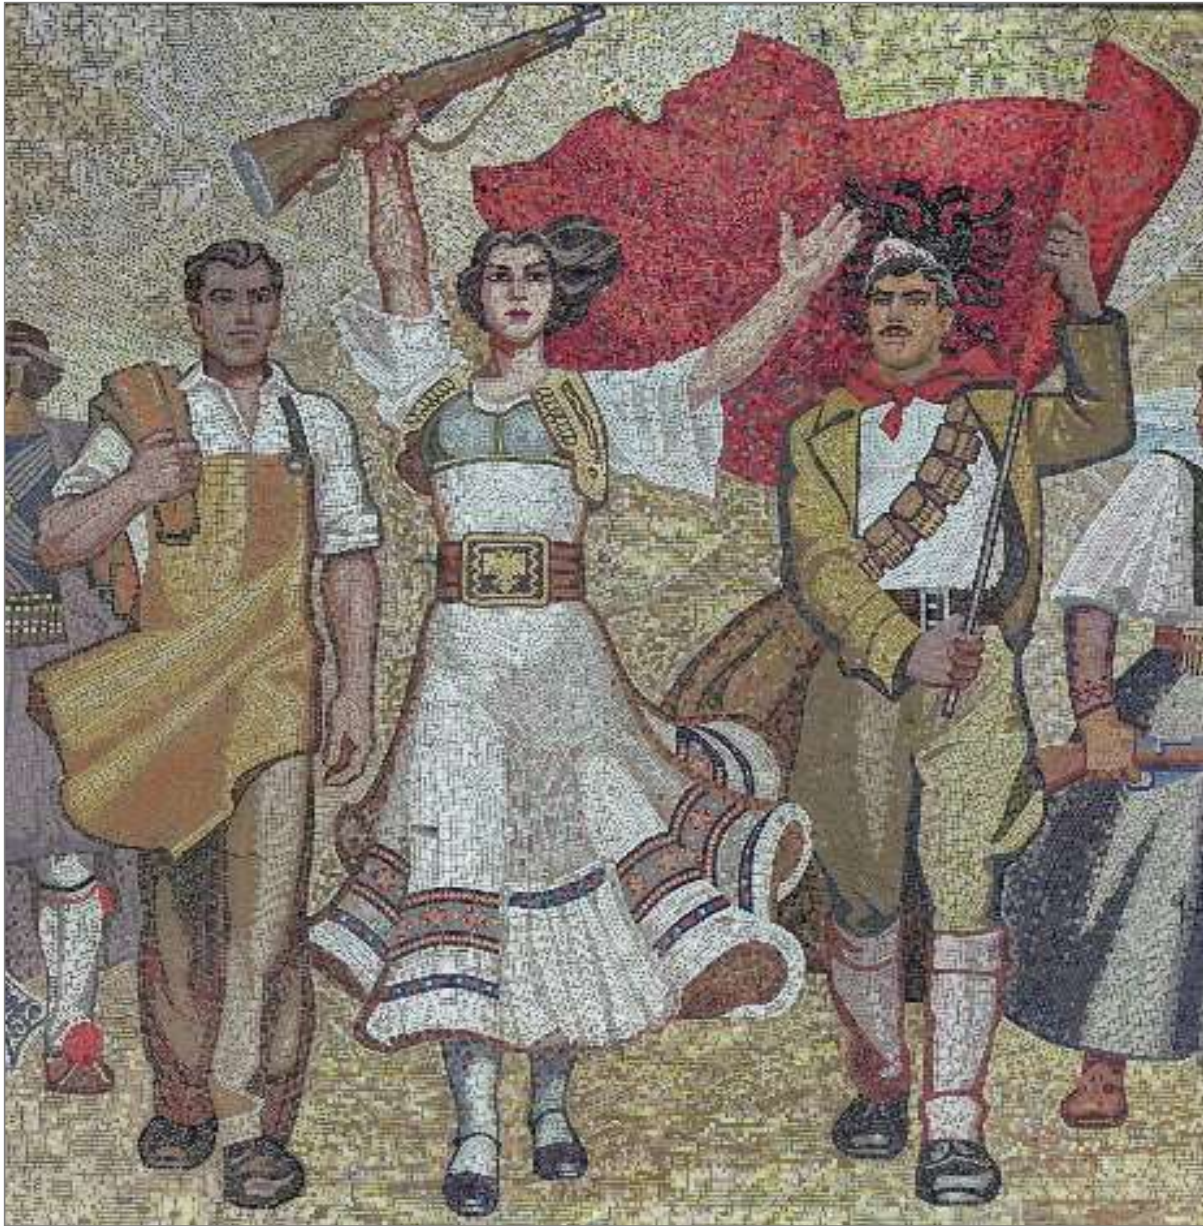
At the center part of the mosaic there are three different people figures, two men and one woman. The woman figure, represents the Albanian woman of the communist era; strong woman (symbolized by the gun that she holds in her right hand) and friendly woman at the same time (symbolized by her left hand that stands wide opened, which reflects hospitality). The woman in the center, wears one of the best known Albanian traditional garments, the Xhubleta.

At the right side of this woman, next to the partisans' figures, can be seen a man holding a gun and the national flag. This character, once again represents the partisan of the national deliverance war, but also through the flag, he represents the precise time of Albanian Deliverance, in 1944.

At the left side of the woman, stands a man in working clothes, whom represents the socialist work individual of the time right after the deliverance until the time of Historical National Museum construction.

Fig. 7 – The central fragment of the mosaic, the scene that represents the albanian woman and man of the communist era and the deliverance partisan

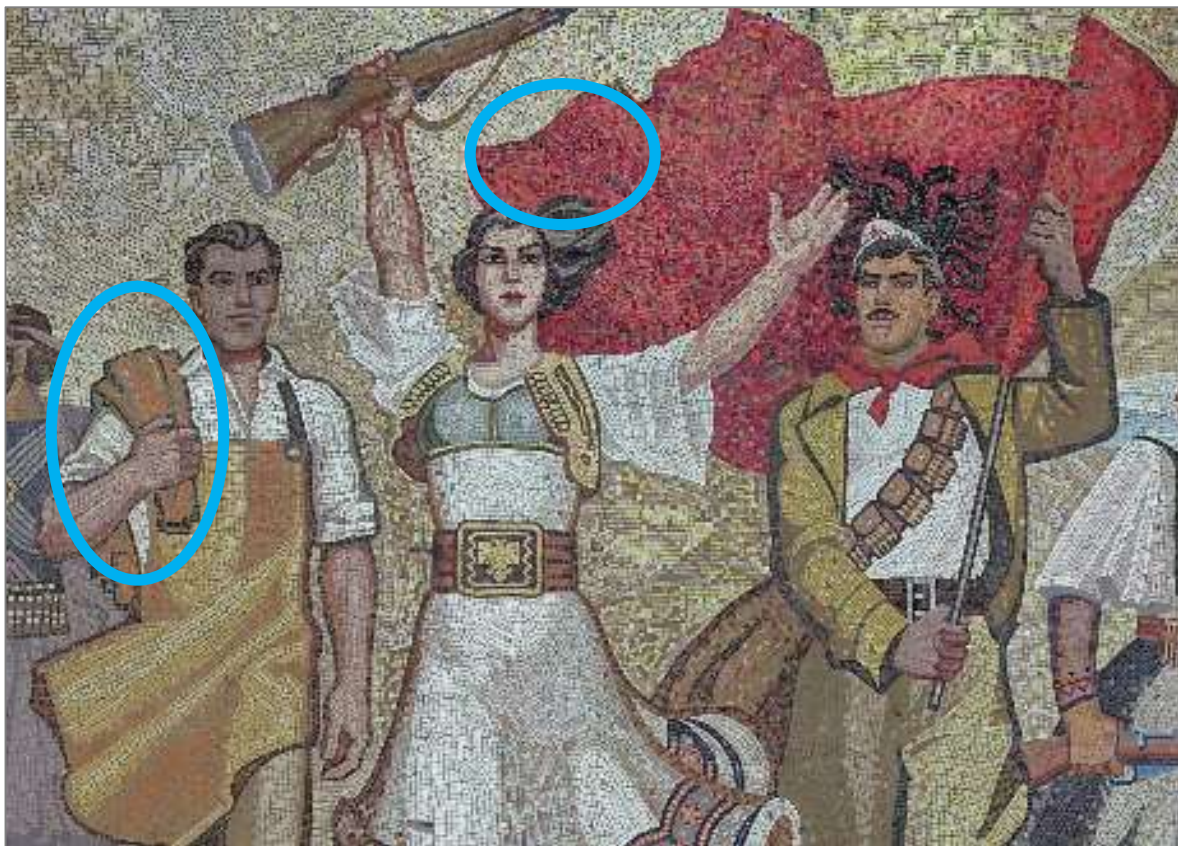
- The star symbol has been removed from the flag; it used to stand right above the head of the woman in the center of mosaic;
- There has been modified also the figure of the man representing the worker of the communist era. In the original mosaic this man, hold a book in his right hand. This element has been removed and the figure has been adopted making the character looking like he is holding his jacket over his shoulder.

Fig. 8 – Fragment of the mosaic, highlighting the areas where has been done the symbols modifications

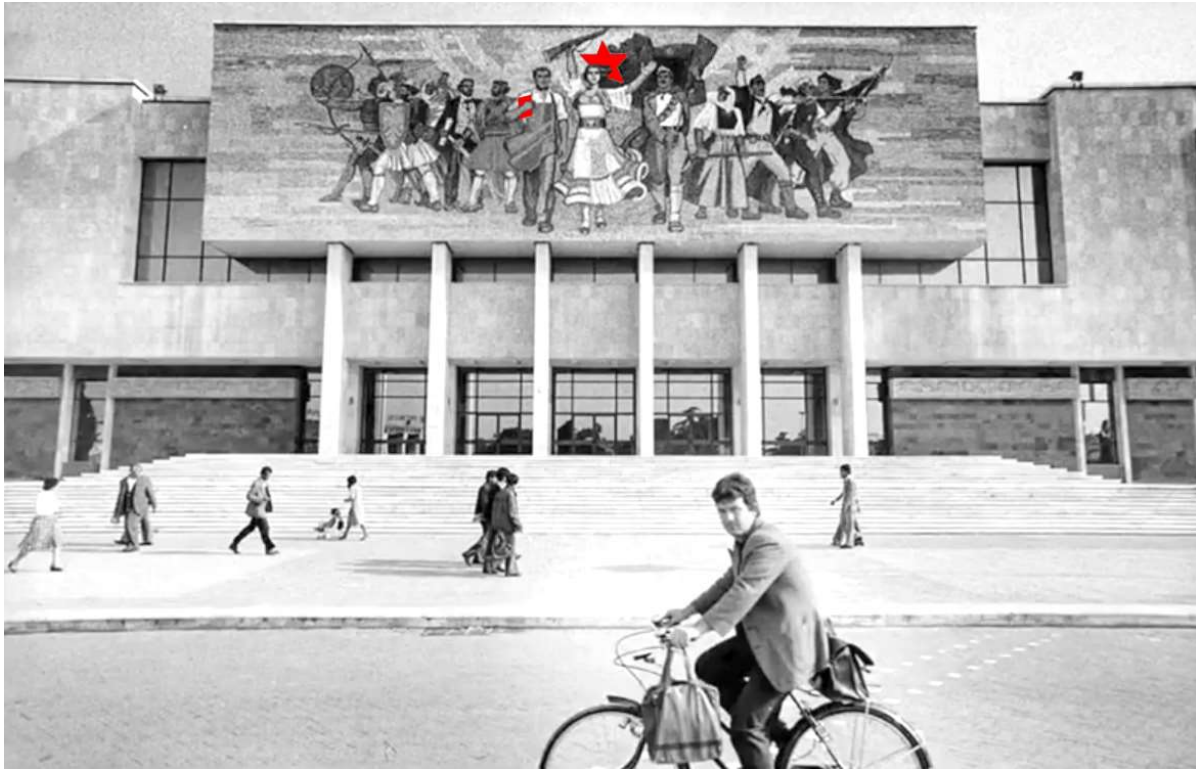
Fig. 9 – The mosaic before '90

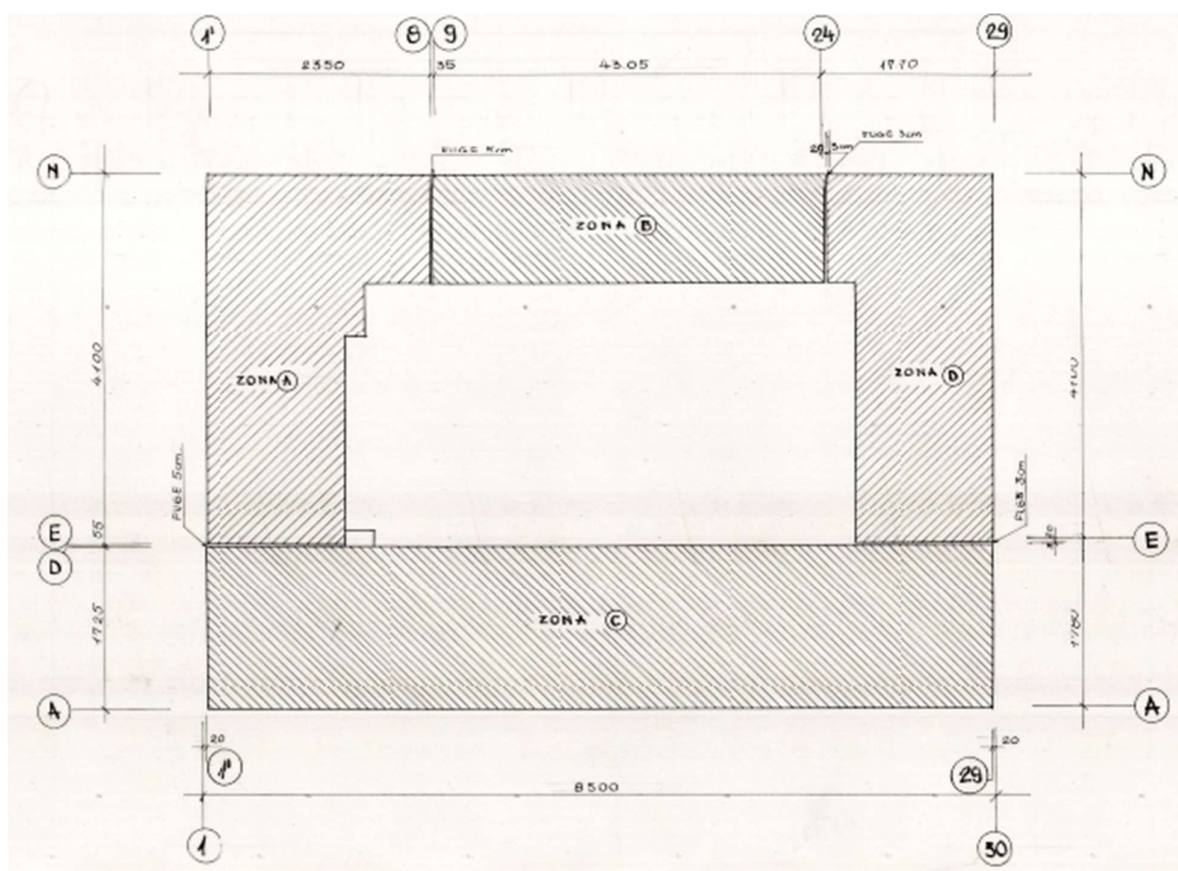
Fig.10 - Substructures, part of the initial project

The existing project of the structures, of which the museum is comprised of, dates back to 1980. The primary structure consists of 4 different substructures, each divided with fugue from one another. They were designated in the existing project as substructure A, B, C, D.

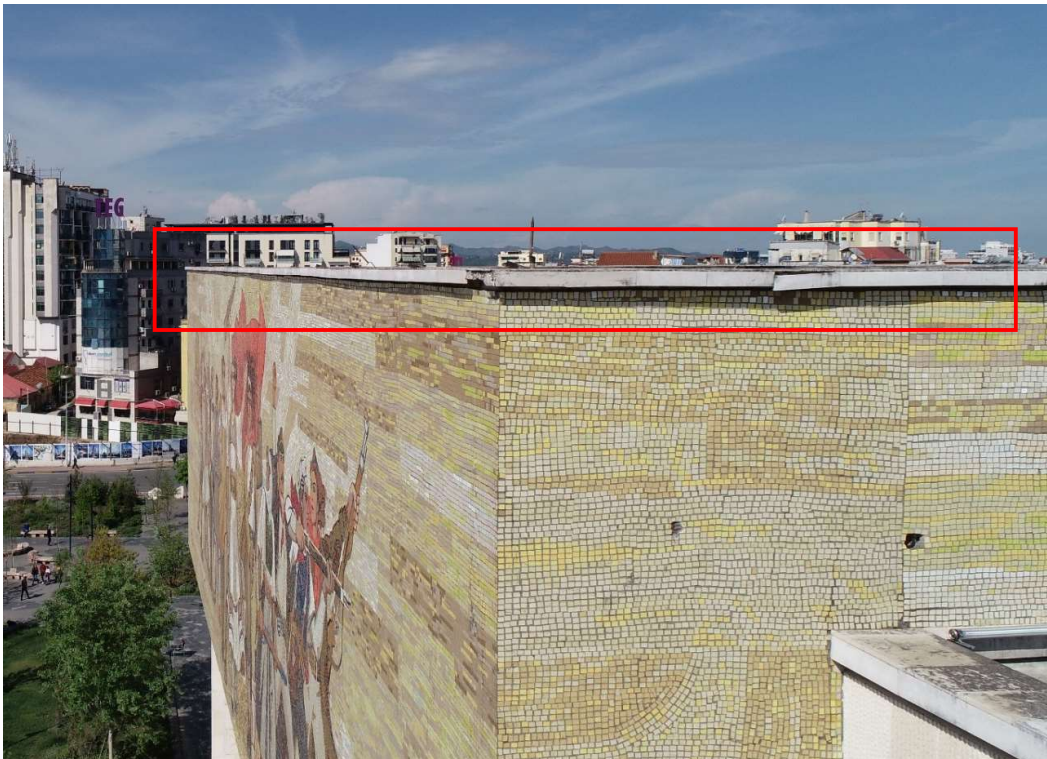
Fig. 25 – Deterioration of the roof parapet (handrail)

- Deterioration of the roof parapet (handrail);
- Cracks (*fissure*) on the mosaic surface;
- Missing of single sporadic tesserae (detached);
- Missing of a group of mosaic tesserae, creating the lacunae;
- Exposed fragments of the metallic grill of the concrete panels;
- A stubborn layer of dirt accumulated on the mosaic surface, due to the fact that the mosaic has been exposed for a long time to the atmospheric phenomena and air pollution.

Another problem is the degradation of the roof parapets above the mosaic area. Through the creation of the joints disconnection of this cover, there are created spaces through which enters the rainwater and flows into the interior of the mosaic, thus affecting the deterioration of its degrading conditions.

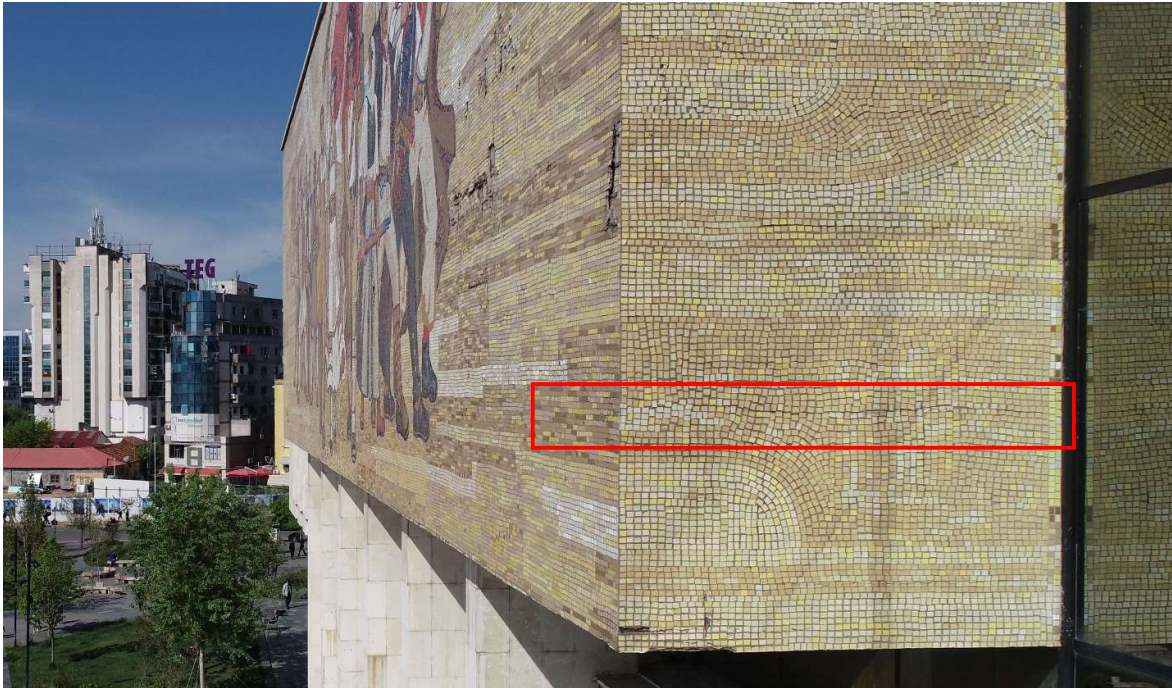
Fig. 26 – Cracks presence

- The deteriorated water spouts are not the only way that the water can leak up to the concrete panels. Another cause is linked to the poor construction quality at the time of construction, like the cracked concrete panels. As it has been mentioned at the paragraph 2.2, the site works are not performed by the mosaic specialists, but by the construction workers. One of the concrete panels, during the transport from the construction factory to the Historical National Museum building, has been cracked, and it was mounted at the facade, anyway. After the installation of this panel, its cracks had been caulked with cement plaster. But this improvement intervention, was not enough, because the cracks already made this panel vulnerable. The cracked panel should have been replaced by another one, in perfect condition.

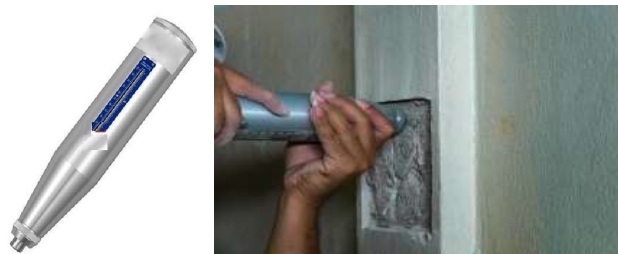
Fig. 29 –Schmidt hammer concrete evaluation

Non-destructive tests are executed without damaging the structure. The evaluation of the concrete state has been done for the structural elements of substructure A, B, C, D using the Schmidt hammer. This test is called "the non-destructive test" and is executed directly on the structure, providing an indication of the compressive strength of the concrete. The test consists of pressing the hammer firmly at least 10 times on a 15x15cm area. The results are based on Gauss curve. Furthermore, at least 10 different structural elements of the existing structure need to be examined in order to give an accurate result for the compressive strength of the concrete.

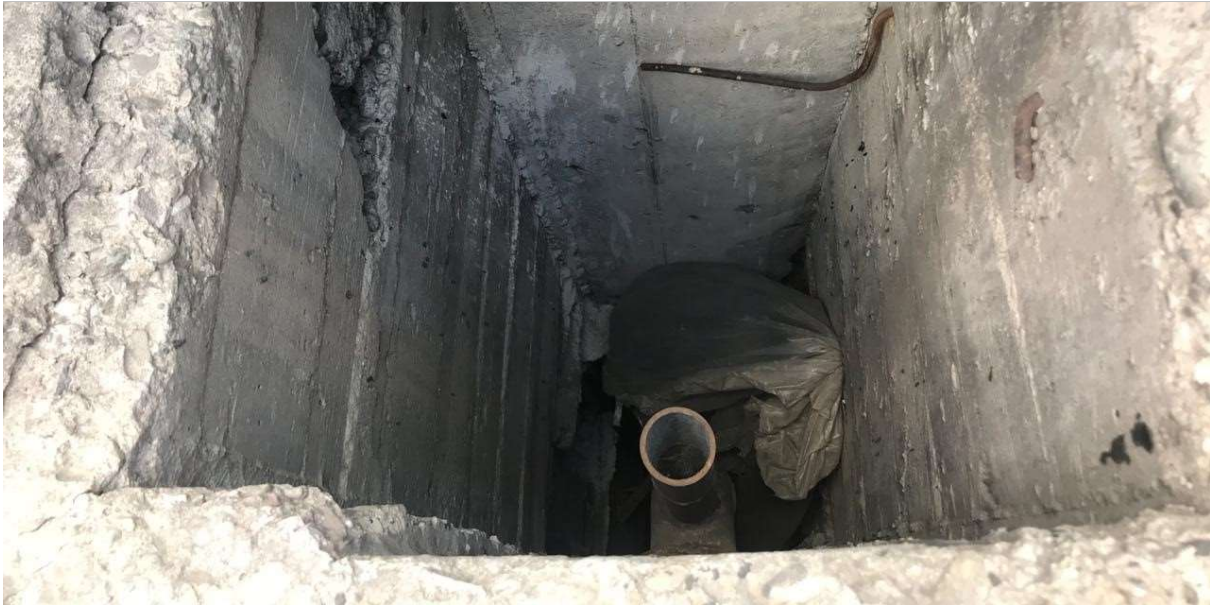
Fig.37- the pit picture of the rainwater discharge columns which is in a position and dimension inaccessible for inspection. It is distinguished the inadequate technique of building of the pit as well as the degradation of the cast iron pipes, their joint etc.

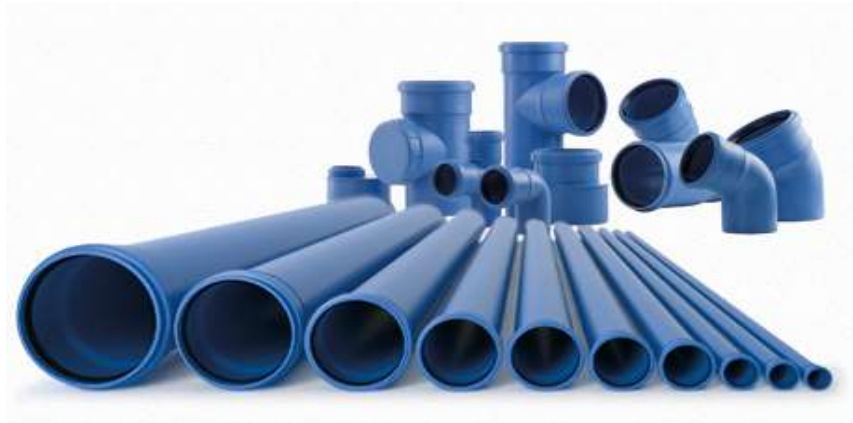
Fig. 43 - Discharge pipes

Nominal diameter Dn (mm)	External diameter. DE(mm)	The average external diameter, minimum, and maximum (mm)		Thickness s (mm)	
32	32	32.0	32.3	1.8	+0.4/0
40	40	40.0	40.3	1.8	+0.4/0
50	50	50.0	50.3	1.8	+0.4/0
70	75	75.0	75.4	2.6	+0.5/0
90	90	90.0	90.4	3.1	+0.6/0
100	110	110.0	110.4	3.4	+0.6/0
125	125	125.0	125.4	3.9	+0.6/0

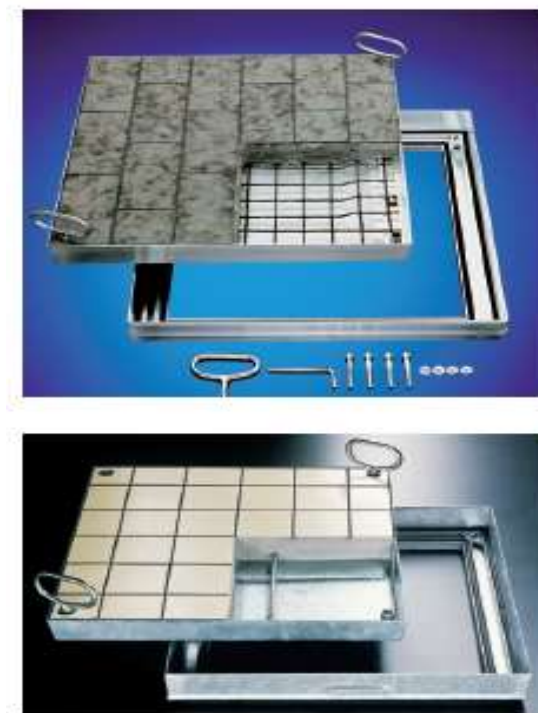
Fig. 45 - Manhole recessed cover D400

- Solid steel base plate
- Double sealed cover, impermeable by water manhole cover
- Completed with lifting keys & locks
- Brass edge & stainless-steel edging available

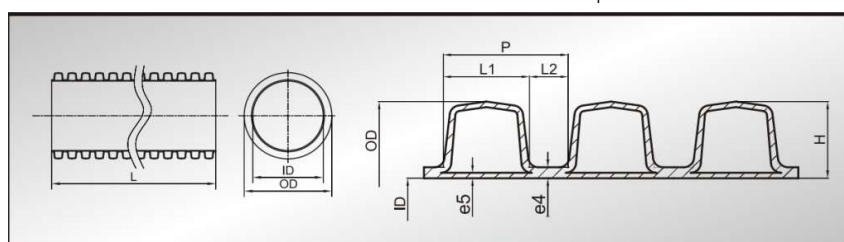
Fig. 46 Corrugated pipe PP

- The technical characteristics that these tubes should have are:
- High resistance to loads that can be exerted on, including their covering layer and the weight of cars passing over the road. According to the standard ISO9969 the loads to be covered by these pipes should range from 2 to 16 KN / m².
- High shock resistance eliminating the possibility of creating cracks during transport, storage and assembly especially at low temperatures. These tubes should have a modulus of 1.0×10^3 M Pa elasticity. High network resistance over the years.
- Taking into account the thermal extensions that occur during the change of temperatures, these pipes should have a linear thermal expansion coefficient $(1.7 \pm 2) 10^{-4} \text{ C}^{-1}$.
- High resistance to various chemicals and to seismic impacts.

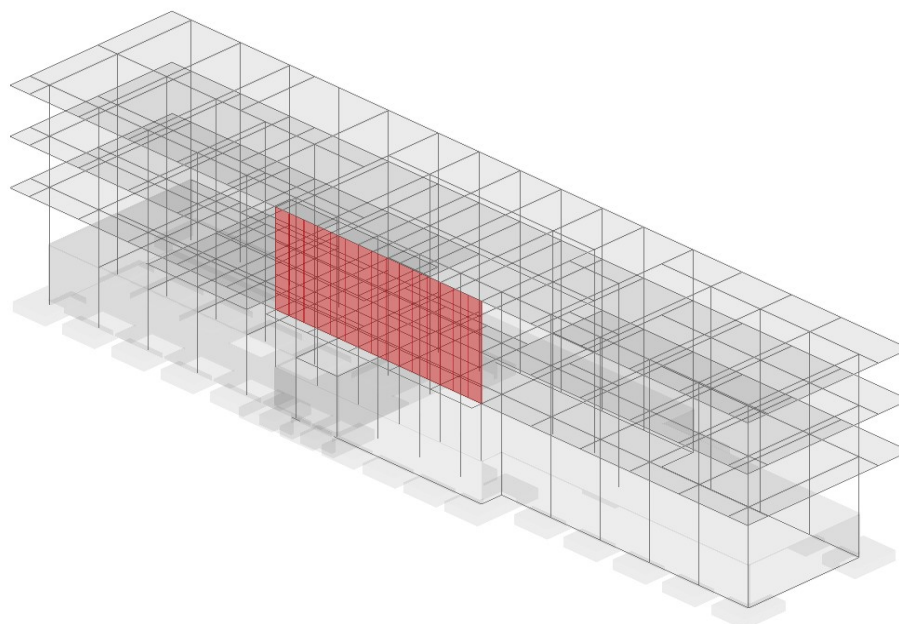
Fig. 47 - The position of Mosaic on the structure scheme

The structural system of substructure "C" has been analyzed according to the loads specified in the Eurocode0, 1. It is noted that, with the parameters of the seismic risk of Tirana, the substructure "C" generally requires a reinforcement on certain elements, mainly in column positions. The columns, on which the Mosaic is supported, do not pose a problem that requires a retrofitting intervention. The presence of masonry columns and ties, where the Mosaic panels are supported, provides enough stiffness.

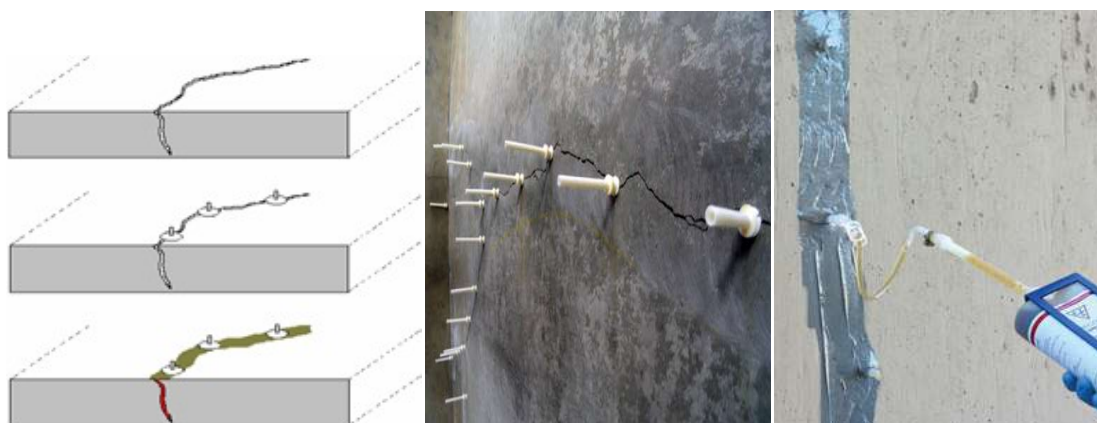
Fig. 48 - Method of concrete crack repair with Epoxy Resin

3. The mixing of epoxy is done either by batch or continuous methods. In batch mixing, the adhesive components are premixed according to the manufacturer's instructions, usually with the use of a mechanical stirrer, like a paint mixing paddle. Care must be taken to mix only the amount of adhesive that can be used prior to commencement of gelling of the material.

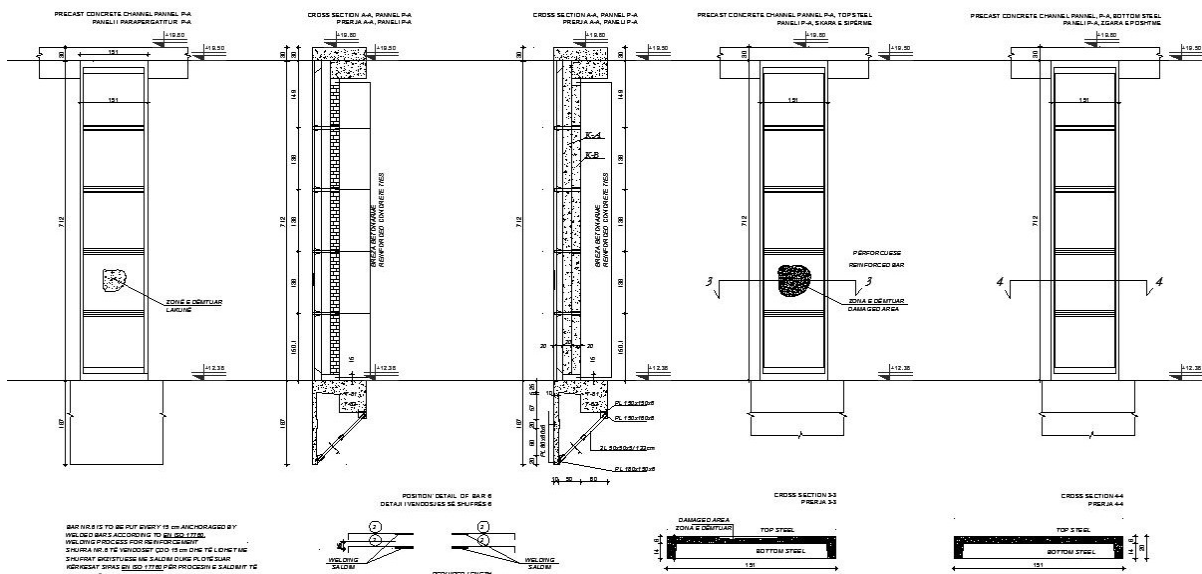
Fig. 49 – Retrofitting of the support panels

Reinforcement interventions in the Mosaic retaining structures take place only in the damaged part of the panels, as mentioned in Chapter 2. It is observed that damage to the protective layer of the panels, exposure of the armature to the outside environment as well as corrosion are all present problems. Therefore, the method of reinforcement will be used for the repair process of the panels.

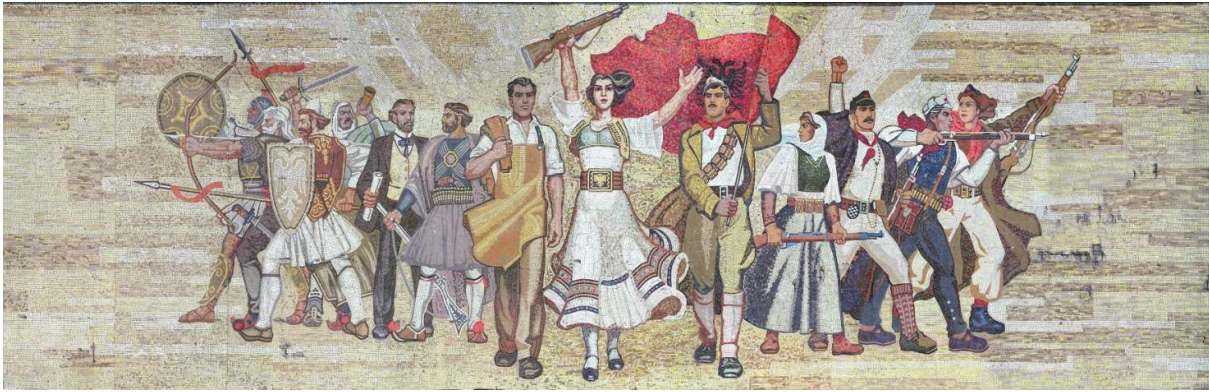
Fig. 50 - The mosaic "Albanians"

Interventions needed for the correction of the deterioration that the mosaic manifests due to the incorrect technique when it was originally mounted on Historical National Museum facade

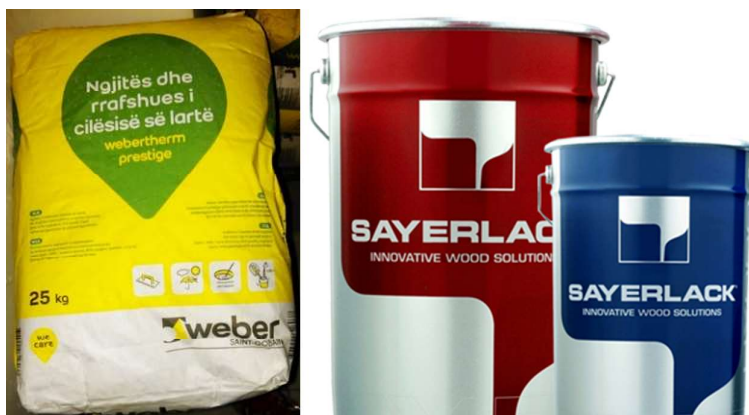
Fig. 52 – On the left, the type of the glue that needs to be used to fix the mosaic fragments over the mosaic support (concrete panels); on the right, the type of the water based transparent varnish that can be applied over the mosaic surface, once it is all mounted and fixed on site.
