Annex XII - a. Survey & assessment with identification of collapsed portions

Annex XII.a.1 - Al-Tahera Syriac Catholic Church- Roof Plan

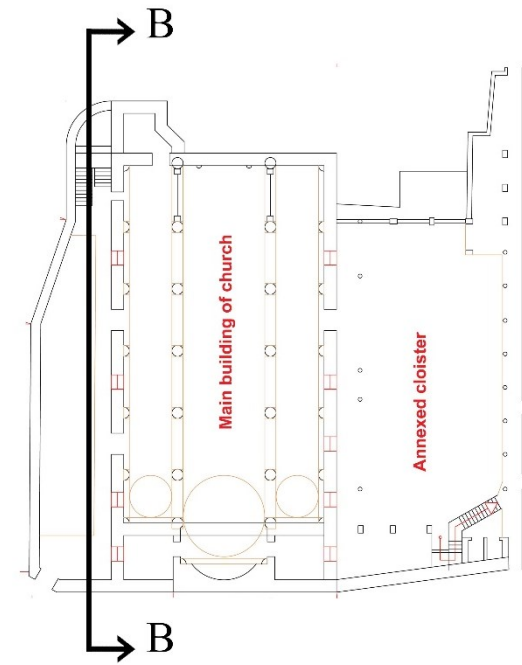
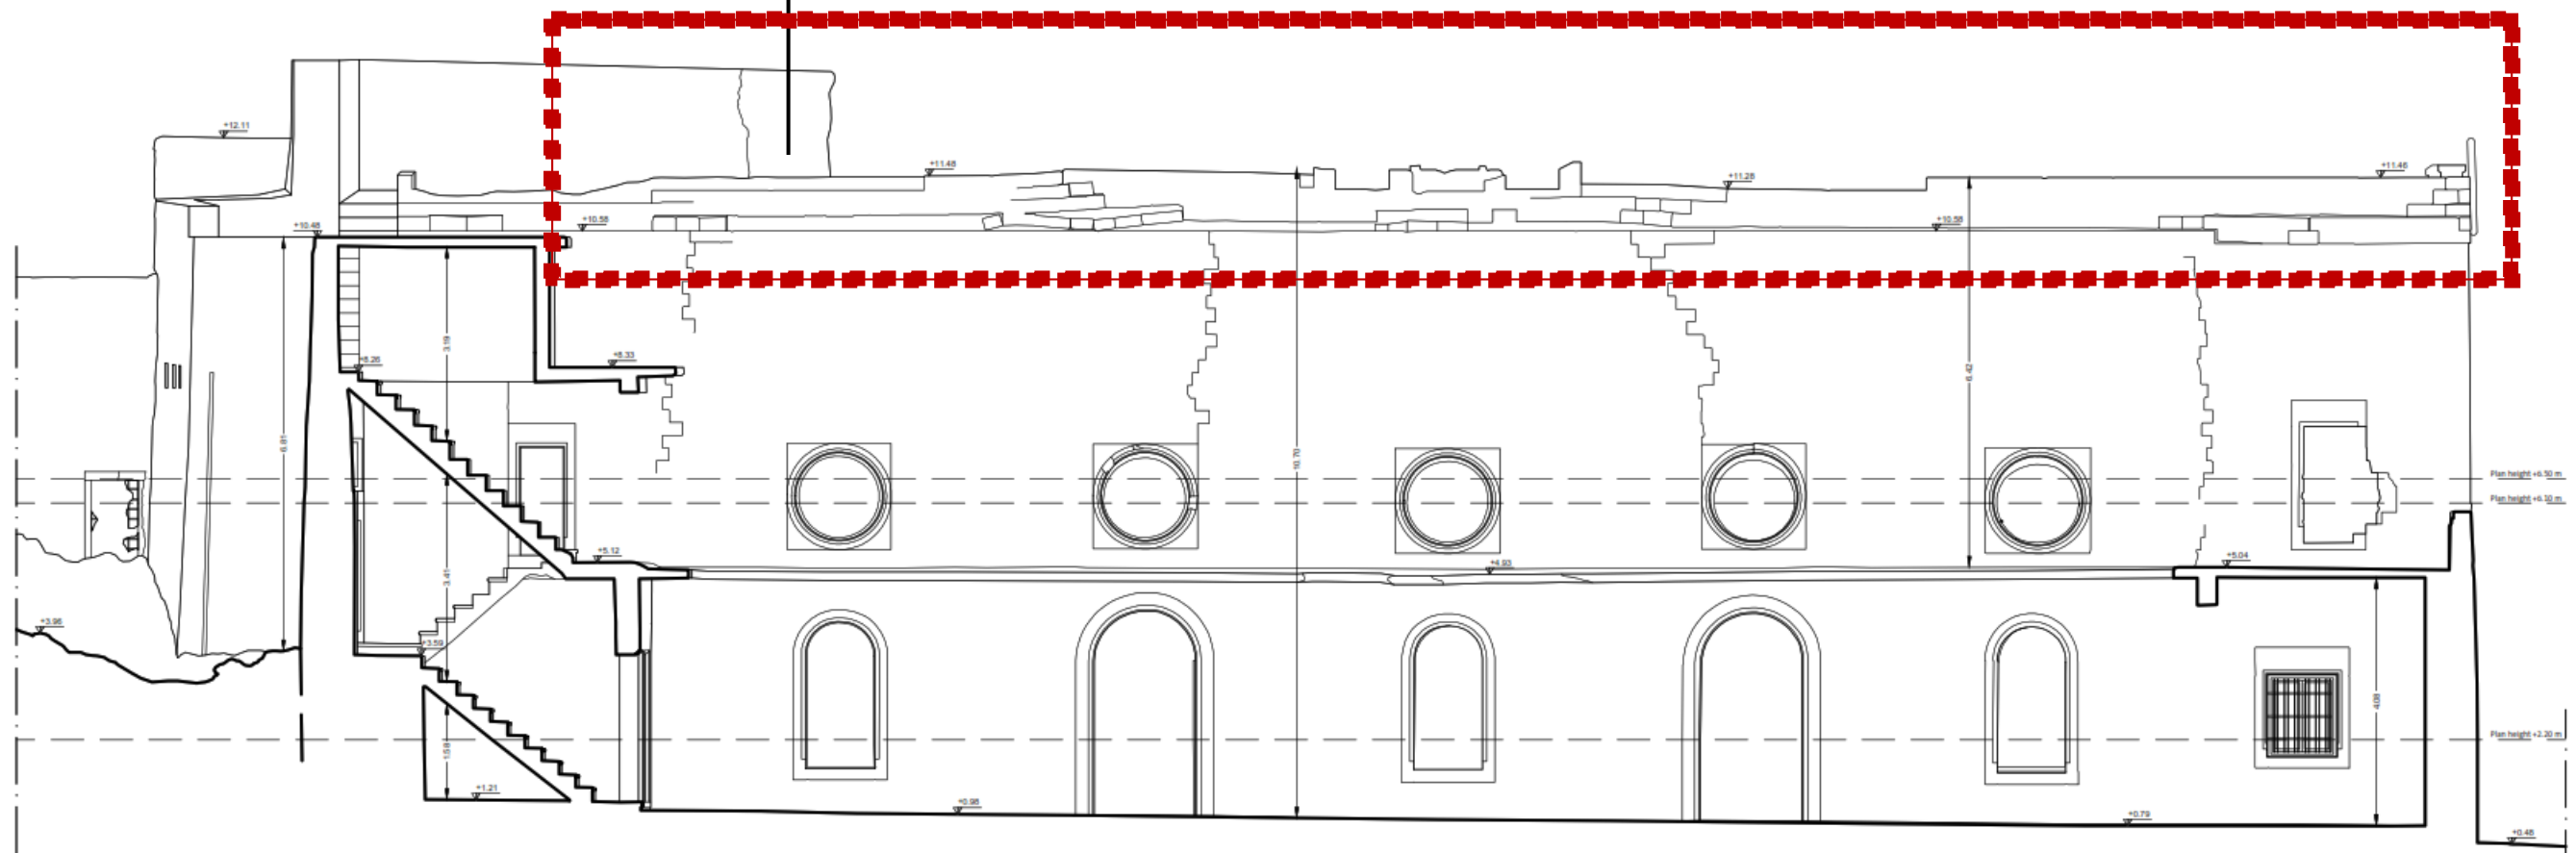
Annex XII.a.3 - Al-Tahera Syriac Catholic Church- Section B-B.

The eastern elevation is quite intact; however, major collapses occurred on roof and underneath vaulted ceilings

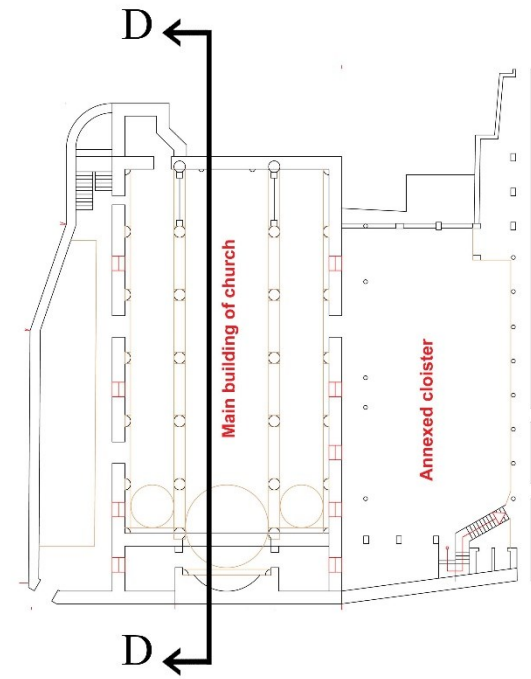
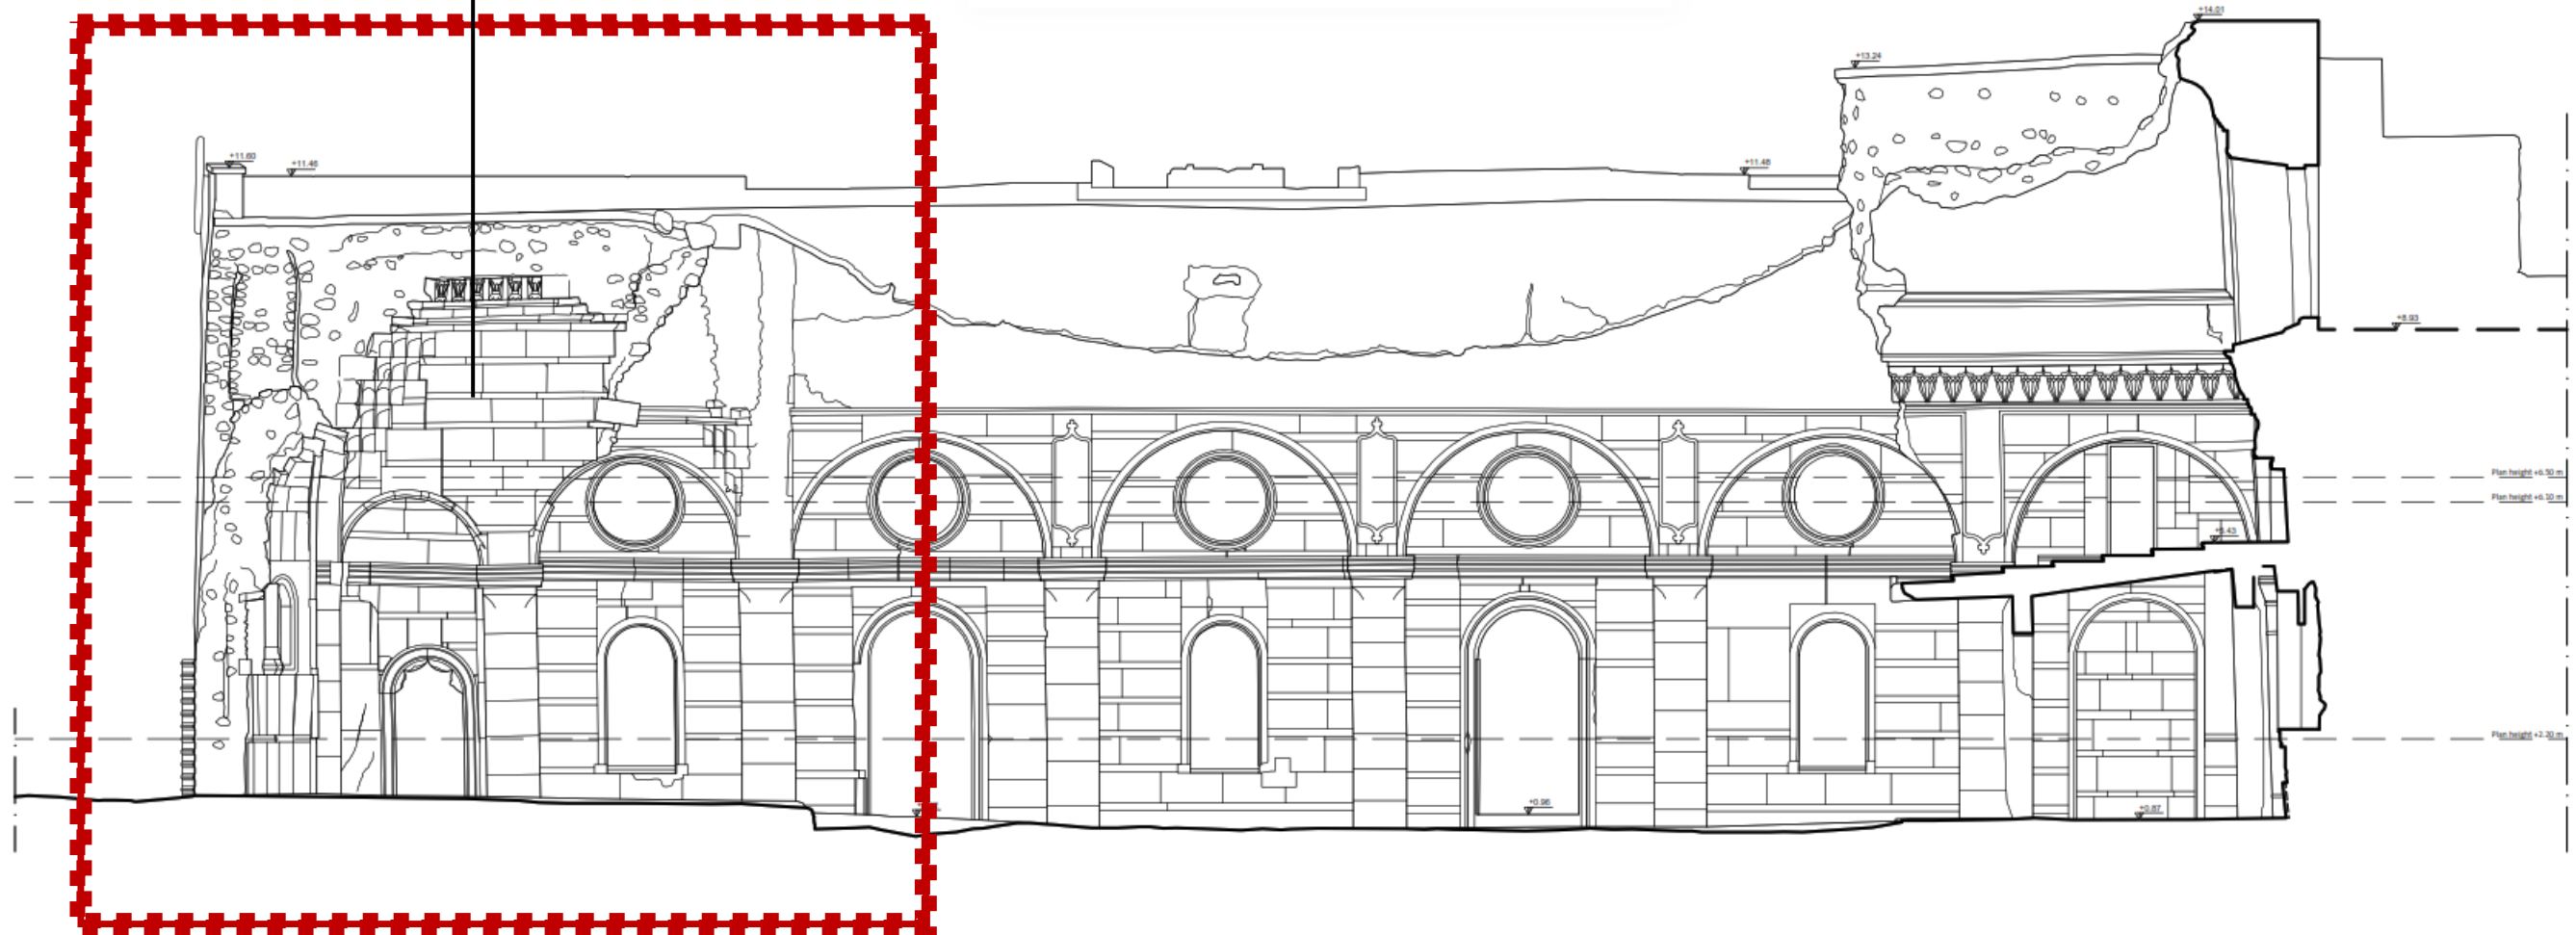
Annex XII.a.4 - Al-Tahera Syriac Catholic Church- Section D-D.

Complete destruction of the southern side with subsequent collapse of the domes, roof and underneath vaulted ceilings

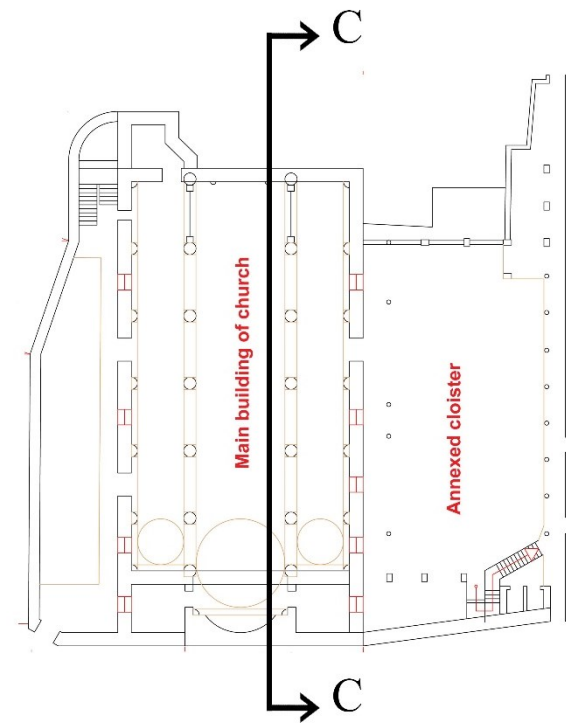
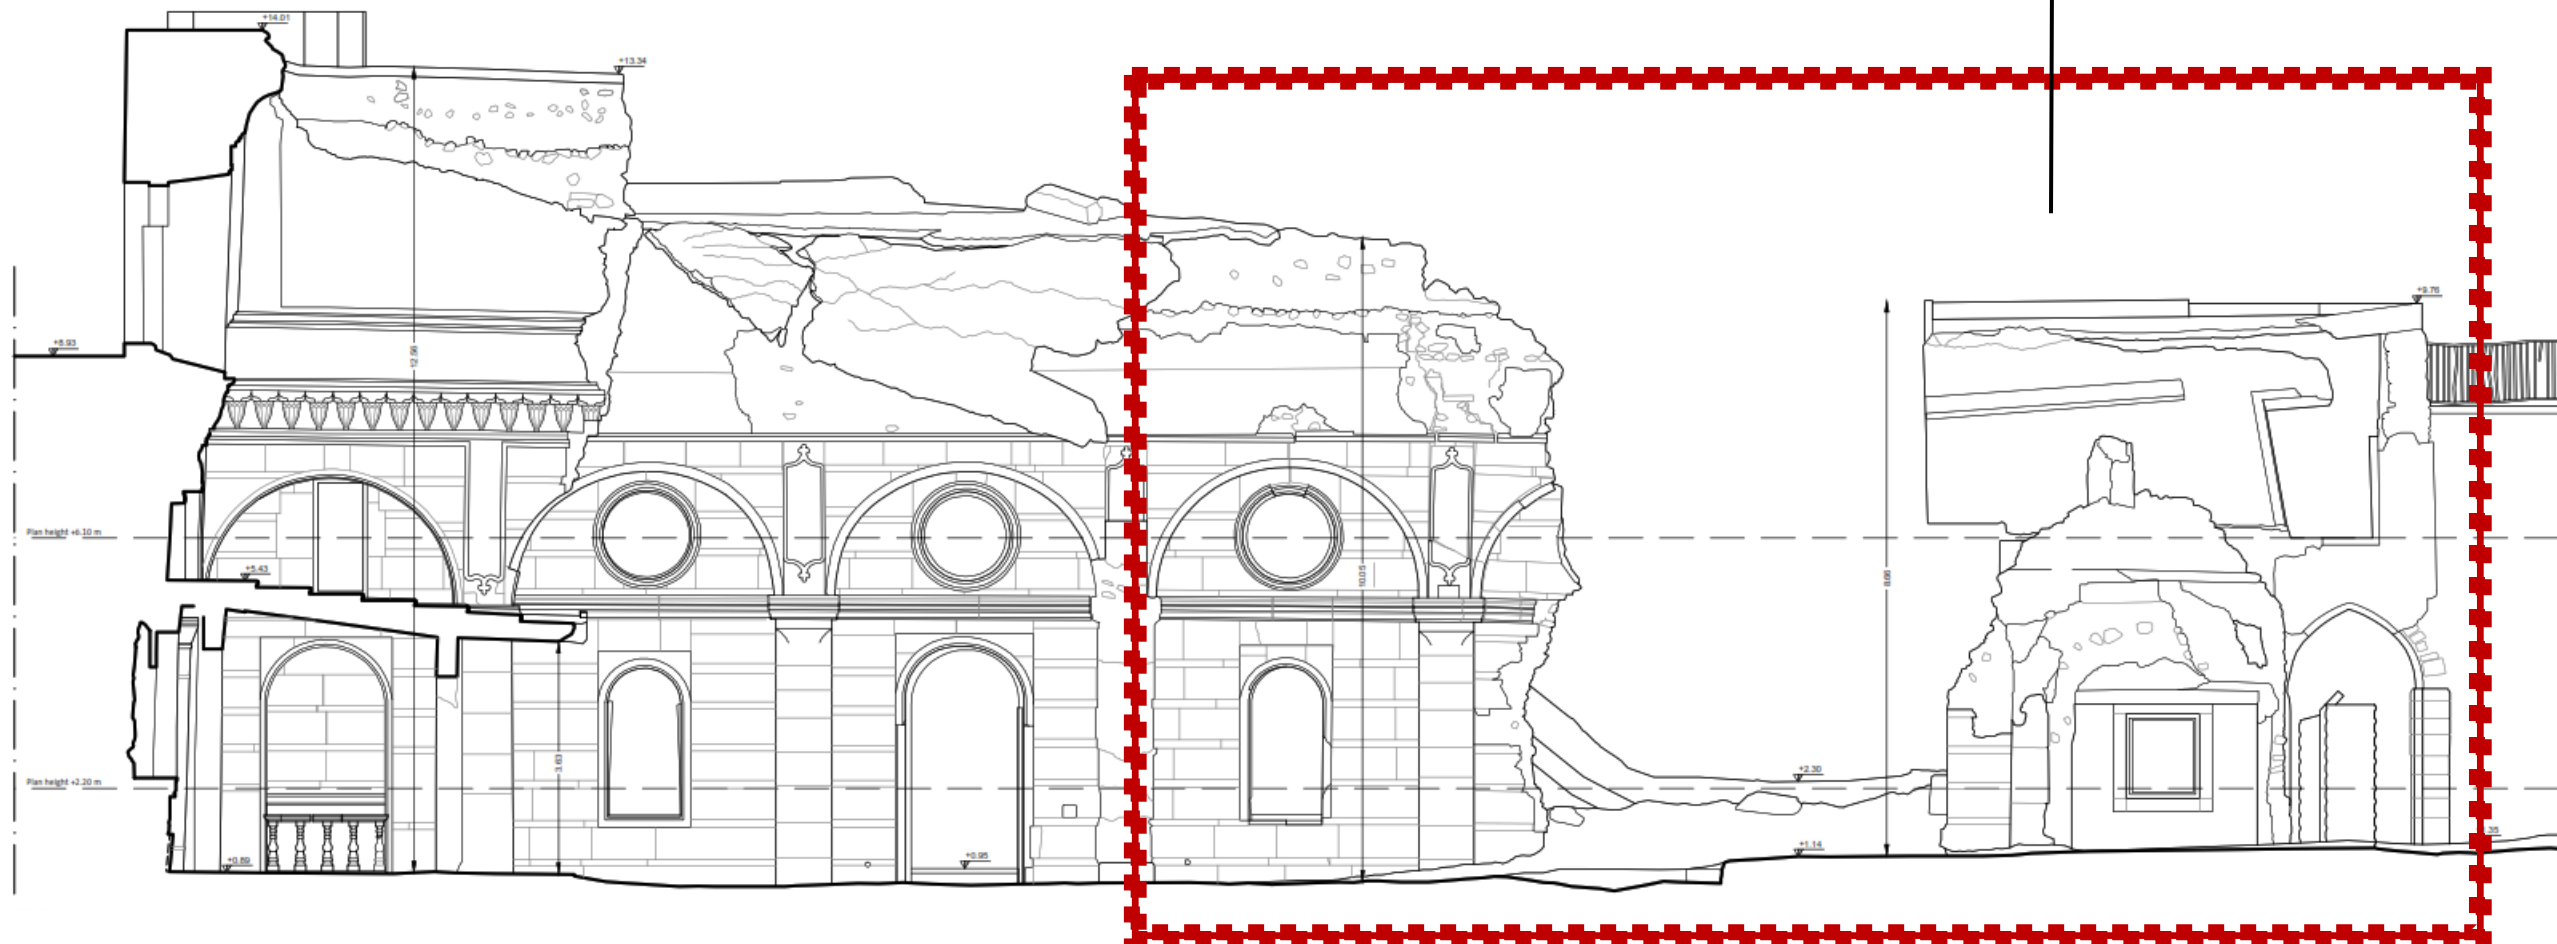
Annex XII.a.5 - Al-Tahera Syriac Catholic Church - Section C-C.

Complete destruction of the southern side with subsequent collapse of the domes, roof and underneath vaulted ceilings
