TECHNICAL REPORT KURCAJ BRIDGE

The laboratory "ALTEA & Geostudio 2000", in cooperation with the company "FOCUS ARCHITECTURE" sh.pk, has conducted an investigation to determine the existing condition of the constructive elements in function of the project "Conservation Plan, Reinforcement and Restoration Interventions in 5 cultural buildings" (Kurcaj Bridge on Zerza stream, Kruja; Bashtova Castle, Rrogozhina; Preza Castle (Clock Tower and Northeast Tower) Preza; Lezha Castle - Archaeological Park; Kruja Castle (Clock Tower and fortification walls) , Kruja).

KURCAJ BRIDGE ON ZERZA STREAM, KRUIJA

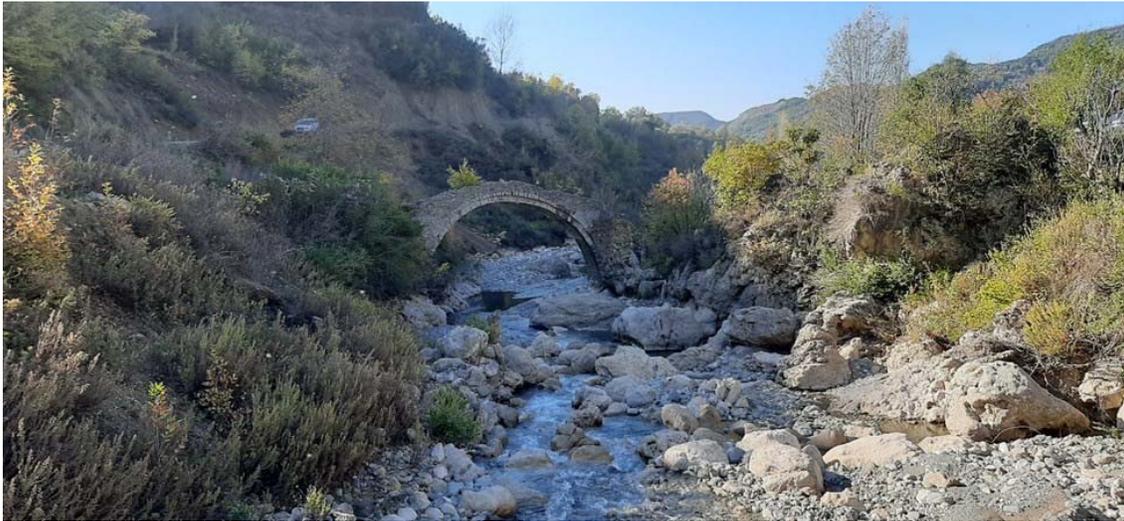
Figure 2: Overview of the Structure

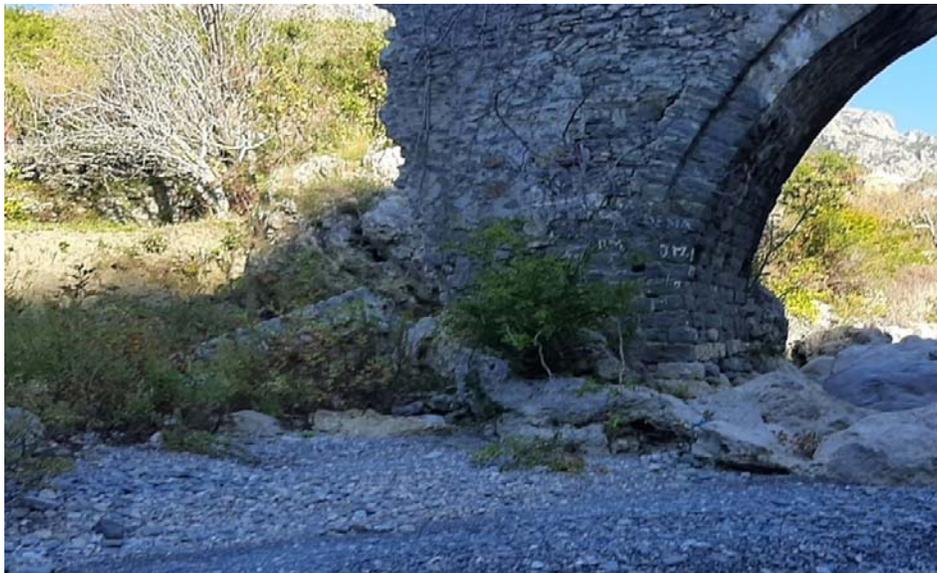
Figure 3: Cracking at an angle of 70 ° at the foot of the bridge from the side of the village Zgerdhesh, width > 10mm, filled with mortar.

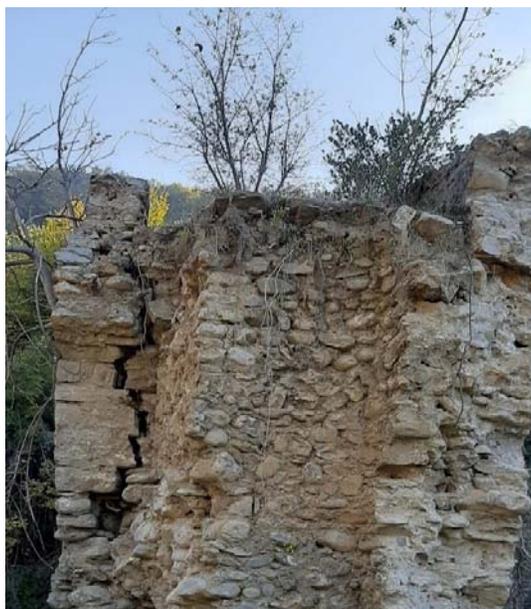
Figure 4 : Detachment of outer shell and inner fill material at the bridge abutment

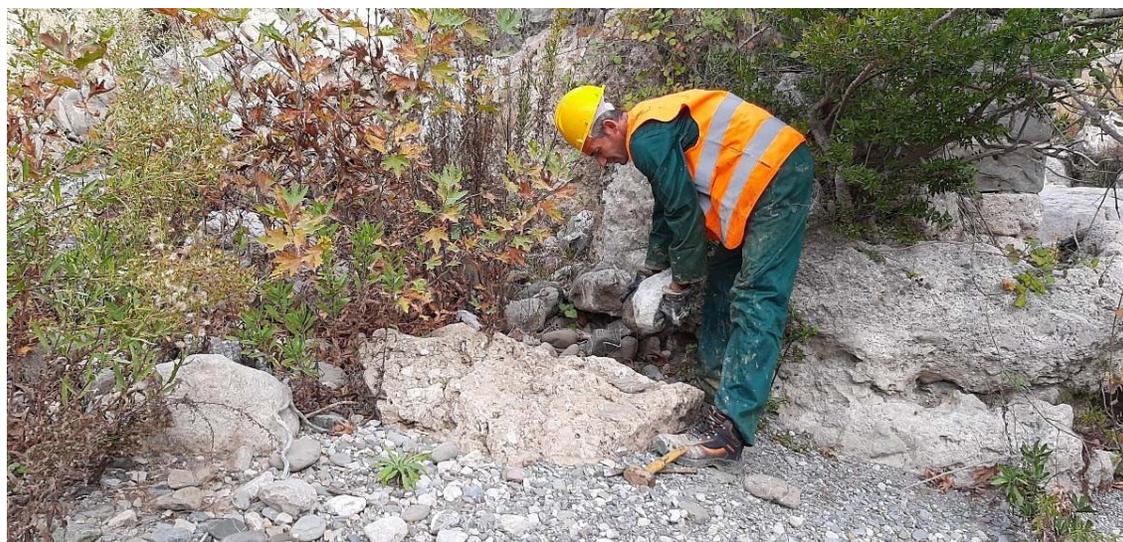
Figure 5: Recovering Limestone sample at the foot of the bridge by the village of Zgerdhesh.

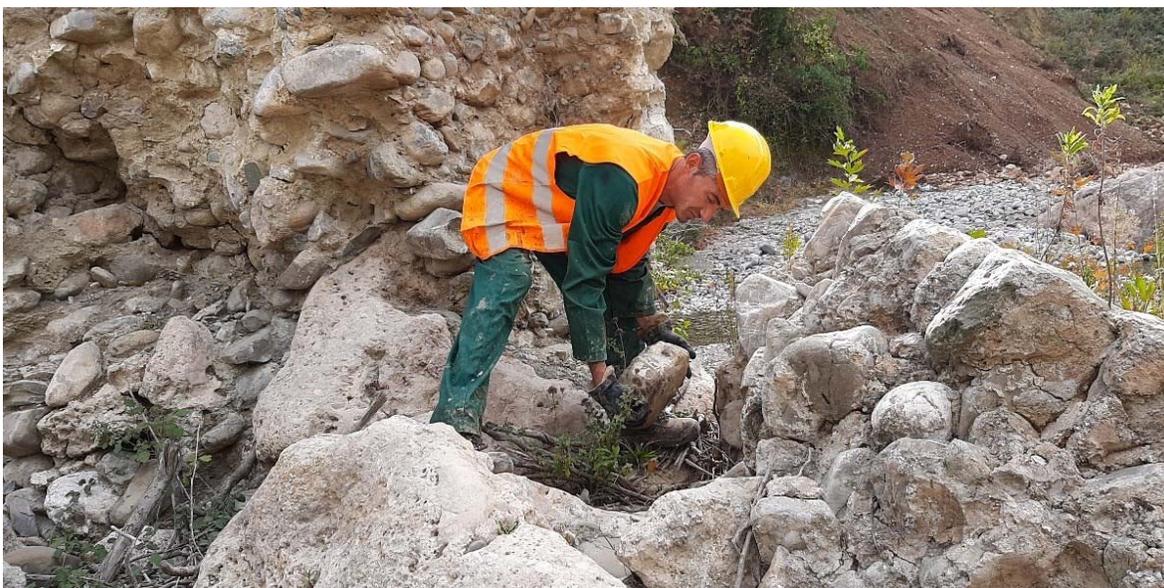
Figure 6: Recovering Sandstone sample at the foot of the bridge by the village of Zgerdesh.

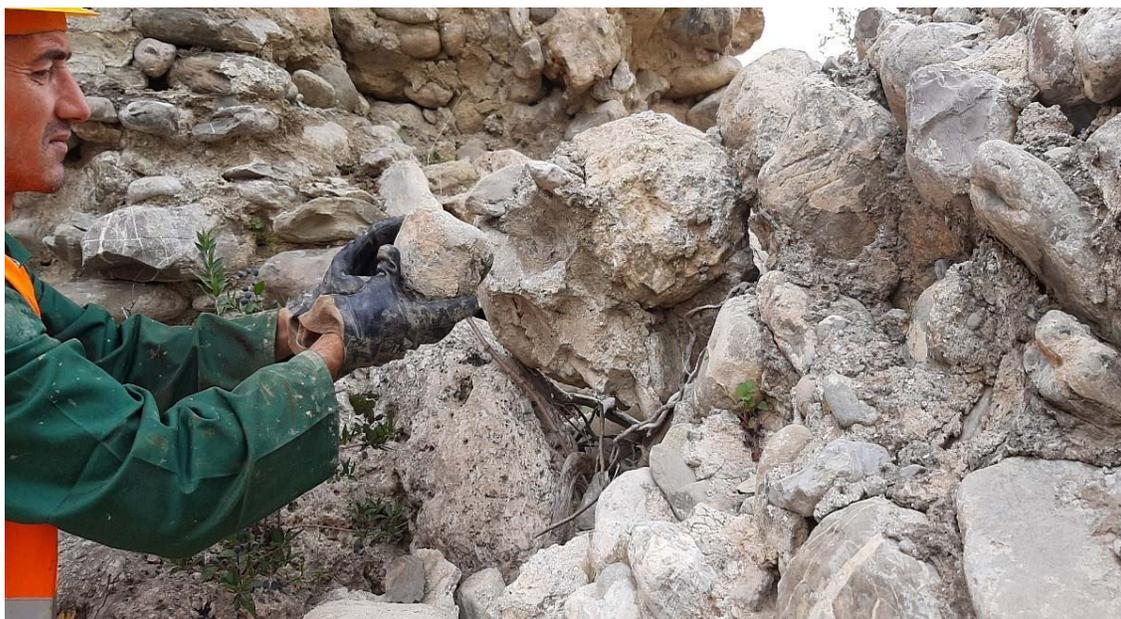
Figure 7: Recovery of Limestone sample at the small arch of the bridge by the village of Zgerdesh.

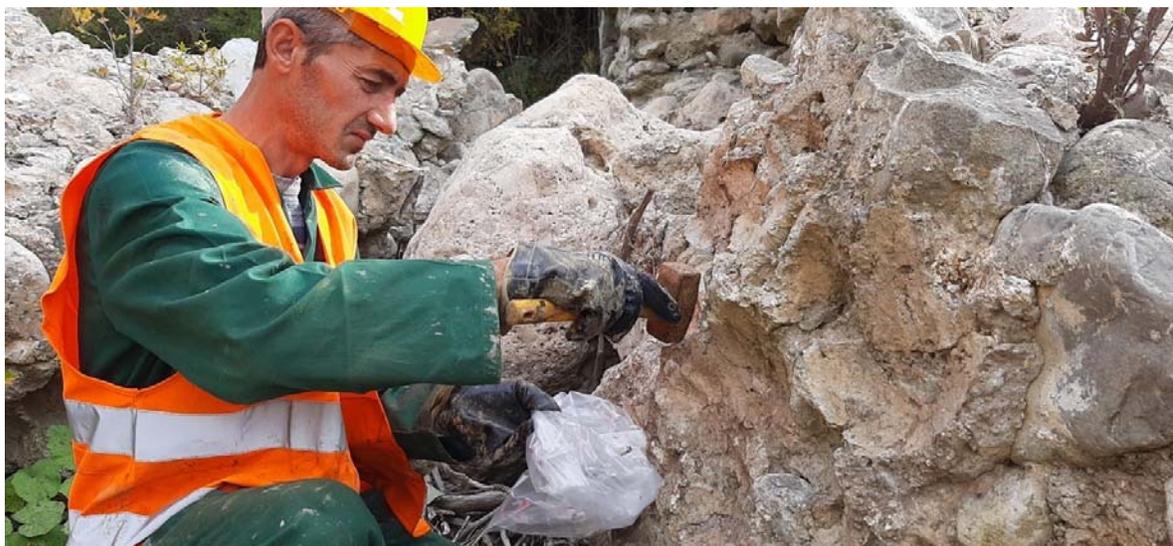
Figure 8: Recovering Mortar sample at the small arch of the bridge.

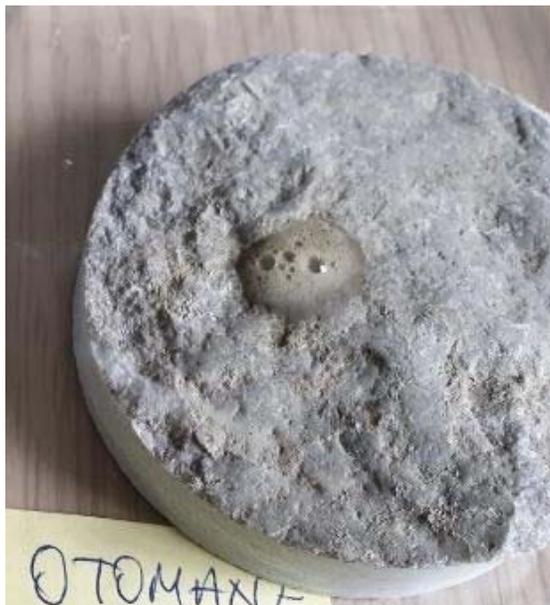
Figure 9. Overview of the 5D sample - Ottoman Bridge, where a rapid reaction is observed below

The sample represents a compact limestone of light gray to white color (Figure 9). There is no special texture in it. The sample reacts rapidly in contact with 10% HCl (Figure 9). The microscopic observation shows a large amount of carbonate particles, mainly of biogenic origin. Based on the distinct deposition texture in limestone, which is of the grain-supported type, we can say that we are dealing with a clastic type limestone (Dunham classification, 1962) (Figure 11).

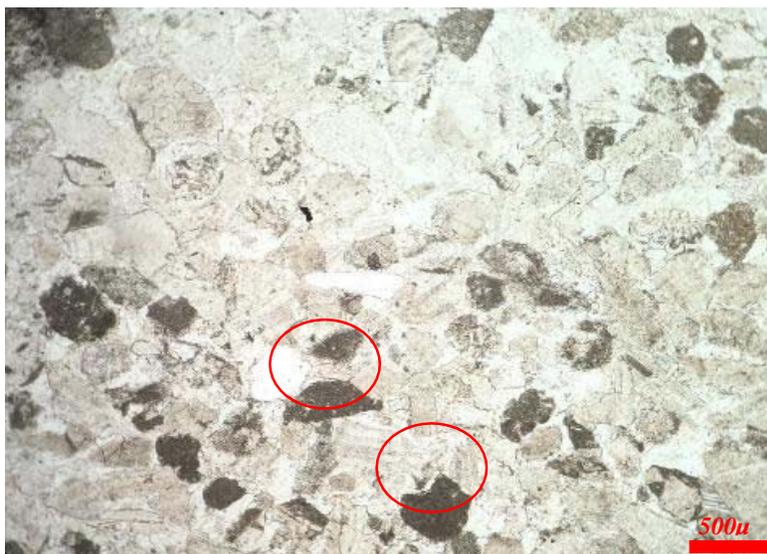
Figure 11. Carbonate material represented by fragments of fauna and subcondytic micritic particles (red circles). 5D sample, light penetrated without analyzer.

According to Folk (1962) classification the sample represents a compact biomicrite (limestone with numerous microfauna in a micritic matrix) (Figure 11). The carbonate particulate material, which makes up about 85% of the mass fraction of the sample consists of bioclasts, rock fragments (extraclasts) and micritic particles (Figure 11 and Figure 13). The micritic matrix does not make up more than 10% of the sample. Bioclasts are mainly represented by foraminiferal skeletons. The rock fragments and micritic particles are mainly angular to sub-angular and with a size ranging from 0.1 to 0.2 mm (Figure 10). They are in contact with each other and form a tight pack.

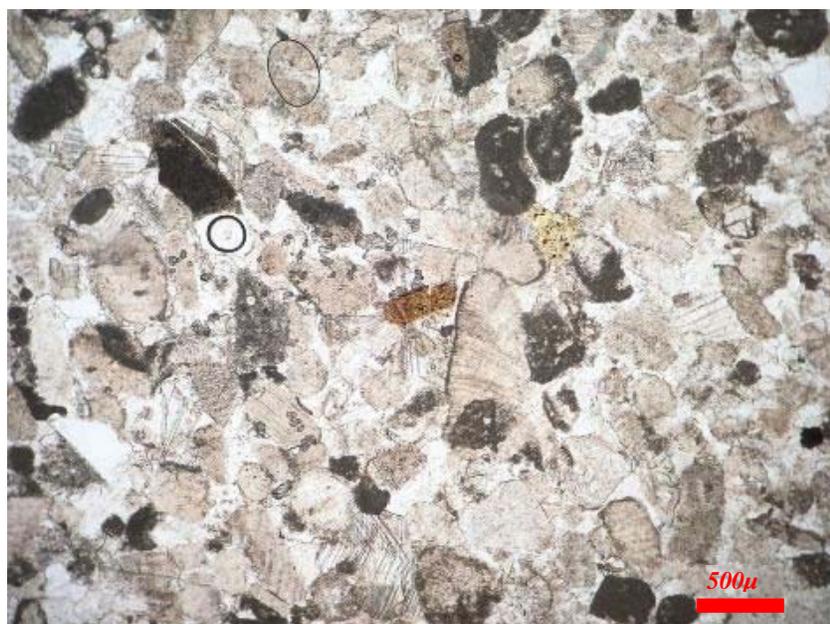
Figure 14. Biotite crystals with typical brown color. 5D sample, light penetrated without analyzer.

In addition to the carbonate material in the sample, the presence of a relatively high amount of terrigenous material is observed. They make up about 5% of the total sample mass (Figure 12, Figure 13, Figure 14, Figure 15, Figure 16, and Figure 17). They generally appear rounded. Quartz crystals in the form of either single crystals or polycrystals are found in the sample (Figure 12, Figure 17 and Figure 18). They appear randomly distributed throughout the sample. Plagioclase crystals are also present in the sample, they often appear with varying degrees of alteration (Figure 13 and Figure 19). In addition to quartz and plagioclase in the limestone sample there are also fragments of igneous rocks (Figure 16) and are mainly fragments of volcanic rocks. In the sample there is only one biotite crystal which without analyzer is easily distinguished from the rest of the rock components due to its pleochroism (Figure 14 and Figure 15). A rock cutter does not show any preferred orientation and has a thickness of less than 15 μm (Figure 20 and Figure 21). The cutters are mainly filled with microsparic calcium (Figure 20).

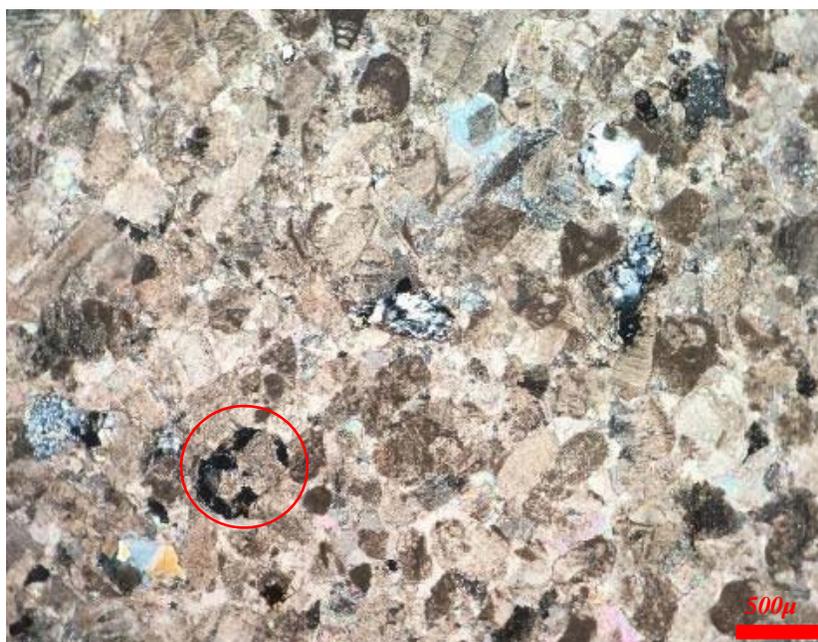
Figure 16. Fragments of well-preserved to partially altered igneous rocks (red circle). 5D sample, light penetrated by analyzer.

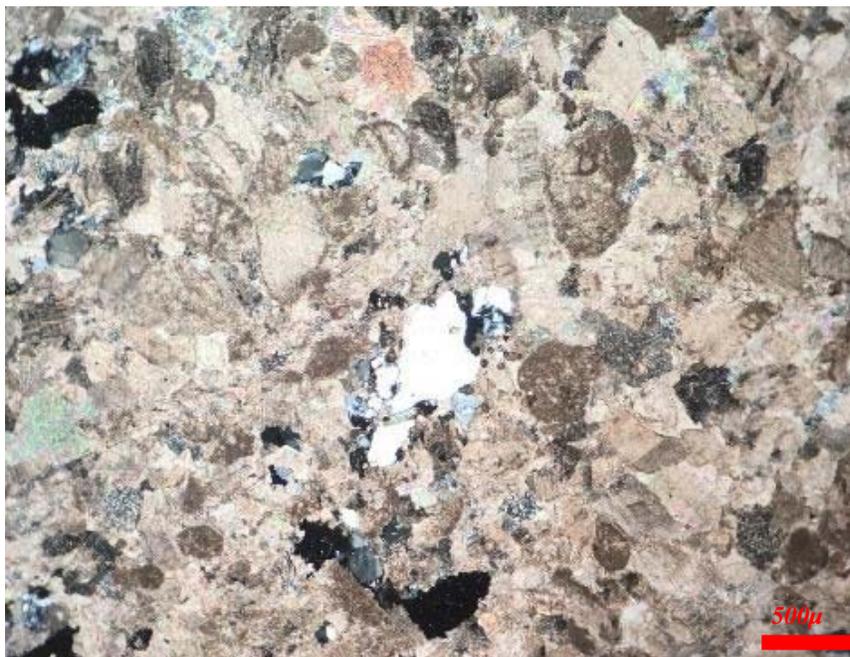
Figure 17. Combination of monocrystalline quartz with polycrystalline. 5D sample, light penetrated by analyzer.

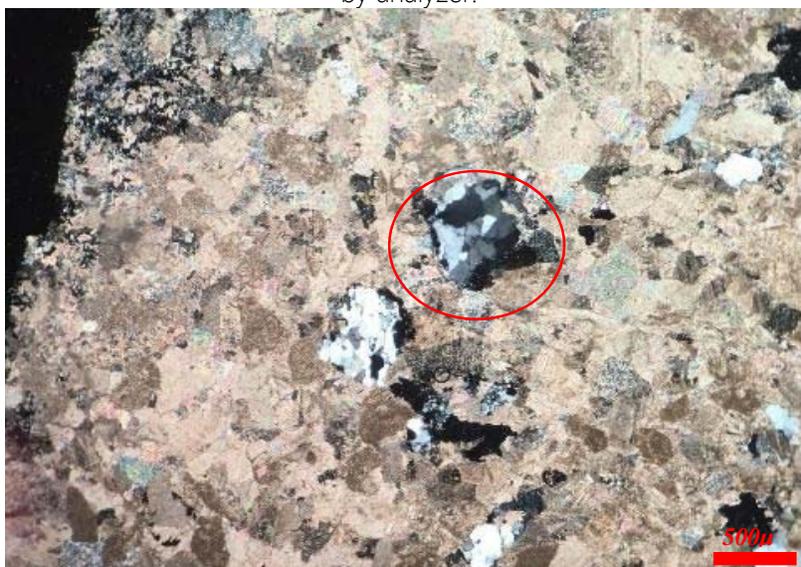
Figure 18. Polycrystalline quartz with straight boundaries between crystals (red circle). 5D sample, light penetrated by analyzer.

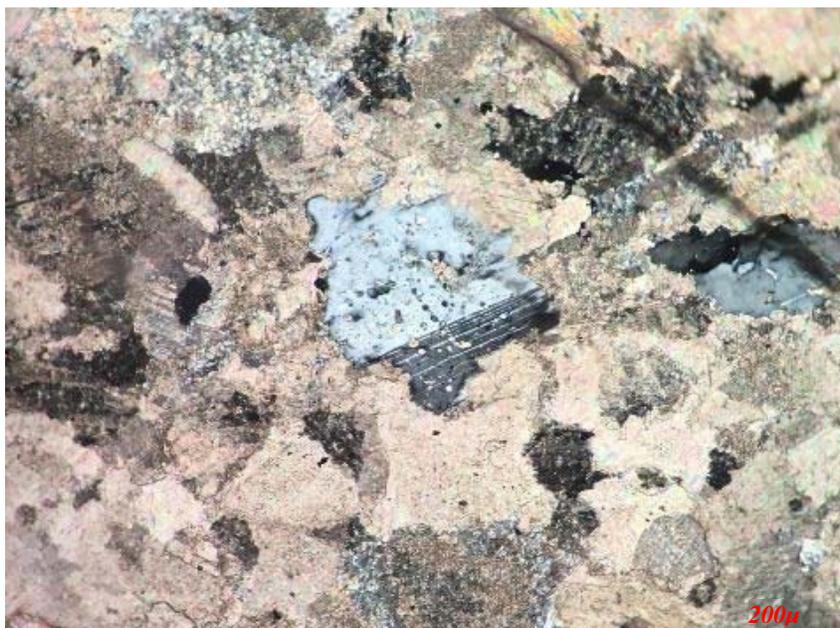
Figure 19. Plagioclase crystals which appear in the early stages of alteration. 5D sample, light penetrated by analyzer.

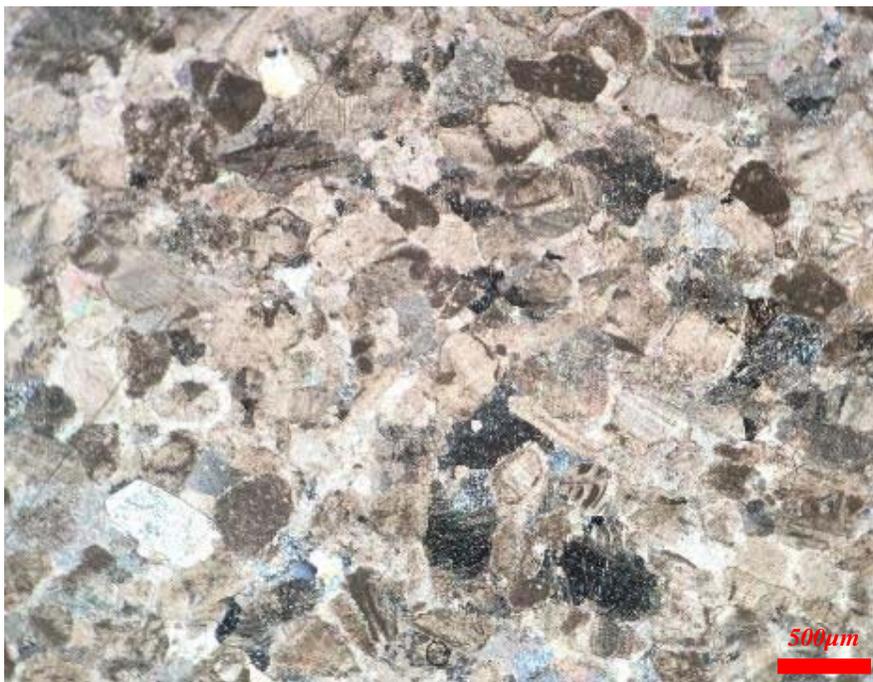
Figure 21. The same area as Figure 11, where the calcitic composition of the plant is observed. Figure 1 5D sample, analyzed light.

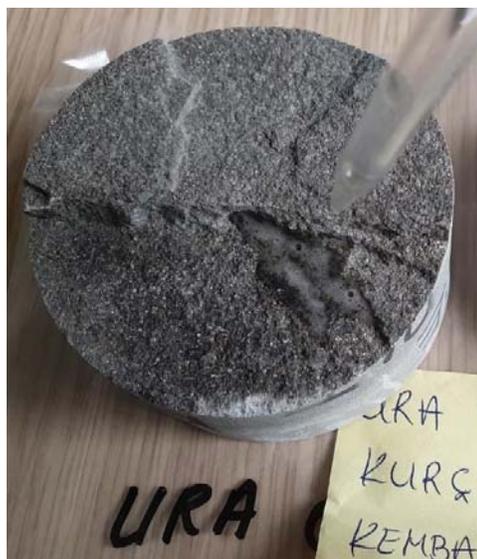
Figure 22. View of the sand sample from the foot of the Ottoman bridge Kurçaj reacting with 10% HCl acid.

Rapid reaction to 10% HCL (Photo 1) indicates the presence of calcite in the sample. The sample is also traversed by a very irregular vein that passes immediately from the vein to the daisies (Photo 2). The thickness of this vein varies from 1 mm to 1 cm.

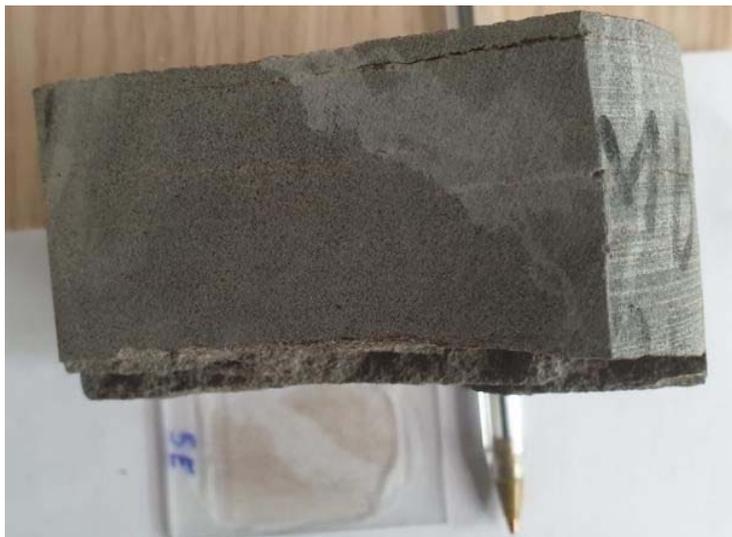
Figure 23.. Irregularly shaped calcite vein that traverses the sand sample from the foot of the Ottoman bridge, Kurçaj.

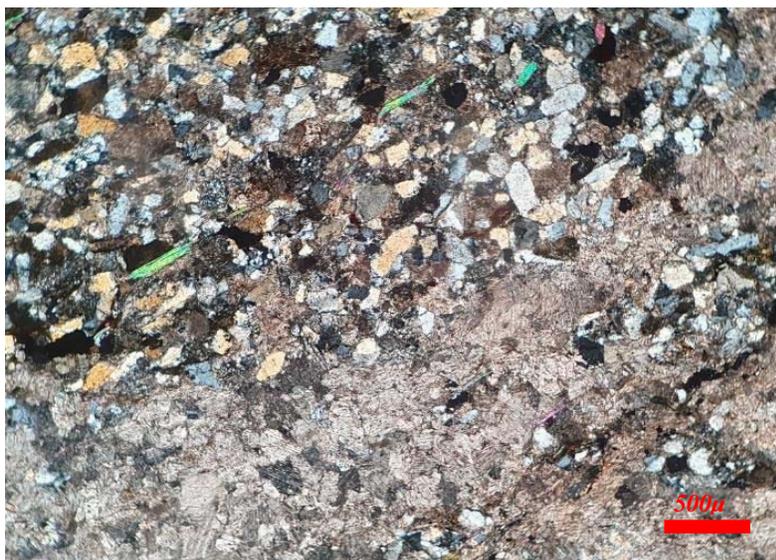
Figure 27. Muscovite leaflets are oriented subparallel to the calcite vein. Thin section of the sand sample from the foot of the Kurçaj bridge. Planar polarized light and permeated, with analyzer.

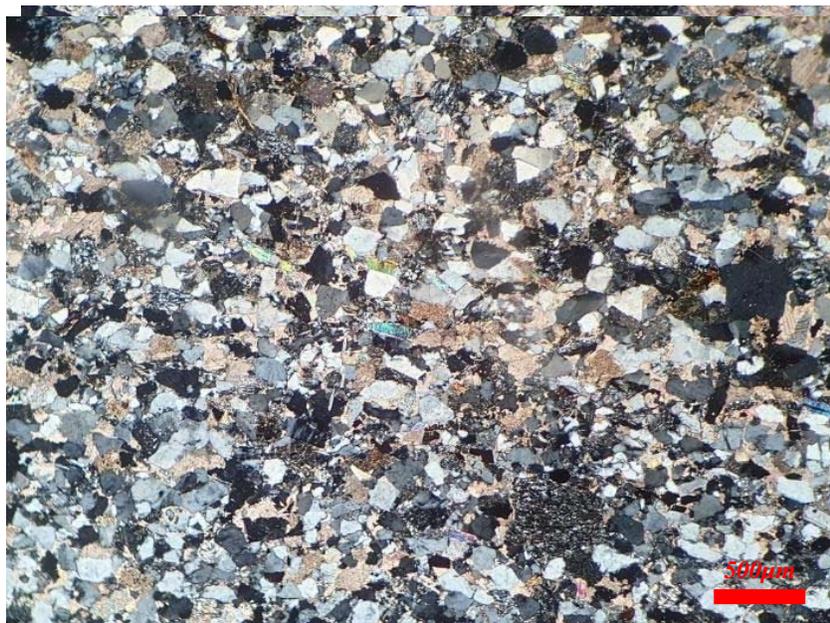
Figure 29. The grains are cemented by calcium. Thin section of the sand sample from the foot of the Kurçaj bridge. Planar polarized light and permeated, with analyzer.

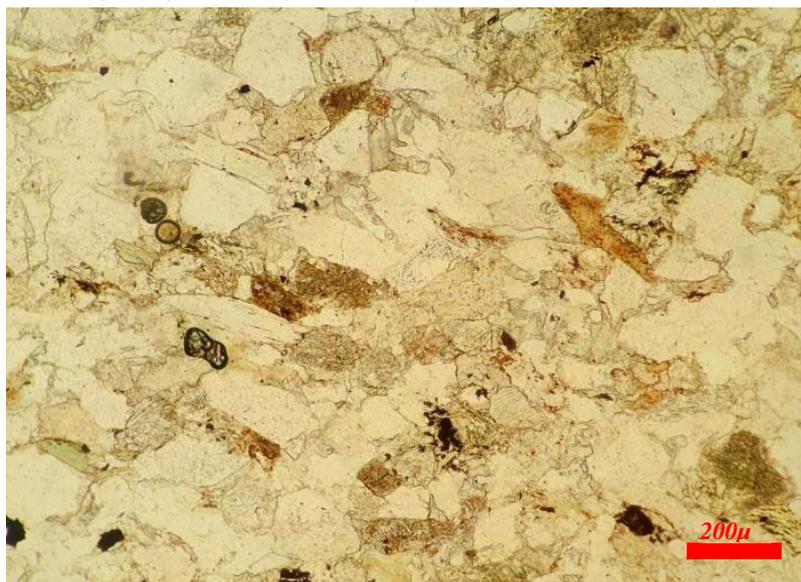
Figure 30. Detail of Figure 18, biotite and chlorite formations. Thin section of the sand sample from the foot of the Kurçaj bridge. Planar polarized light and permeable, without analyzer

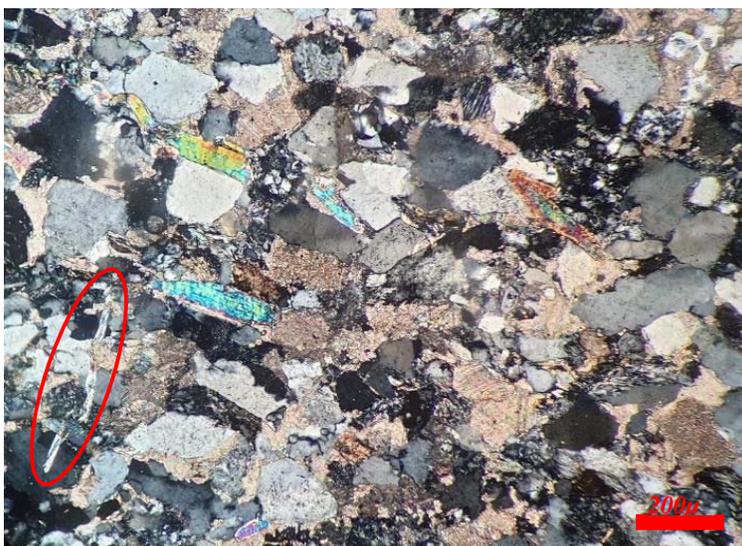
Figure 31. The same area as Figure 20, in addition to the larger sheets of muscovite and biotite, there are also small sheets of muscovite (red circle) with a transverse orientation to the first. Calcium cement has a clear crystalline structure. Thin section of the sand sample from the foot of the Kurçaj bridge. Planar polarized light and permeated, with analyzer.
