STRUCTURAL REPORT OF KURCAJ BRIDGE

22644-001_ALB_EU4C_RFP_01 - "Provision of Consultancy for Design services for EU4CULTURE Project - Support for revitalization of cultural heritage sites and monuments affected by Earthquake in Albania."

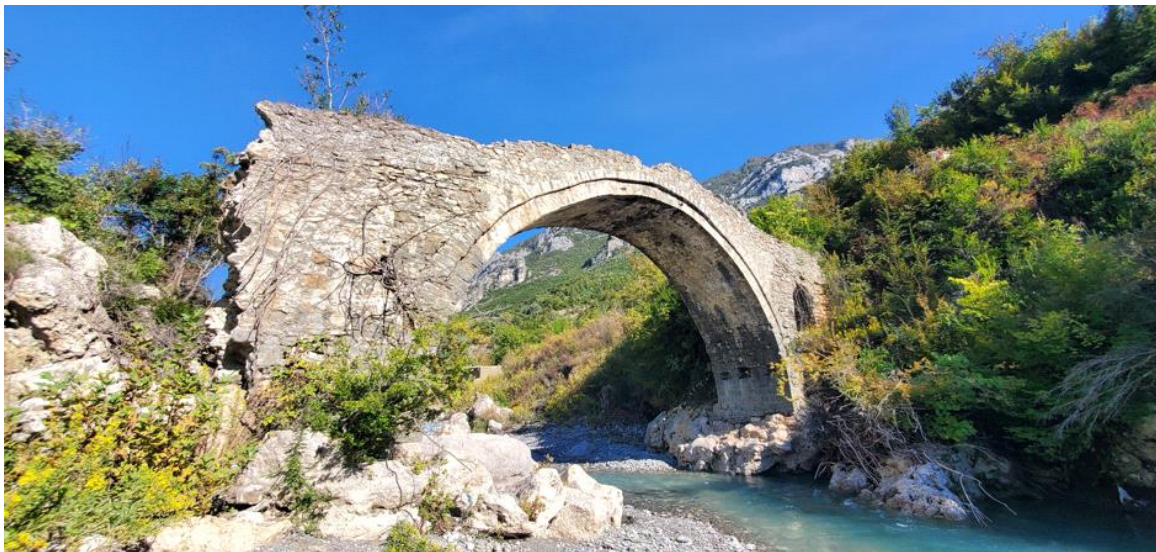
Figure 2: Front photo of the bridge during the measurements bridge

The current situation presents only the central arch with numerous damages. The foundations from the visual observation (terrain part/surrounding layers) do not look damaged or cracked, but during floods the water affects the abutments of the bridge. We have carried out a structural measurement (update) for the whole building and have made an assessment of the degree of vulnerability of structures as well as simulation **design and in-depth analysis**.

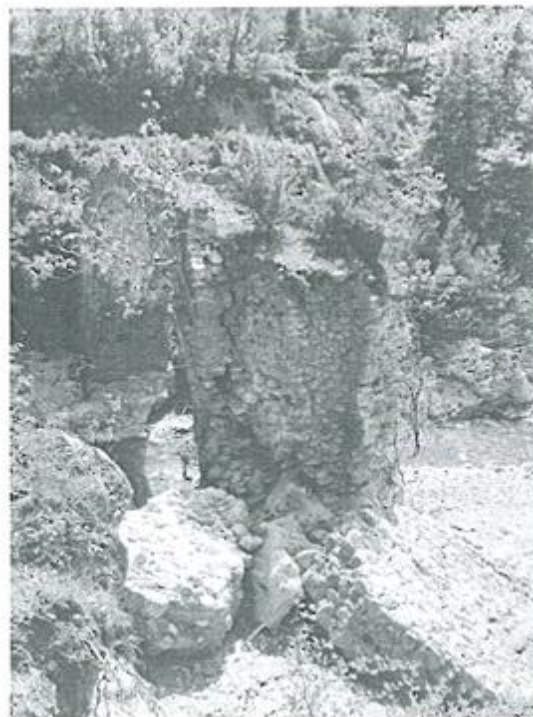
Figure 6: Photo from the damages found in the project of 2018 (IMK Archive)

There are cracks in the sides, arches, falling parts in the sides, detachment of the integrity of the elements.

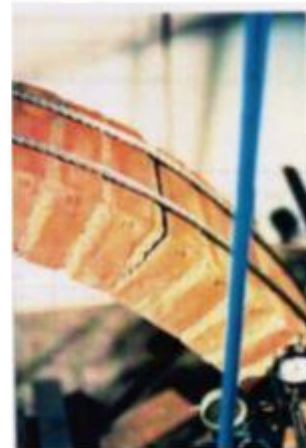
Figure 19: Reinforcement of the arch with steel cables

Implementing the prestressing force will prevent the formation of the 4 hinges which can bring the arch to collapse. Prestressing force will serve to close cracks, therefore, improve the stiffness of the arch and to remain in the elastic range of response.
