# STRUCTURAL REPORT HAMMAM OF DURRES

Funded by  
the European Union

**22644-001\_ALB\_EU4C\_RFP\_01 - "Provision of Consultancy for Design services for EU4CULTURE Project - Support for revitalization of cultural heritage sites and monuments affected by Earthquake in Albania."**

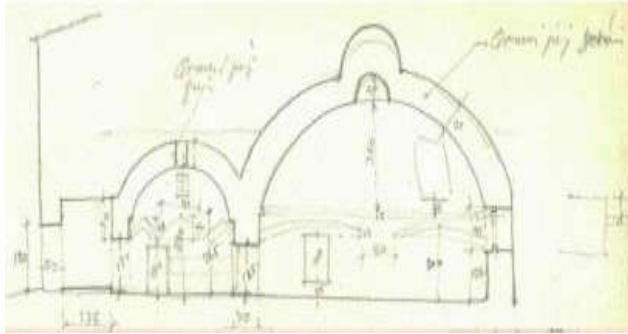
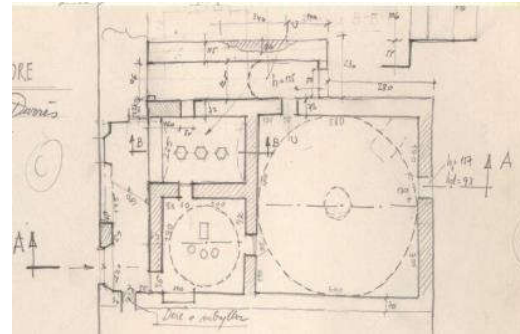
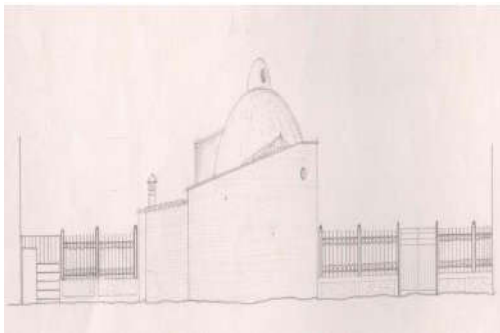
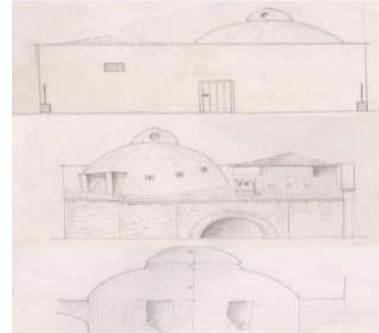
In the Hamam of Durrës, works were carried out in the early 1980s, where from a volumetric point of view it was preserved in the condition it is today. Below are the longitudinal cuts and the layout of the Hammam, as measured in 1985.

Figure 3 The longitudinal sections and the layout of the Hammam in 1985

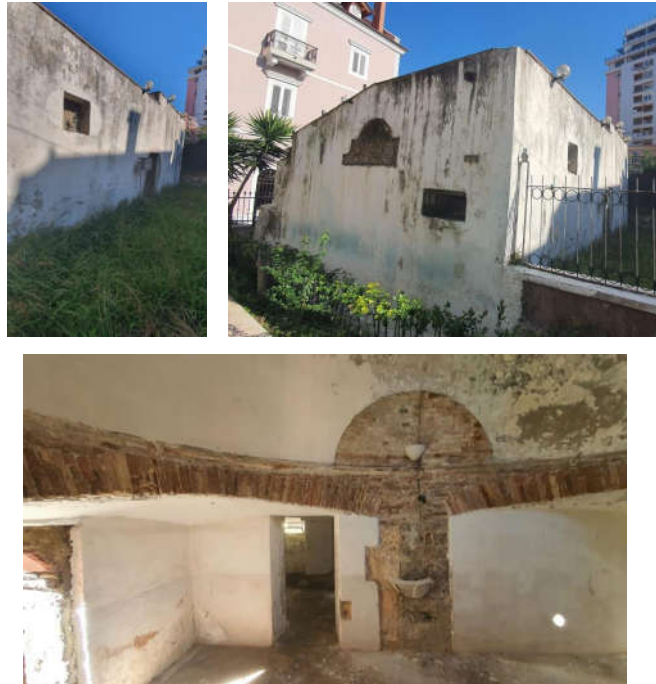
- Irregular stone masonry;
- Stone masonry combined with brick.

Irregular stone masonry is encountered on the south façade and in some fragments inside, as the other façades are plastered. Interior walls today are presented with interventions made over the years, such as plastering or painting. In the interior walls we encounter stone masonry which are thinner than perimeter walls. The walls are generally plastered in addition to room 3 and 4.

Figure 4 Stone masonry combined with brick, we encounter both in the premises inside and outside the Hammam.

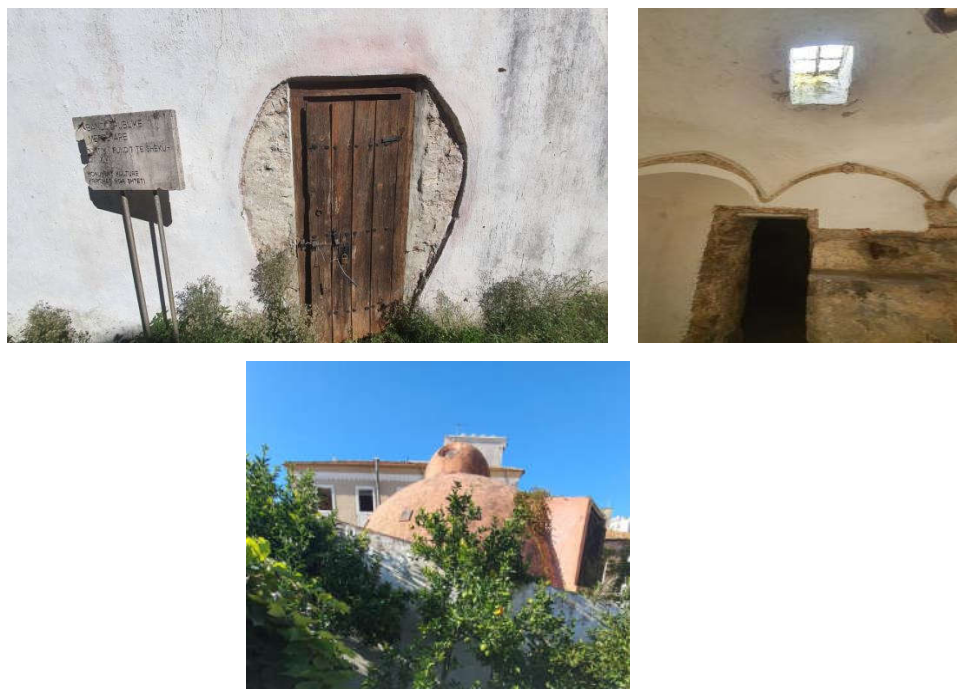
The central part of the building is a dome while the other part that is lower is made with stone arches. The lighting is realized through small domed spaces with dimensions 15x15 cm. The heating of the premises was done through copper boilers, where steam circulated through ceramic pipes. Mixed technique was used. Existing masonry is found in 2 types of forms divided based on the technique and the time when they were made in:

Figure 4 Hammam cover includes elements like Dome and shelter

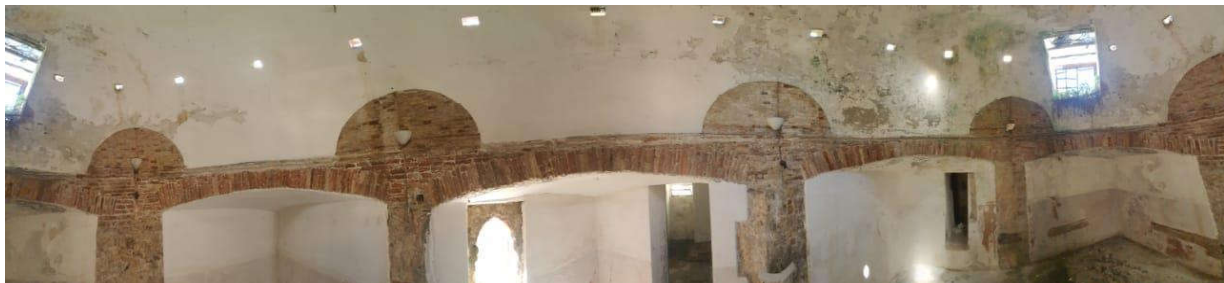
1. Cracks in the stone masonry;
2. Presence of moisture and mold;
3. Drainage problems;
4. Vegetation development in walls and windows;
5. Rusting of metal elements;
6. Degradation of the front door;
7. Detachment and falling of plaster;
8. Lack of windows;
9. Depreciation of the electrical network

Figure 5 Presence of moisture, mold and vegetation

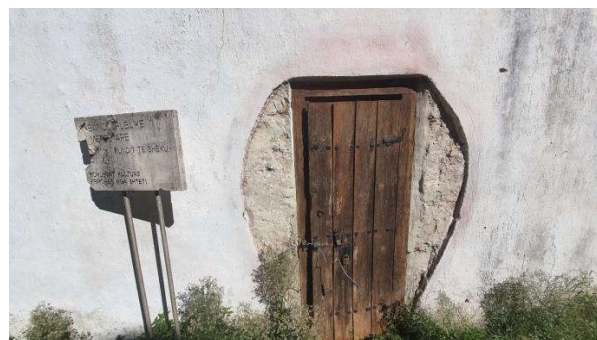
The building has only the main wooden entrance door. We have the inner cracks of the doors, which are in stone masonry and arched. There is a window in the main dome, in the intermediate environment as well as a window in the water deposit but it is closed from the outside. The building has floor marks laid after the 90s. The building is currently without electricity but the electrical system exists which was made after the 90s.

Figure 6 Degradation of the front door

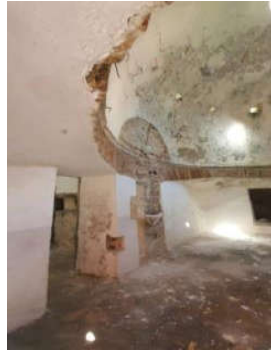
Figure 7 Detachment and drop of plaster

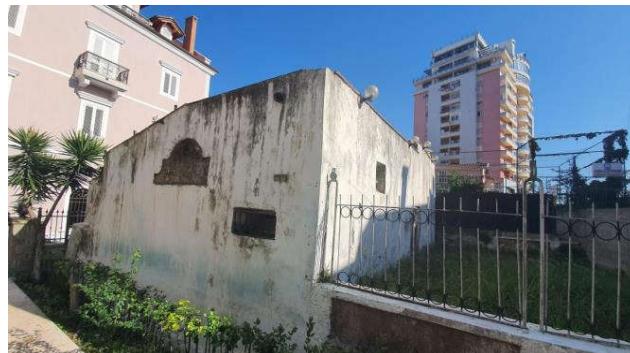
Figure 8 Presence of moisture and mold as well as degradation of plaster on the facade

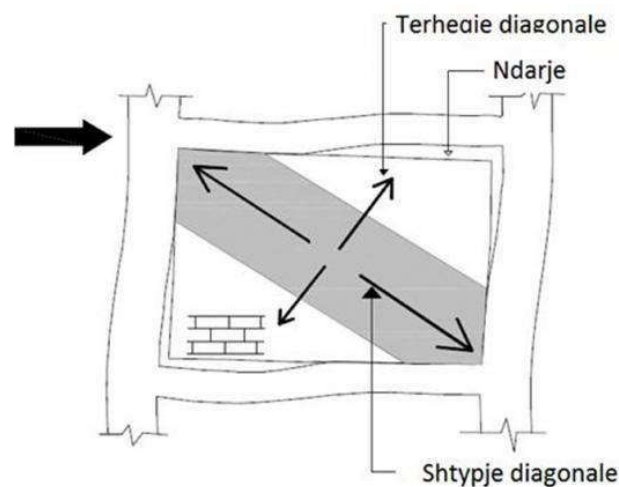
The basic feature of macro models is that they take into account only the overall stiffness and the load of masonry destruction, regardless of all possible modes of local damage.

-The concept of equivalent diagonal

Figure 9 Modeling by means of diagonal in printing

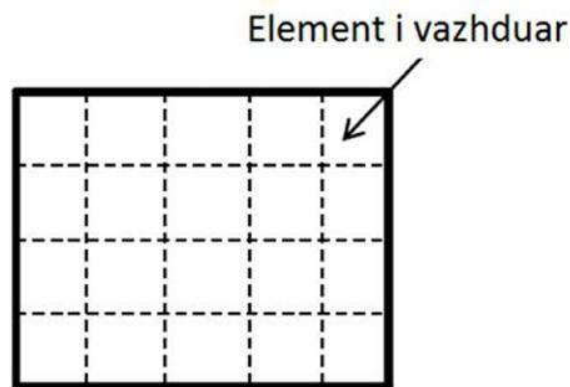
According to this method, the effect of the brick, mortar, and brick-mortar contact surface is modeled as a continuous element, as shown in the following Figure:

Figure 10. Idealization as a continuous element

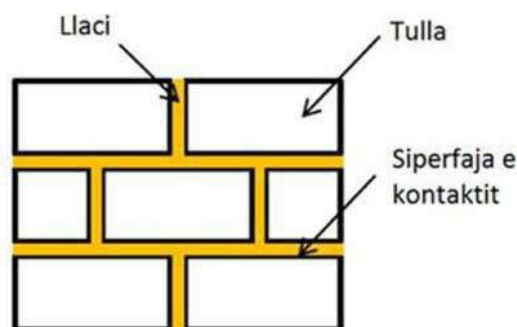
In this method bricks and mortar joints are modeled as a continuous element and the contact surface between the brick and mortar is modeled by an interface element. Both the continuous element and the model interface can be defined by a nonlinear strain-strain relationship. The modeled elements are 1) brick, 2) mortar, 3) the contact surface between the mortar and the brick.

Figure 11 Detailed micro modelin

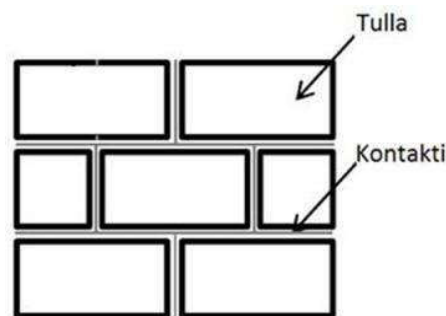
In this method the brick is modeled from the continuous element, while the mortar and the interaction with the brick are modeled together as an Interface element, as shown in the following figure:

Figure 12 Simplified micro modeling

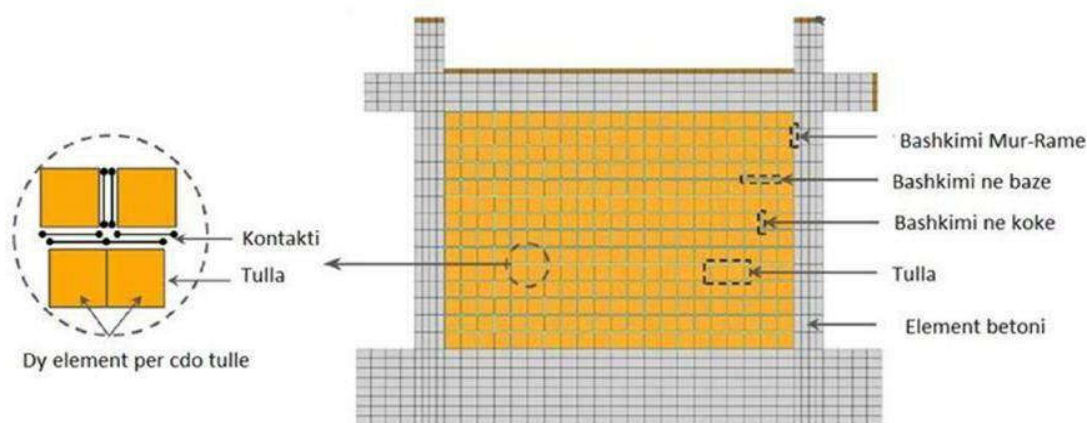
The development of finite element methods provides an aid to the shortcomings of previous methods. The following figure explains the micro model with a finite element.

Figure 13 Nonlinear micro modeling with finite elements

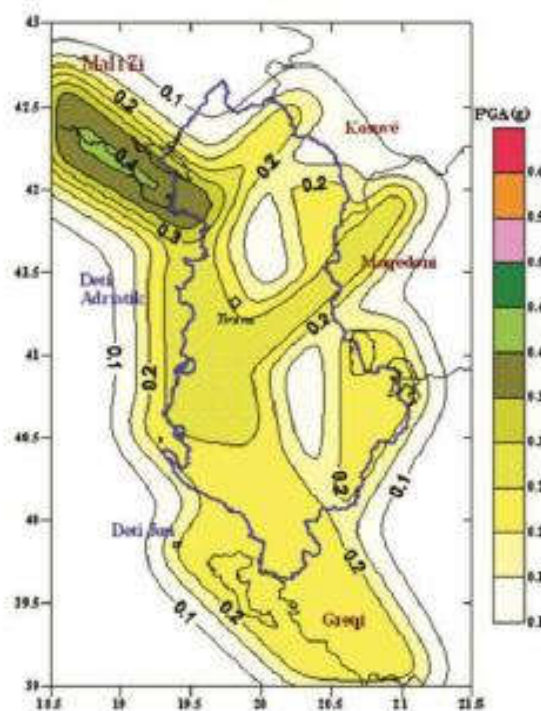
Ground Acceleration (PGA	$a_g = 0.394 \text{ g}$ (EC-8), $I=8.5$ degrees (KTP-89)
Category of soil (KTP.N2.1989)	Type C (EC-8), Soil Category III
Factor of soil categorization by type	$S=1.15$
The behavior coefficient of structure	$q=1.5$
The importance factor	$\gamma_I=1.2$
The factor for damping	$\zeta=5\%$
The correction factor for damping	$\eta=1$
The foundation factor	$\beta=2.5$
The regularity of the building in height	$K_r=1$

Figure 14 Maximum PGA acceleration on rock with probability 10% / 50 years (475 years of repetition)

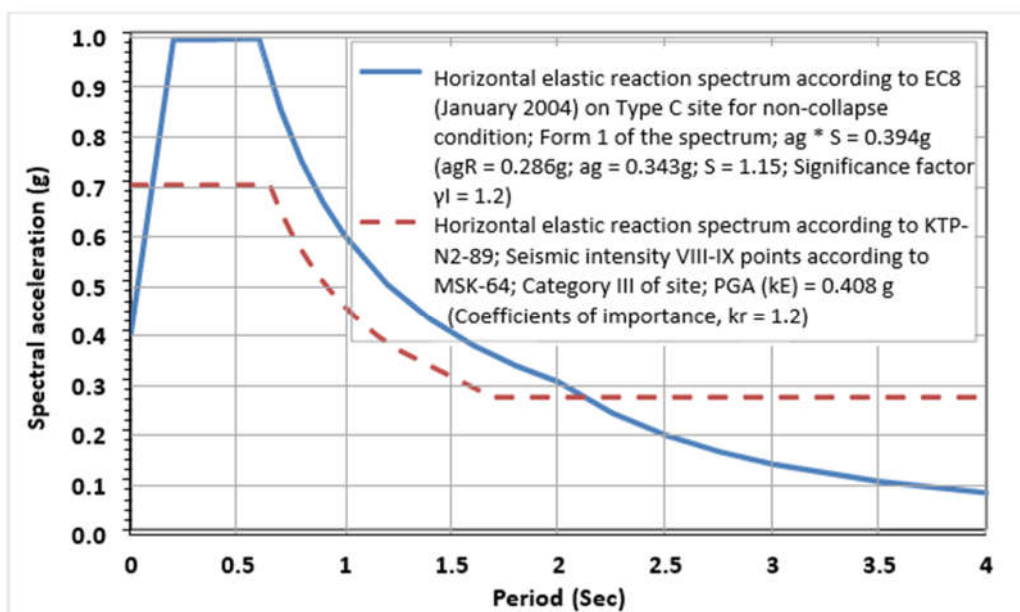
Figure 15 Elastic horizontal spektral

The figure shows the comparison of the horizontal reaction spectrum according to KTP-N2-89 with the horizontal design elastic spectrum for the non-collapse condition for reinforcement and restoration interventions in the Hammam.

From this comparison it results that the spectrum of horizontal design reaction for the non-collapse condition according to EC-8 is with better protection than the respective spectrum according to the technical condition KTP-N2-89 with seismic intensity VIII-IX front according to MSK-64 and category III plots of land.

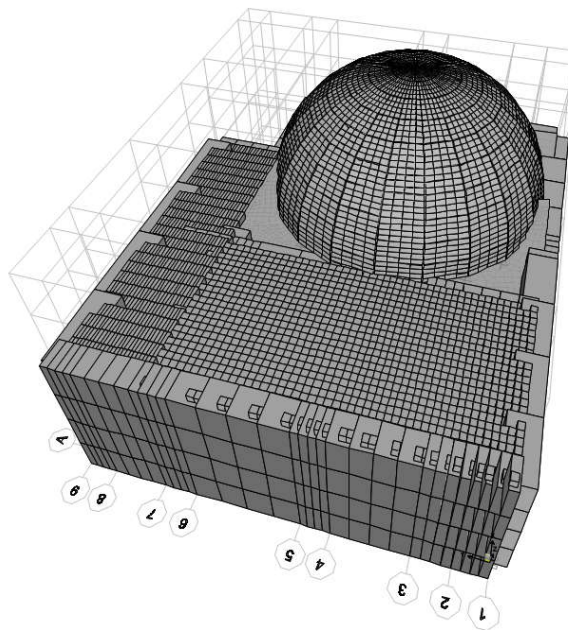
Figure 18 3D model of the dome structure in Sap 2000

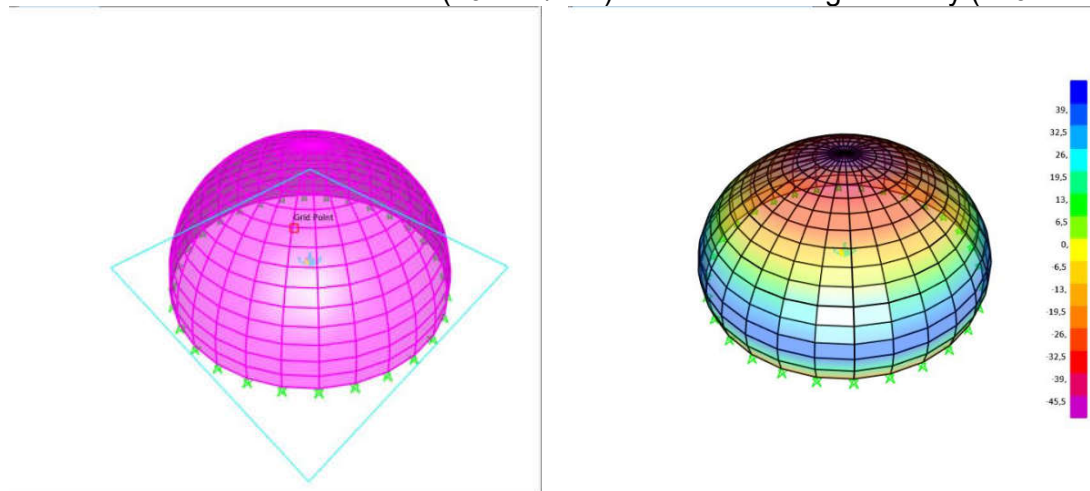
The values of compressive stresses during earthquake loading on the dome (0.5 daN/cm<sup>2</sup>) and in the load-bearing masonry (1.2 daN/cm<sup>2</sup>) are within the in-situ measured compressive strength of stone block units for the dome (40 daN/cm<sup>2</sup>) and load-bearing masonry (270 daN/cm<sup>2</sup>).

Figure 19 Stress S11

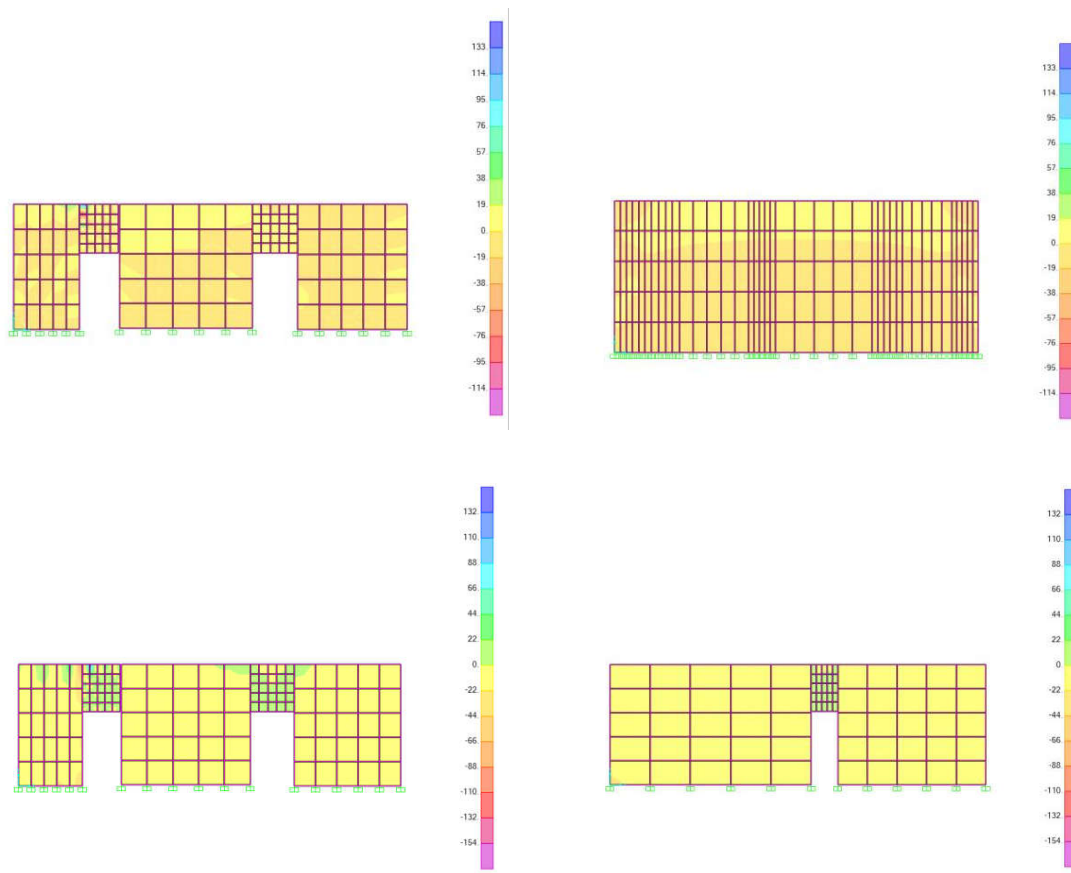
Figure 20 Stress  $S_{11}$  dhe  $S_{22}$  on walls

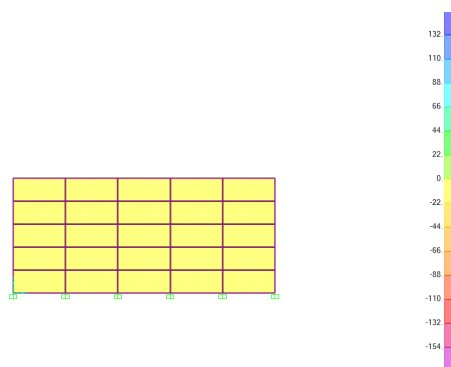
Figure 21 Stress  $S_{11}$  dhe  $S_{22}$  on walls

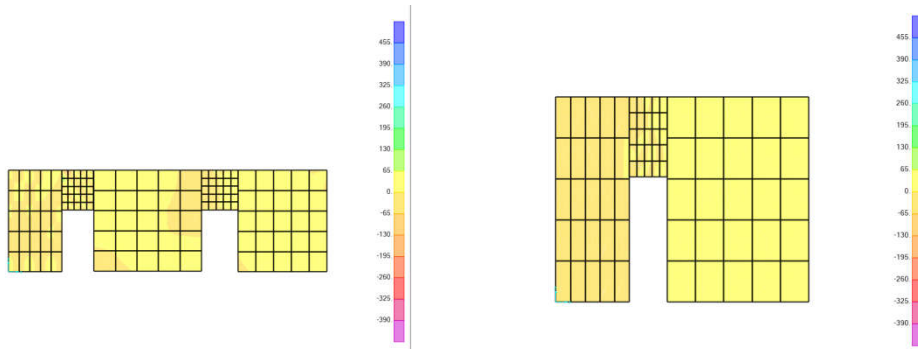
Figure 22 Stress  $S_{12}$  on walls

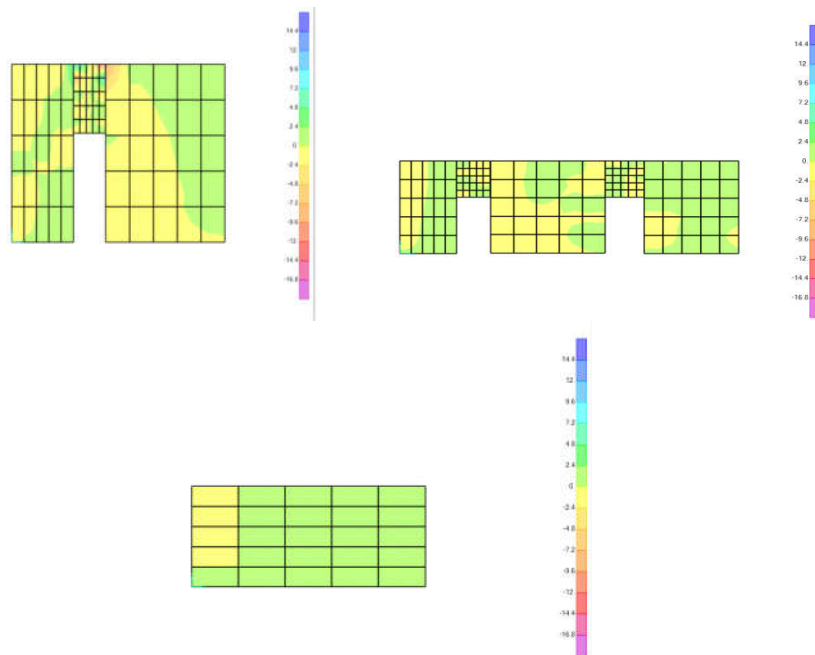
Figure 23 Stress  $S_{13}$  on walls

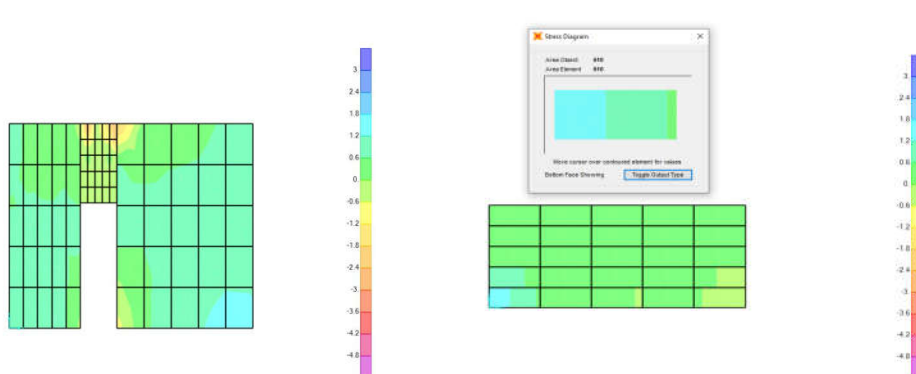
Figure 24 Stress  $S_{23}$  on walls

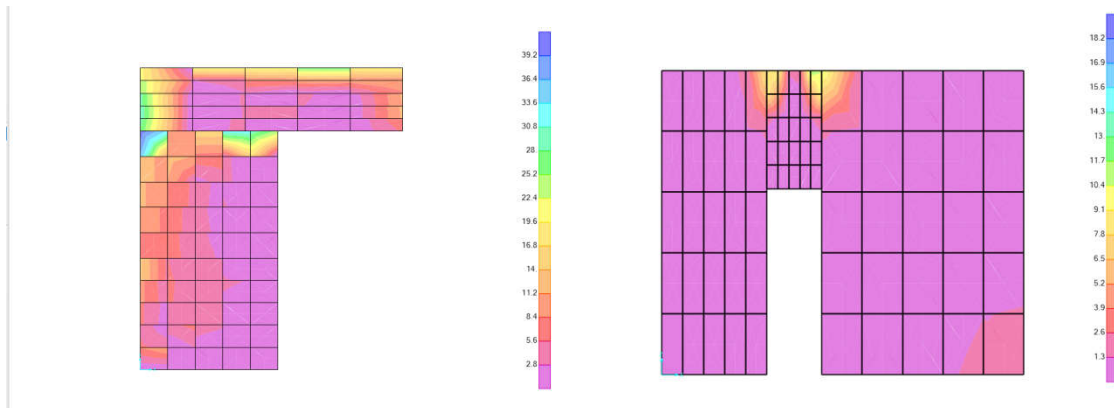
Figure 25 Maximal stress on walls

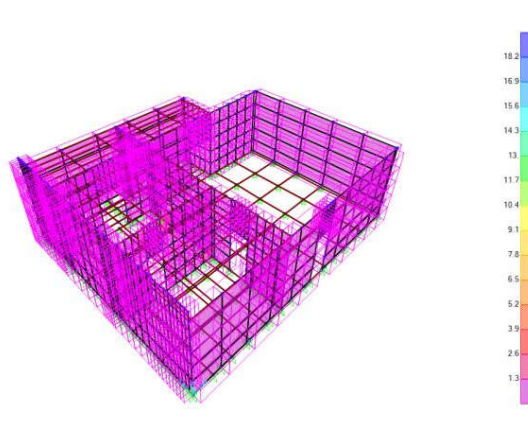
Figure 26  $V_{max}$  from combination 1
