GEOLOGICAL REPORT HAMAM OF DURRES

22644-001_ALB_EU4C_RFP_01 - "Provision of Consultancy for Design services for EU4CULTURE Project - Support for revitalization of cultural heritage sites and monuments affected by Earthquake in Albania."

The Medieval Hammam building is a cultural monument Category I, declared by decision of the Ministry of Education and Culture dated 10.06.1973, No. 1886. This building is located in Durres, Administrative Unit Municipality of Durres, Neighborhood 1, Rruga Tregtare, with geographical coordinates 41 ° 18'38.38 "N and 19 ° 26'50.51" E.

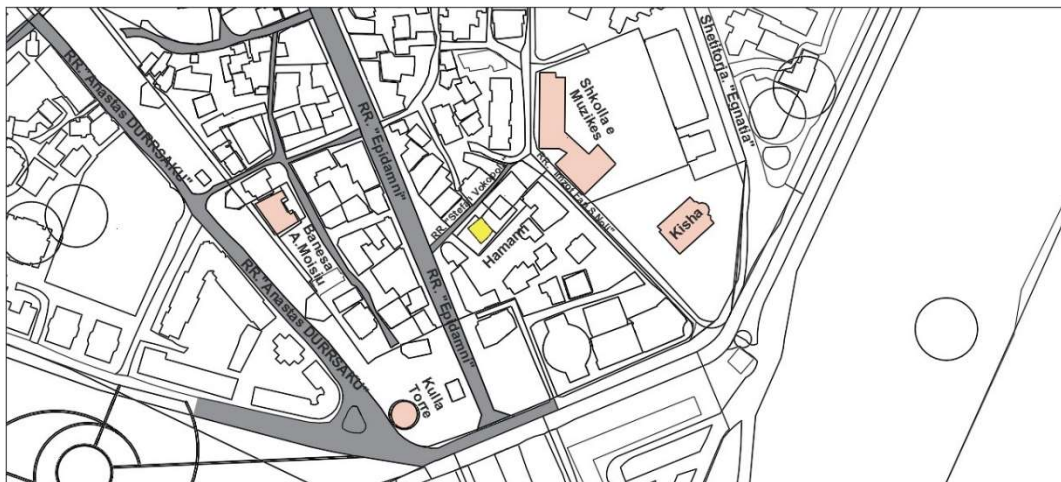
Figure 1. Map of the layout of the Hammam of Durres

The area where the building is located has a slightly sloping relief and represents the sea terrace of Durres which consists of marine and Neogene deposits. The deposits have a thickness over 5.00-10.00 m. Neogene deposits have a thickness of 100-250 m.
