## DESIGN OF INTERVENTIONS

**ETHNOGRAPHIC MUSEUM OF KRUJA**  
**MUZEU ETNOGRAFIK I KRUJËS**

## **ETHNOGRAPHIC MUSEUM IN KRUJA - Components of intervention**

22644-001\_ALB\_EU4C\_RFP\_01 - "Sigurimi i Konsulencës për Shërbimet e Projektimit për Projektin EU4CULTURE - Mbështetje për rijetëzimin e siteve dhe monumenteve të trashëgimisë kulturore të prekura nga Tërmeti në Shqipëri."

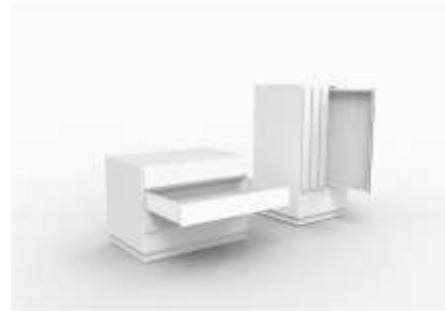
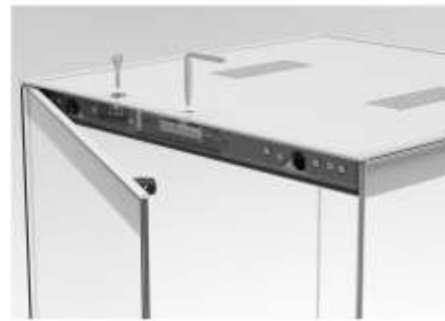
- ◆ New expositors collecting and combining objects:

- Costume
- Interior elements

The new expositors would replace the old ones which are not built by the standard of atmosphere control

The new expositors would replace the old ones which are not built by the standard of atmosphere control

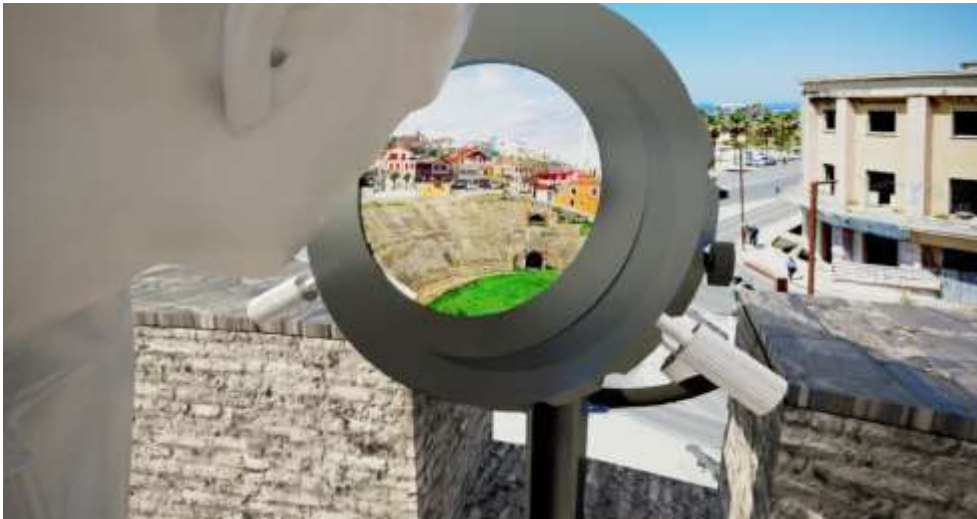
- ◆ Viewing binoculars on the top terrace showcasing Durres through the history of development
- ◆ 5 viewing spots showcase a 360 degree view on how the area have changed in last 80-100 years
- ◆ The digital comparison images rely on photography and sketches developed by travellers

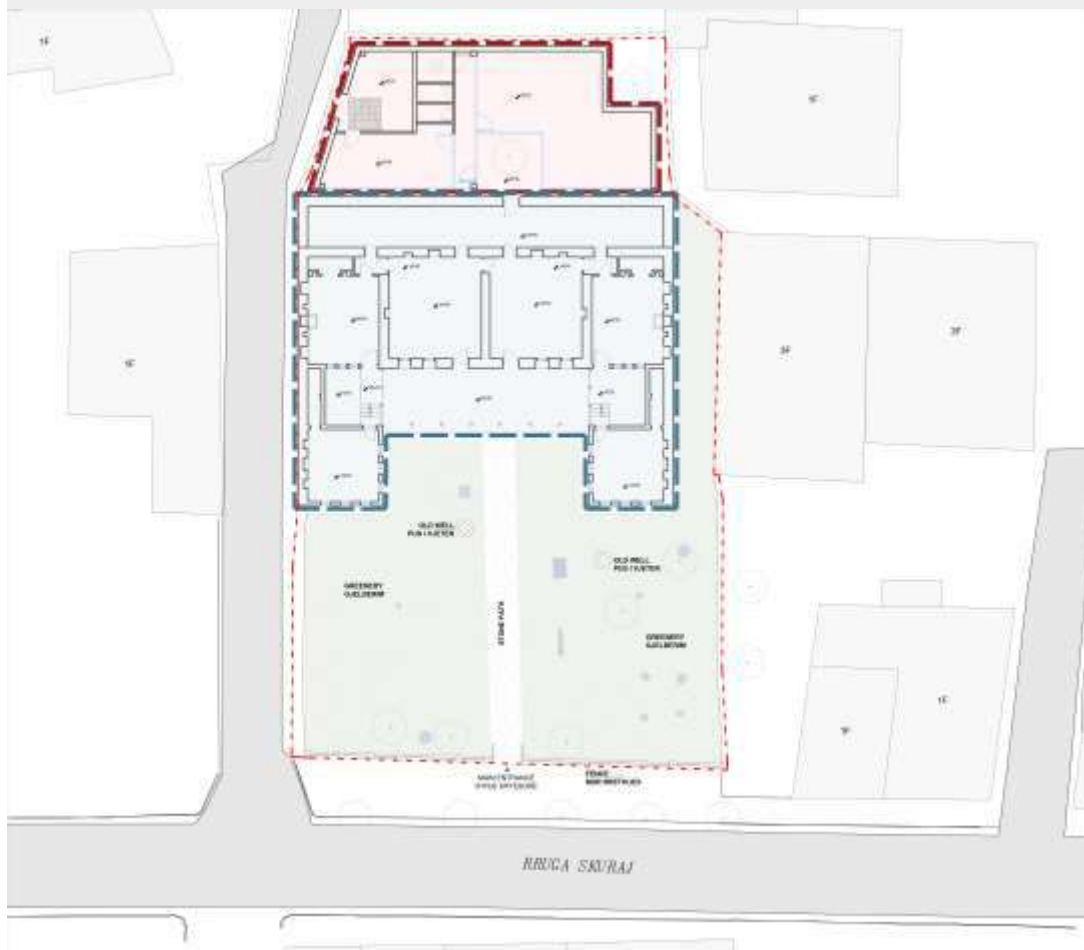
- ◆ An new volume will be added at the back of the existing building
  - The existing building will be fully restored (roof, walls, floors, timber elements, doors and windows).
  - The be building will be constructed with the traditional technique (adobe walls) but with modern materials. The new building will accommodate different functions: Administrative; Laboratories for the conservation of the artefacts; Storage; Exhibition.
- ◆ The yard in front of the building will be reconceptualized so to put outside temporary exhibitions
- ◆ The wells in the yard will be restored

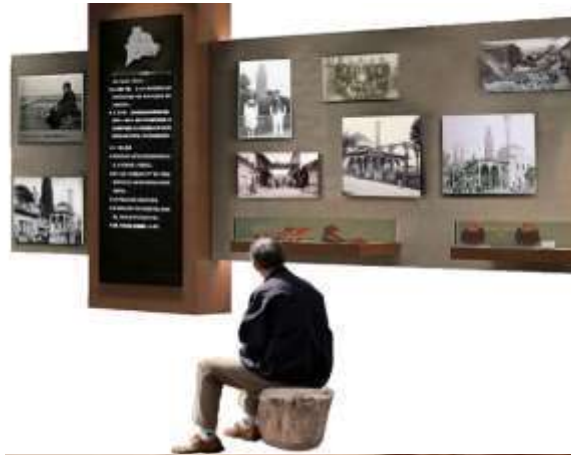
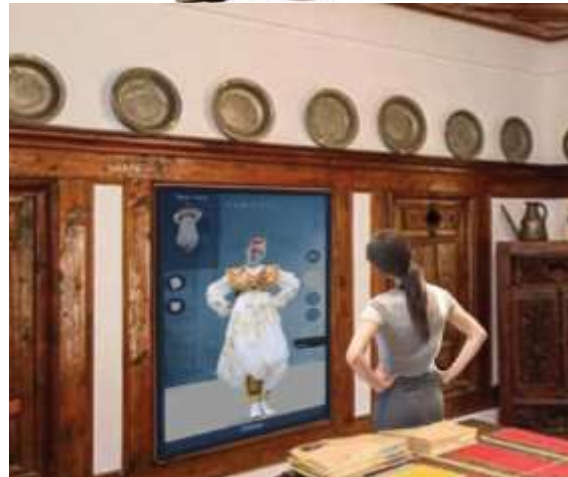
PAVILLION 1-EXHIBITION/  
PAVIONI 1-EKSPOZITA

- ◆ The entire ground floor will be reconceptualized and organized in three main pavilions and in each pavilion there will be a specific thematic exhibition

In the Pavilion 1 will take place:

- The ticket office
- The traditional furnishing of the Fire House
- Traditional everyday use house objects

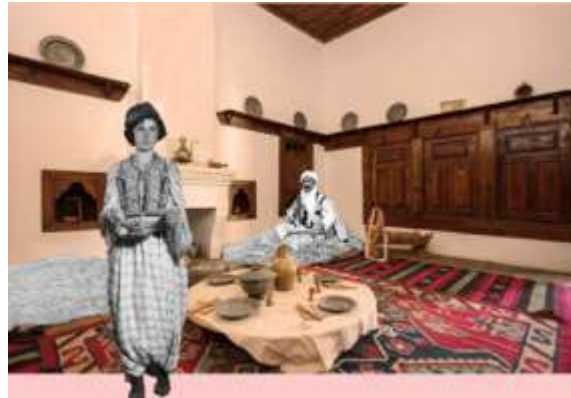
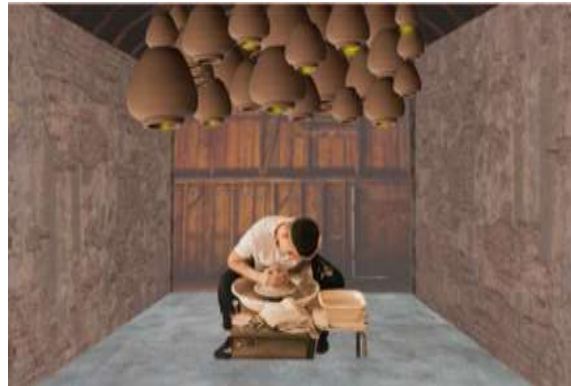
PAVILLION 2-FIRE HOUSE/  
PAVIONI 2-SHTEPIA E ZJARRIT

In the Pavilion 2 traditional costume exhibition.

Exhibition means will be reconceptualized.

- FX Mirrors will be installed so visitors can “try” on themselves the traditional costumes
- New expositors will be installed for better presentation and better conservation of the traditional costumes
- Informative panel will be installed

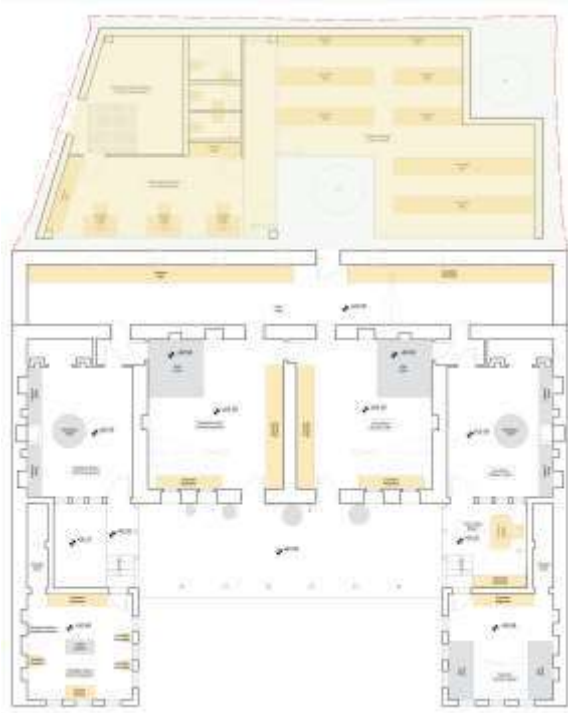
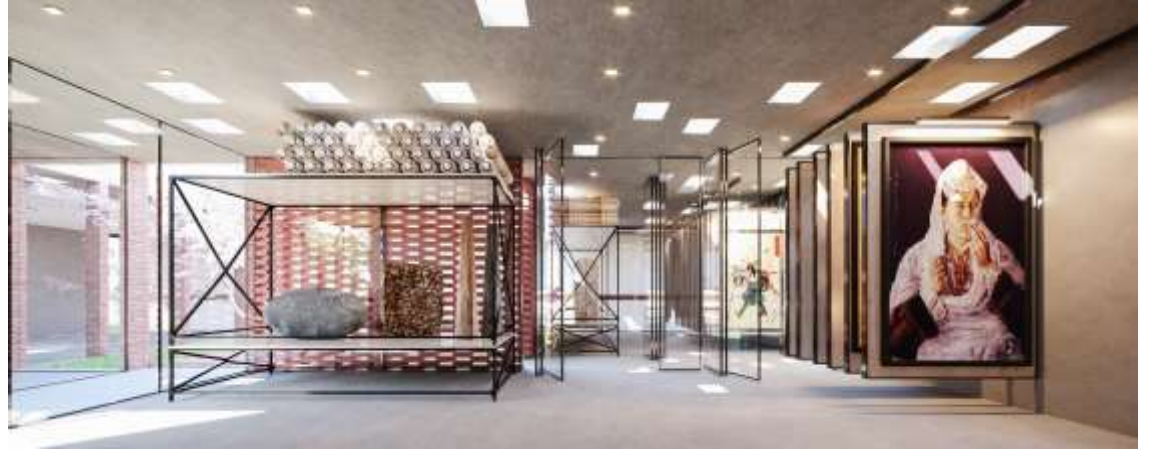
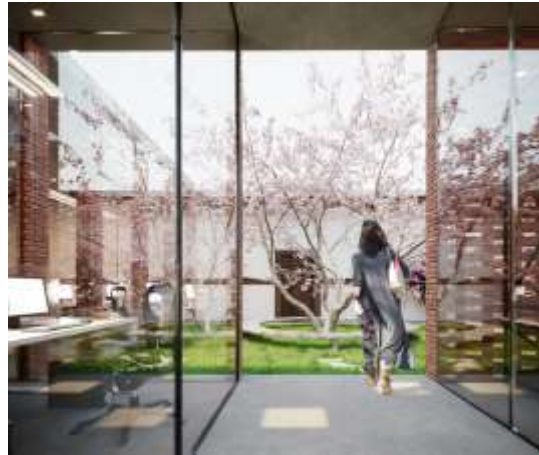
ADMINISTRATION/  
ADMINISTRATA

In the Pavilion 3 the auxiliary areas of the museum.

- Storage area
- Temporary exhibition
- Administrative areas
- Laboratories for conservation of the artefacts

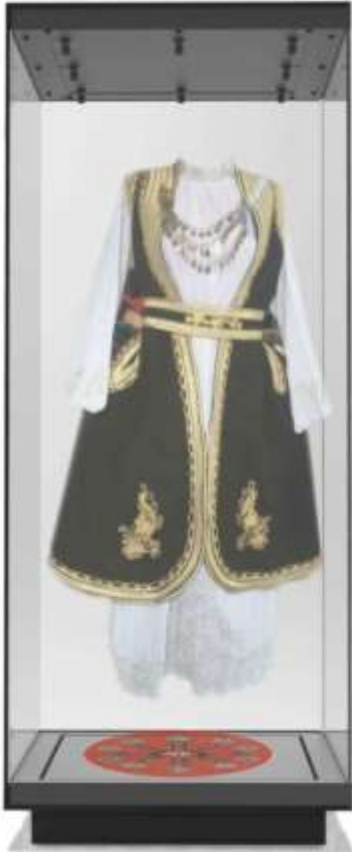
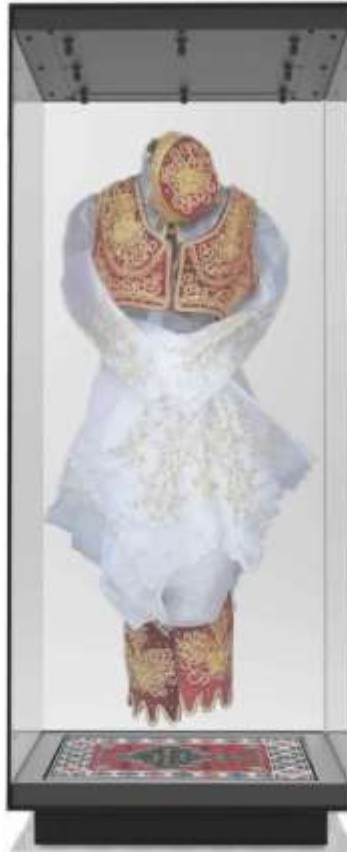
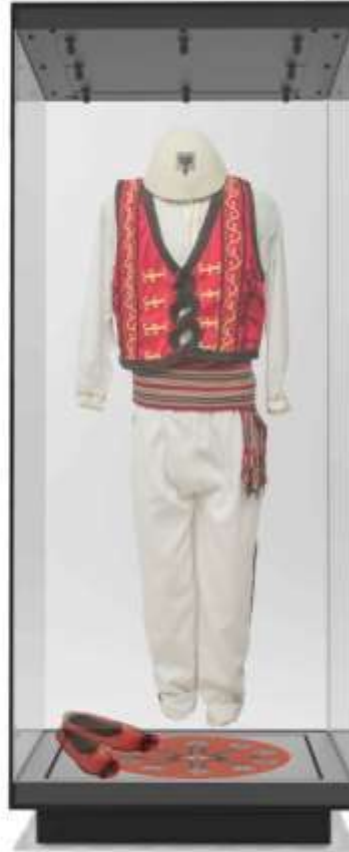
- ◆ New expositors collecting and combining objects:
  - Costume
  - Interior elements

- ◆ Reconceptualization of the exhibition displays including removal and better display of all the objects currently stapled to walls or exposed while leaning on wall paintings
- ◆ Change in environment of exposition for fragile objects (textile)
- ◆ Short/mid and long term conservation plan for continuous upkeep
- ◆ Clearer storytelling of traditional lifestyle

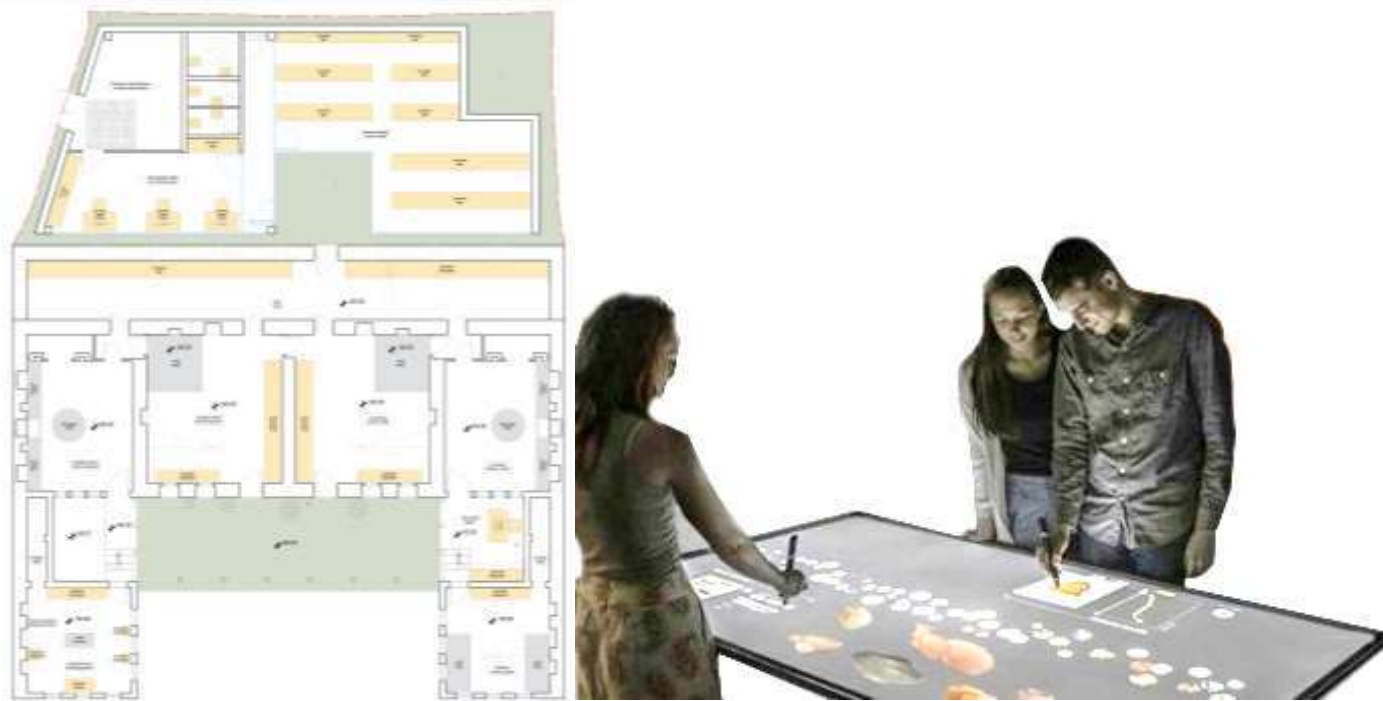
- ◆ Digitized objects available through touch screens set in the entering space allow for viewing the content of the Museum both on site and remotely
- ◆ Digitizes objects available as a part of the overall database in utility spaces and administrative units

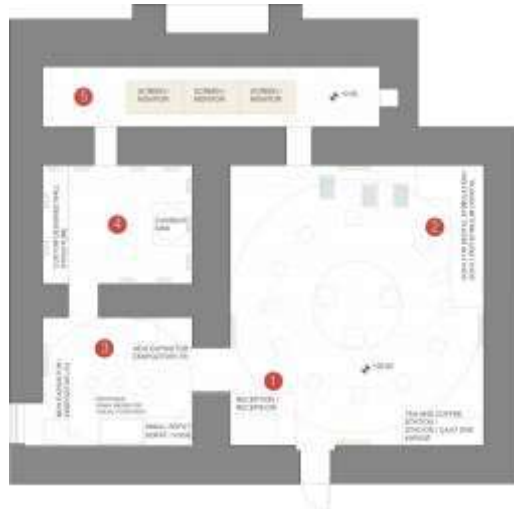
- 1 Ticket Box / Biletari
- 2 Sofa for digital stimulation / Sofat per stimulim dixital
- 3 Lukewarm Room-Exhibition space with visual stimulation / Dhoma e Netermjete-Hapësitë ekspozimi me stimulim vizual
- 4 Steam Room Exhibition space with visual stimulation / Dhoma e Avullit-Hapësitë ekspozimi me stimulim vizual
- 5 Steam-Interactive room (audio & video) / Sfera-Dhomë interaktive (audio & video)

Fog Machine / Makineri Avull  
Screen Monitors / Monitore

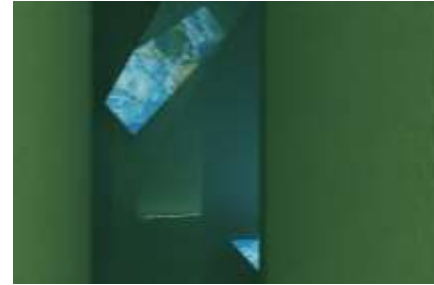
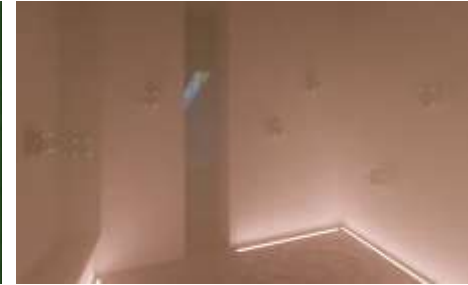
- ◆ Each room in the Hamam represents the typology of usage with panels explaining the historical and contemporary use of water in public and private spaces of similar purpose
- ◆ The experience is strengthened through sensory performances using sound of water, chatter and moving air
- ◆ The structure of hamam's hypocaust floor is viewed from the floor level through openings left
- ◆ The system of water heating and warm air circulation interpreted for educational purposes
- ◆ Seating places installed simulating the way one used to sit and enjoy the hamam while using its functions

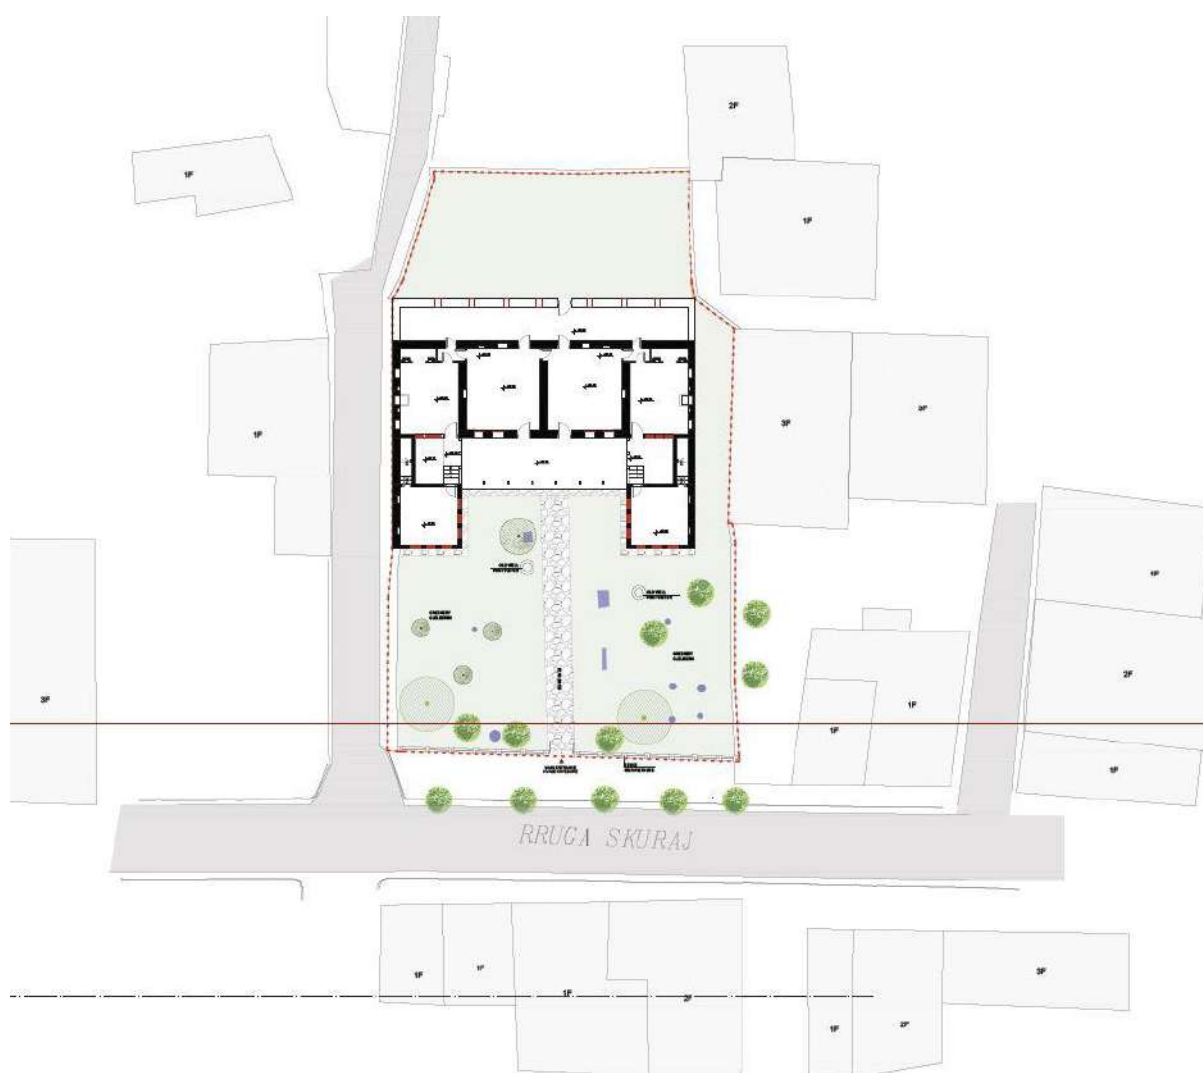
The museum is located in the Skuraj neighborhood of the city of Kavaja. It is surrounded by other relatively low 1,2 or 3 storey houses. It can be easily accessed through the main road "Skuraj" and it's surrounded by a low brick wall and steel railings. There is a spacious courtyard in front of the museum. Likewise, there is a backyard which is accessible from the barn of the house.

Fig. 11: Site Plan, Current Condition

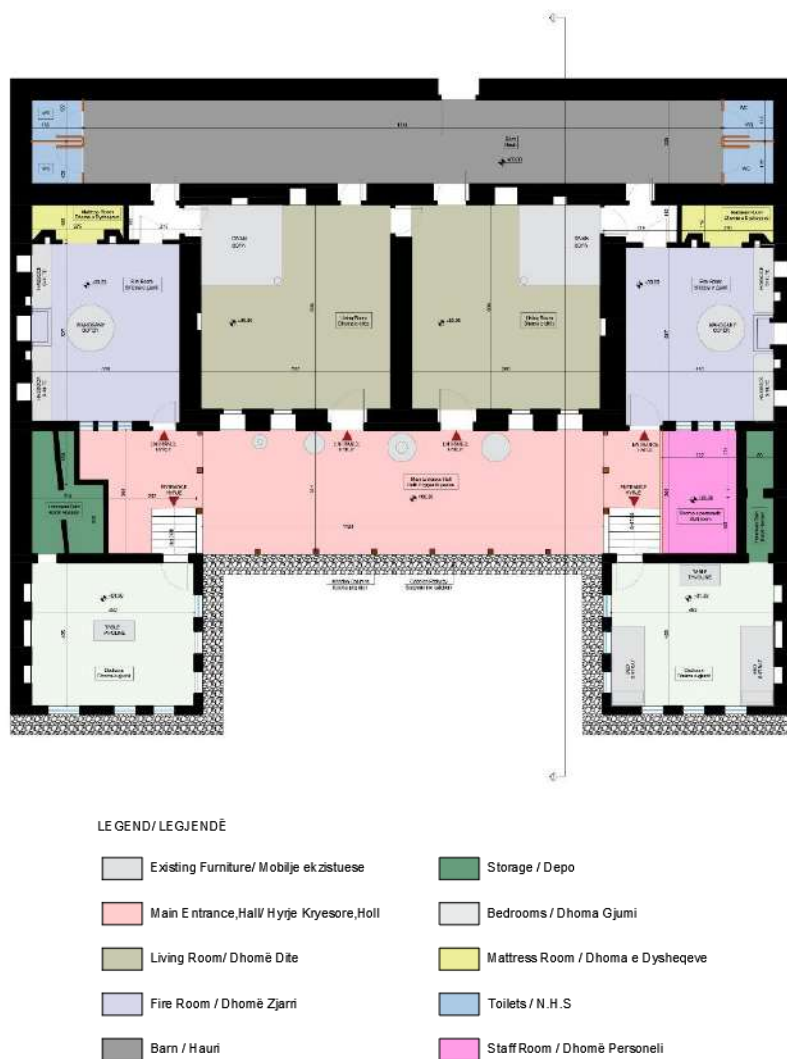
The Ethnographic Museum of Kavaja is adapted into a characteristic dwelling of this area. It belongs to the typology of traditional buildings with porches, with three living quarters. The building in question in its initial composition was built as two adjoining dwellings of two families (usually the families of two brothers or relatives) with three living spaces each. The ex-dwelling (nowadays established as the Ethnographic Museum of Kavajë) extends through one floor with a considerable horizontal extension developed in the horizontal direction. The apartment has a symmetrical development where the axis of symmetry goes through the middle of the frontal porch. The porch is covered and has a portico of seven wooden columns.

Fig. 12: Functional Scheme of the Museum, Current Condition

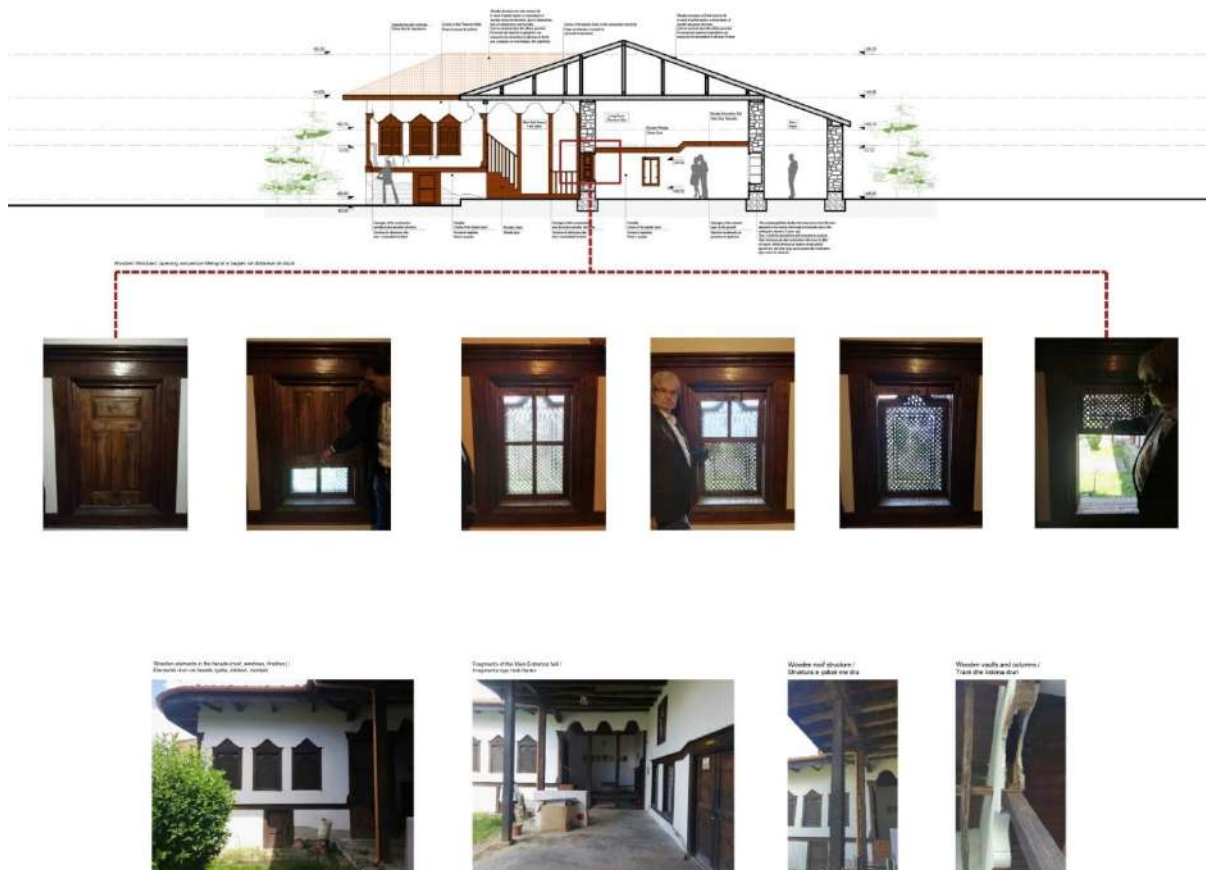
Fig. 13: Peculiar Wooden Window with three layers: wood,

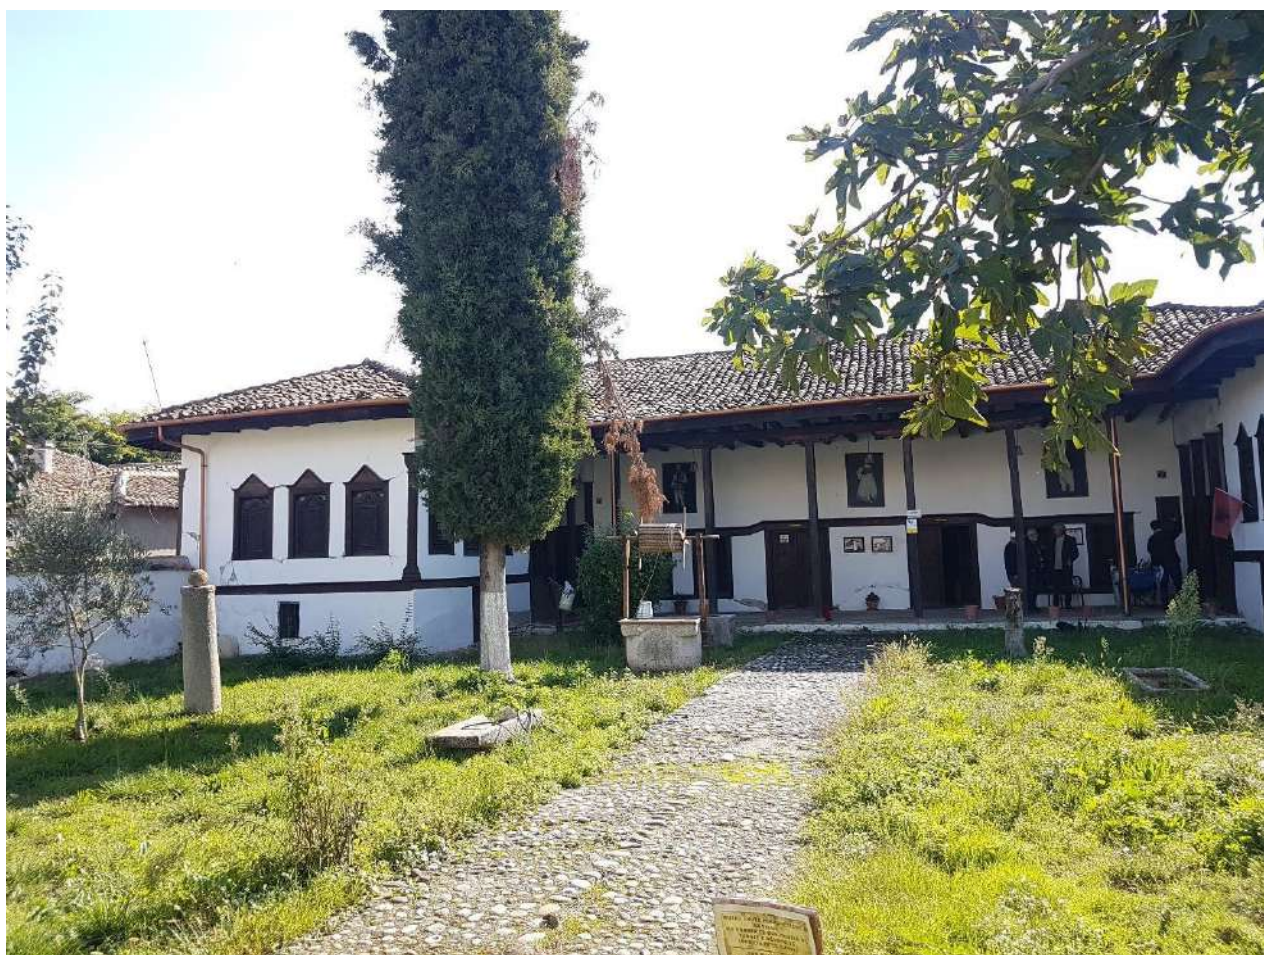
*Fig. 15: Courtyard and main facade, Current Condition*

The building was severely damaged by the earthquake of November 26, 2019. The main damages are noticed in the structure. The constructive supporting structures of the building are stone foundations and adobe walls with antiseismic woodeen strips which, at certain moments represent the deterioration of the material as well as the earthquake damages, which consist of cracks in the walls and the plaster finish in the whole building.

Wooden elements such as; the porch columns, the floors and the wooden ceilings are damaged due to the weather and the atmospheric agents, as well as capillary moisture invading most of the surfaces. Biological patine is observed as well. These elements need restoration or replacement depending on the degree of deterioration.

Another problem of the building is its outer plaster which, due to additives, has made the plaster absorb moisture from the air.

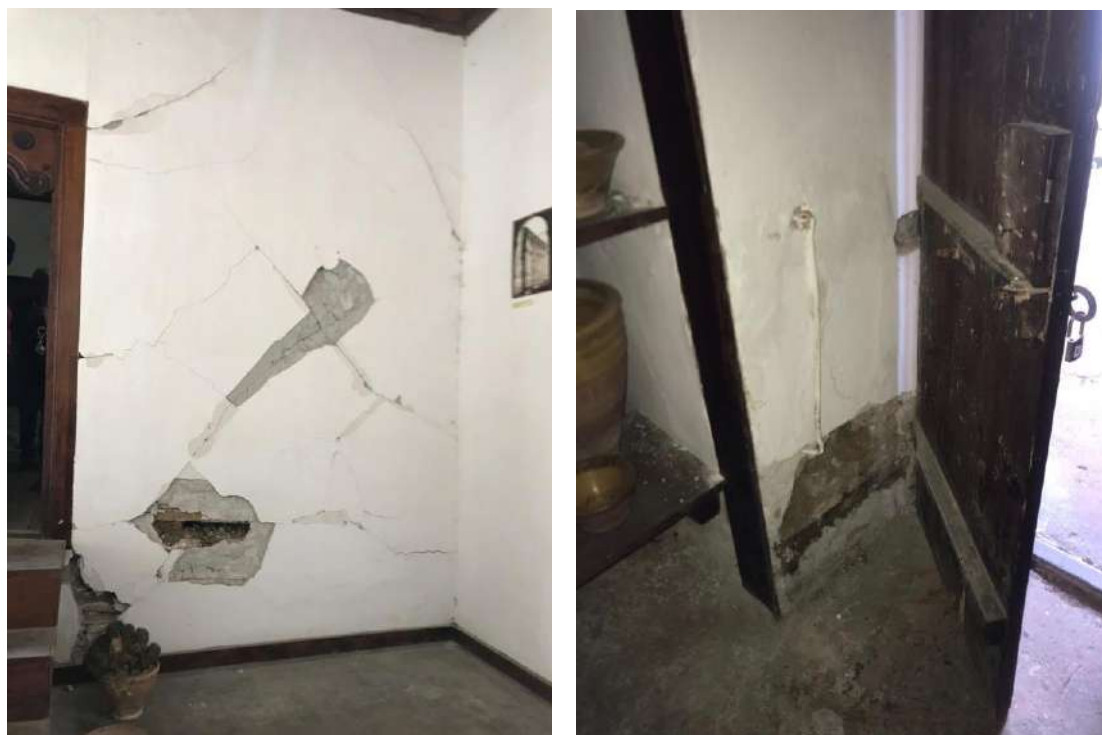
Fig. 16: Masonry Deteriorations

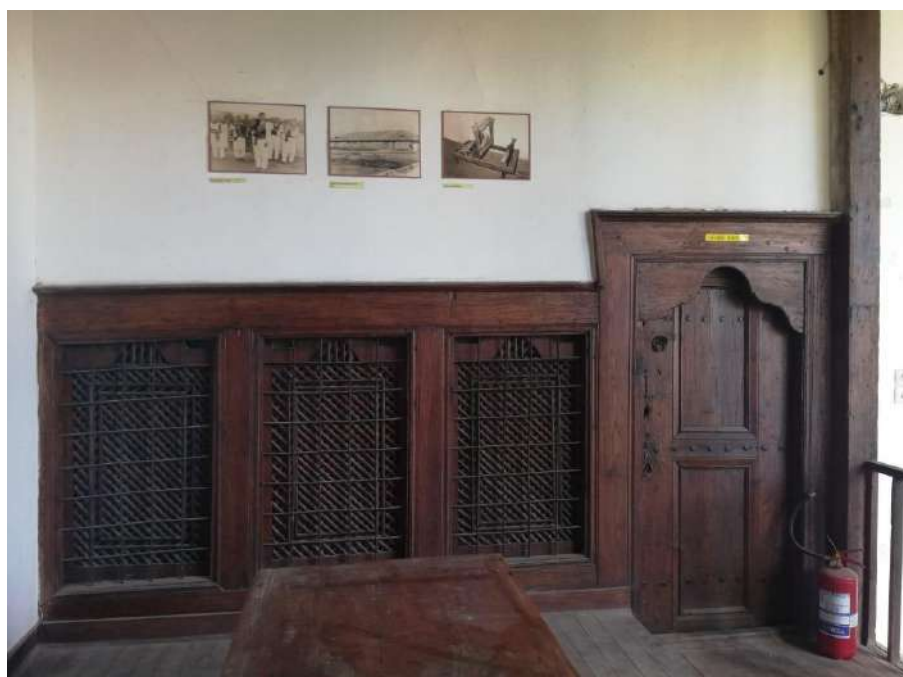
Fig. 17: Damaged woode decorative elements

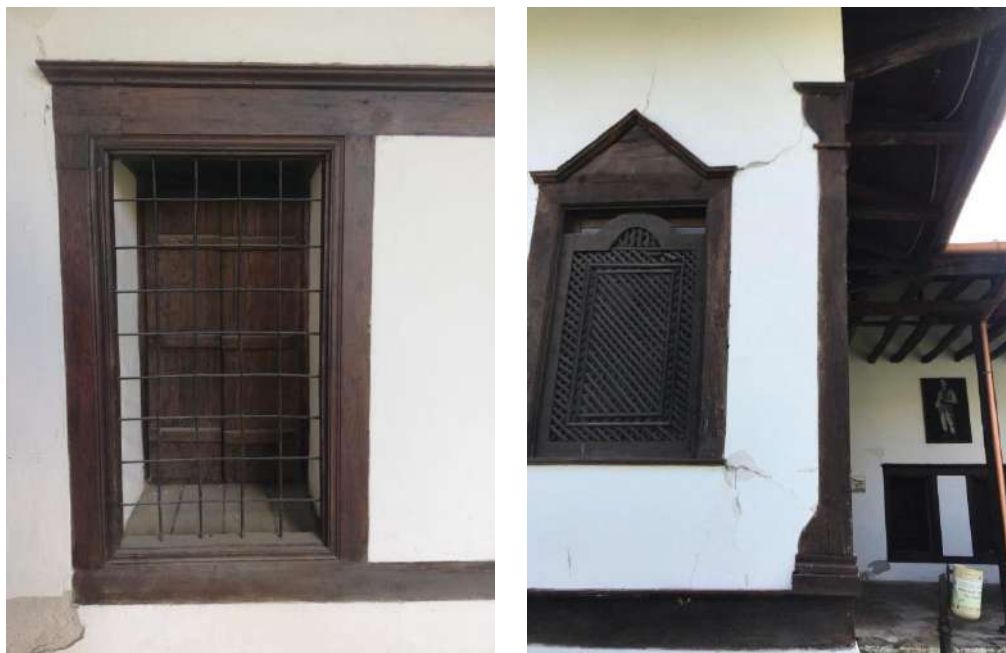
*Fig. 18: Damaged wooden decorative elements*

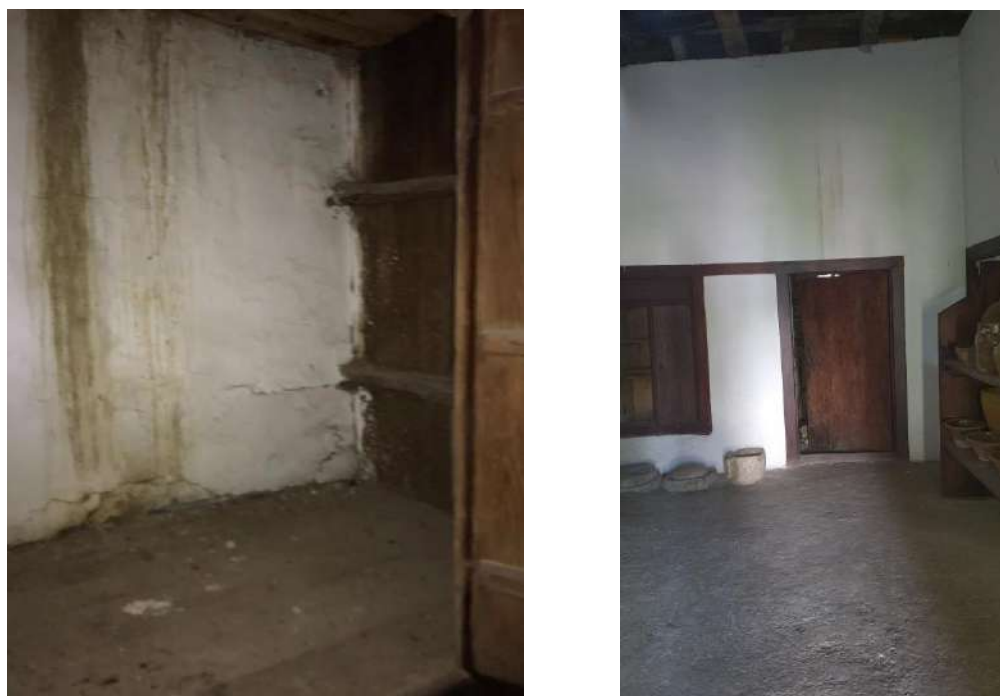
The most common forms of deteriorations are closely related to the problem of the rising humidity. In general, the main feature of capillary moisture is that it mainly attacks the bottom surfaces of the building, for the most part, due to the underground water. Ergo, all necessary measures will be provided for the elimination of such matter and the restoration of the damaged elements (or the replacement of those with maximum grade of deterioration).

*Fig. 19: Presence of moisture in the masonry*

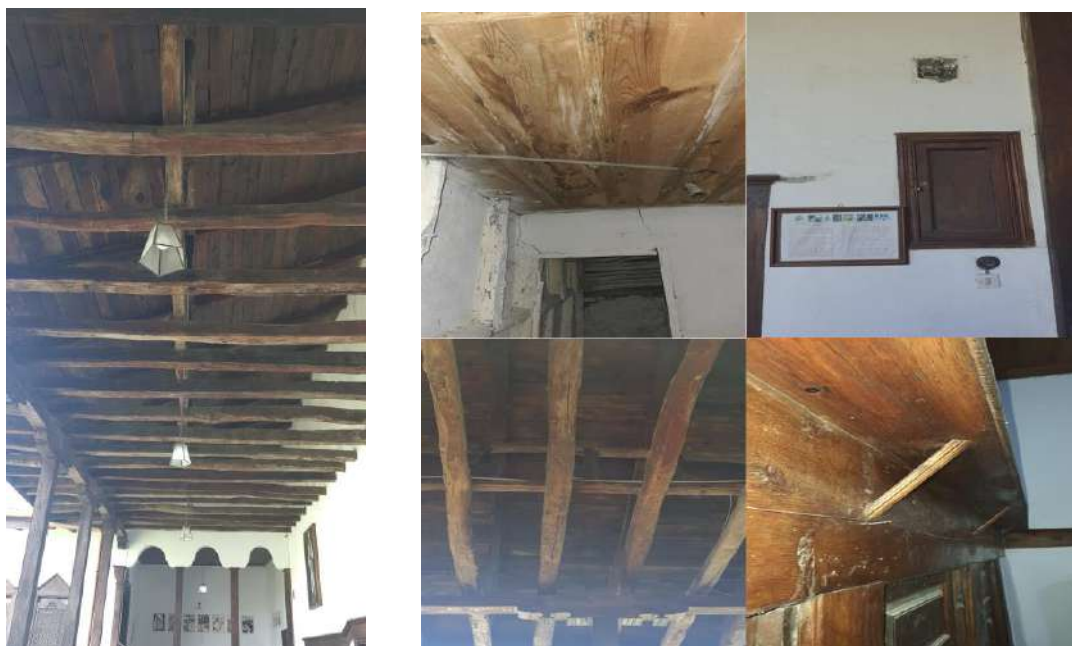
Deficiencies and damages are also noticed in the electrical, mechanical systems, lighting and CCTV. The electrical system is outdated and currently partially non-functional.

The lighting in all rooms is achieved through improper lamps and is insufficient as well. Likewise, the exhibitors are poorly enlightened, thus lacking in showcasing the variety of artefacts displayed in the museum.

The lighting of the exhibitors is also missing. The lighting intensity does not meet the requirements of each room or even the optimal conditions of a museum. The facility is monitored by a non-standard camera system.

*Fig. 22: Photos showing the current electrical systems and installations*

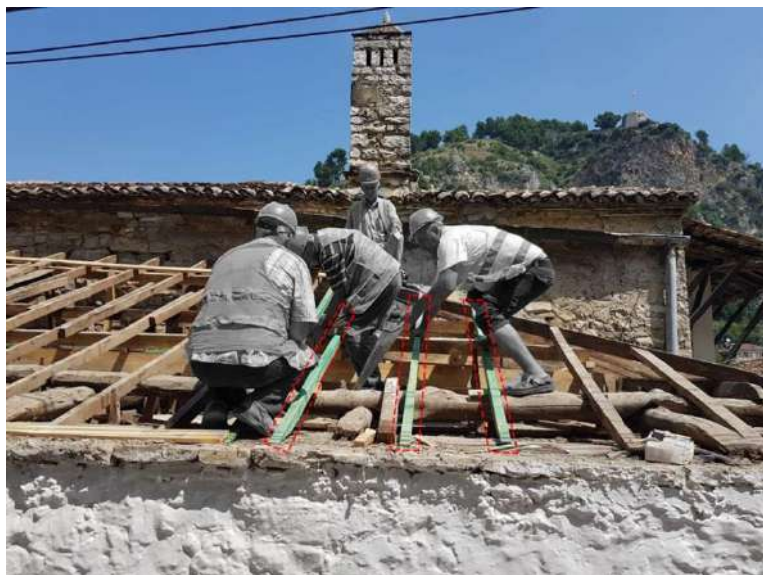
The roof restoration includes all the work that needs to be done to fill the tiles after the roof is opened and reuse the unharmed tiles, laying the waterproofing, evaluating the roofs, replacing the highly deteriorated structural elements, treating the wood elements with linseed oil and insect oil.

Fig. 24: Example of the replacing works for the damaged roof elements

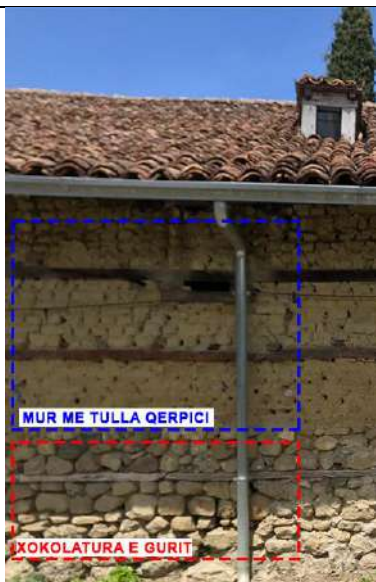
Fig. 25: The adobe wall layers

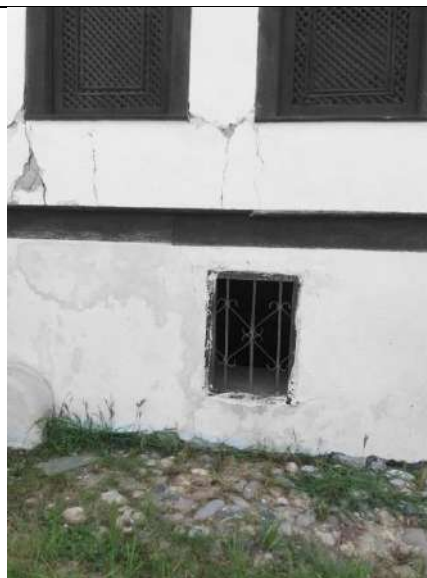
Fig. 26: The humidity of the building coming from the damaged drainage

The drainage of the building is another intervention to consolidate the building as we notice the effects of the capillary moisture which comes from the underground water affecting the foundations. During the works for the perimeter drainage of the building, it will be also assessed the current condition of the foundations.

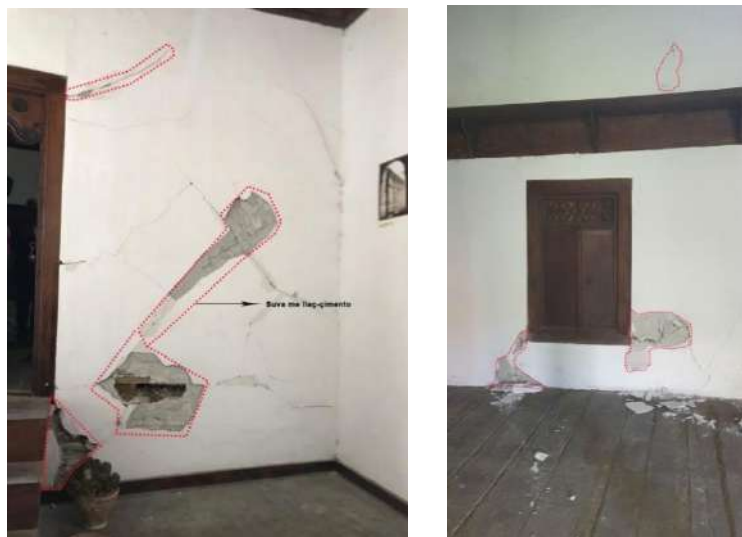
The plaster finishing layer of the external walls is currently with cement mortar (a non-original material), which has also enhanced the phenomena of the absorption of moisture from the walls. The walls will be stripped of the current plaster finishing layer, thus it will be re-plastered with mixed lime mortar with goat hair, a local traditional technique used at the time the building was constructed. This material mixture has good properties against moisture.

*Fig. 27: Damage to the current plaster of the building*

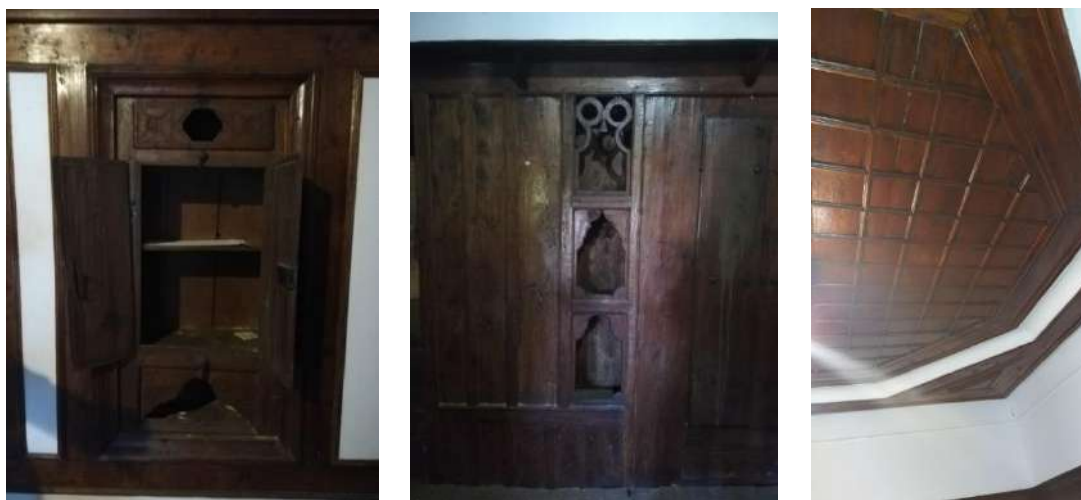
During the observations in situ and the survey, there were noticed several; deteriorations of the decorative elements of wood. Their restoration will be accomplished by completely or partially replacing the missing / deteriorated parts with the same material. Likewise, the same process will be performed with the aged sections.

All the deformed and bulging elements will be carved all the deformed parts, the cracks will be filled with suitable stucco of the same color as the wood. After the plastering, all the elements will be painted with first quality primer and linseed oil. Flaxseed oil should have the characteristics mentioned in the technical specifications.

*Fig. 28: Damaged wooden decorative elements*

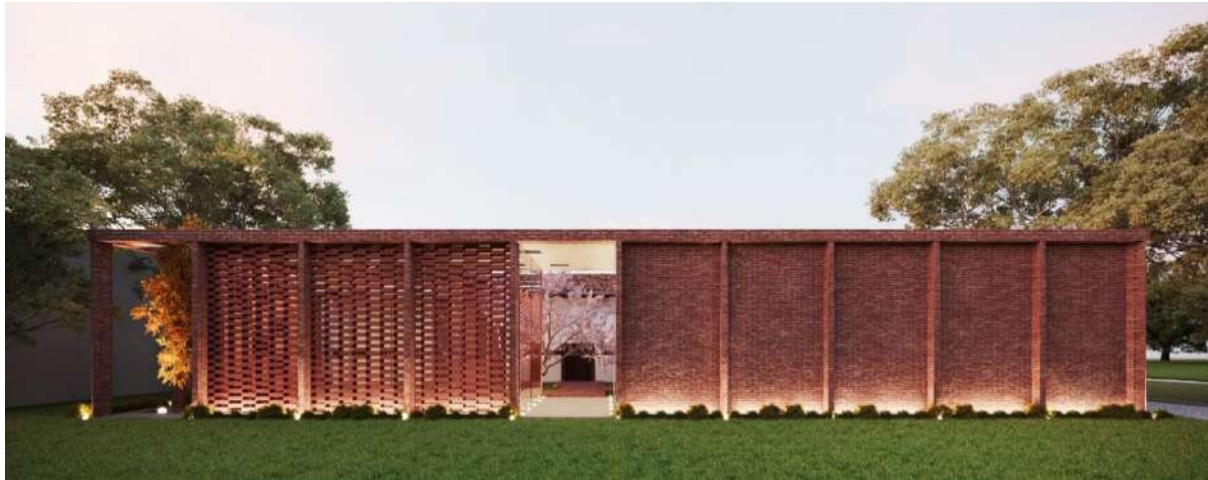
*Fig. 30: 3D image of the new extension of the museum*

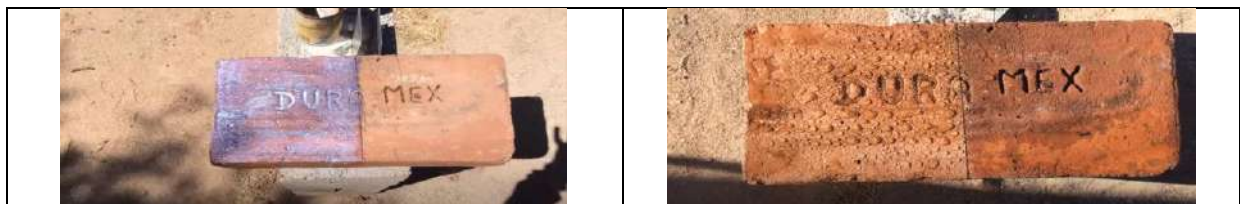
To achieve this, we must make sure to avoid the problem of the humidity due to the underground water levels to the object and appearing in various forms damaging it. Initially, the southern adobe facade will be restored, due to it being left uncovered, which allows it to be affected by changes in weather and rain. This is accomplished by rinsing it with water and then letting it dry. Afterwards, apply a liquid product of the type "Adobe Water Repellent" with 2 layers. In the water test afterwards, the adobe brick with this product, does not allow water to penetrate inside it, consequently it does not damage the material.

Given that one of the reasons why moisture is a problem for the adobe is that in the back facade is left exposed as a material, which makes it deform according to atmospheric variations. Therefore, after being sprayed with the "waterproof" liquid mentioned above, it is coated with a layer of plaster. However, care must be taken in choosing this layer, which must have as few additives as possible and be the original material, in order to properly protect the adobe.

*Fig. 31: Application of hydrophobic solution to adobe bricks*

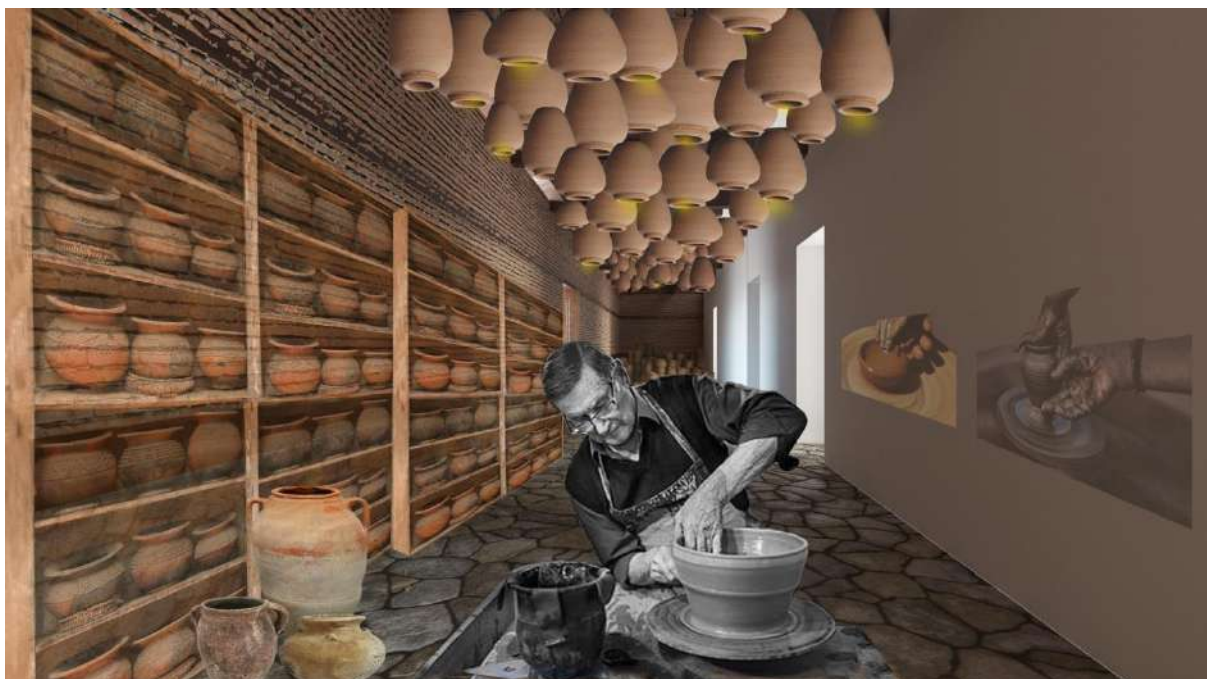
*Fig. 32: Illustration of the barn interior after its restoration*

As for the conceptual side, it is thought that the object is conceived as a museum with two pavilions. Since the object has a symmetrical plan, this makes the division of functions easier. The first pavilion will be conceived as a traditional Albanian house where the way of life of a family of that time will be exhibited. In this pavilion, there will be exhibited traditional objects as well as information on the way of life or the use of work tools. The barn will be a room specially dedicated to the crafts practiced at that time.

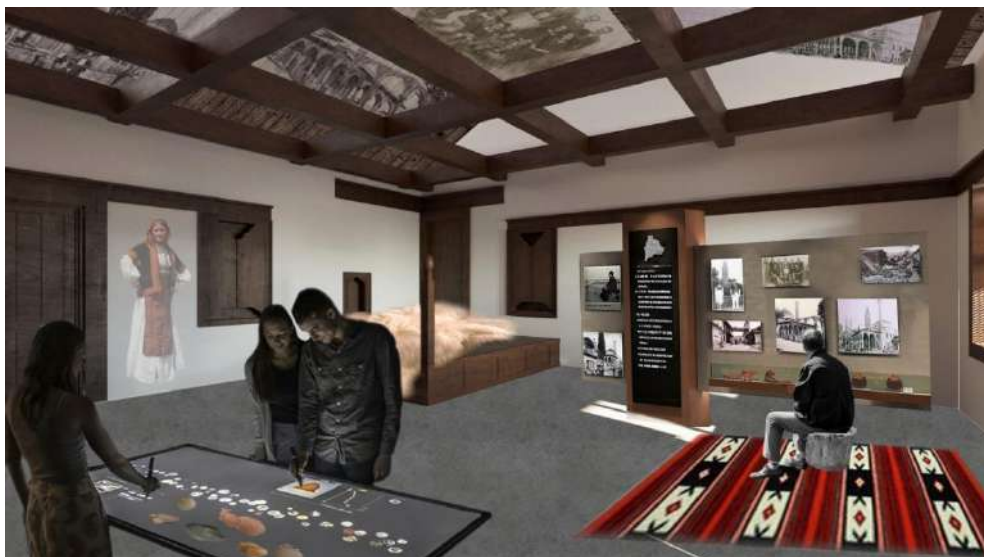
Fig. 34: 3D visualizations of the museum interior after the restoration intervention

The screens will be interactive where the visitor in addition to the information can also have simulations of different crafts. In one of the rooms, by means of interactive screens the visitor will have the opportunity to "try" different folk costumes, get information on them but also print or post photos online. Moreover, on the walls of the building inside, on the facade or special parts of there will be installed screens for the projection of various informations on the living of traditional Albanian families. This information can be obtained through various documents, photos or videos.

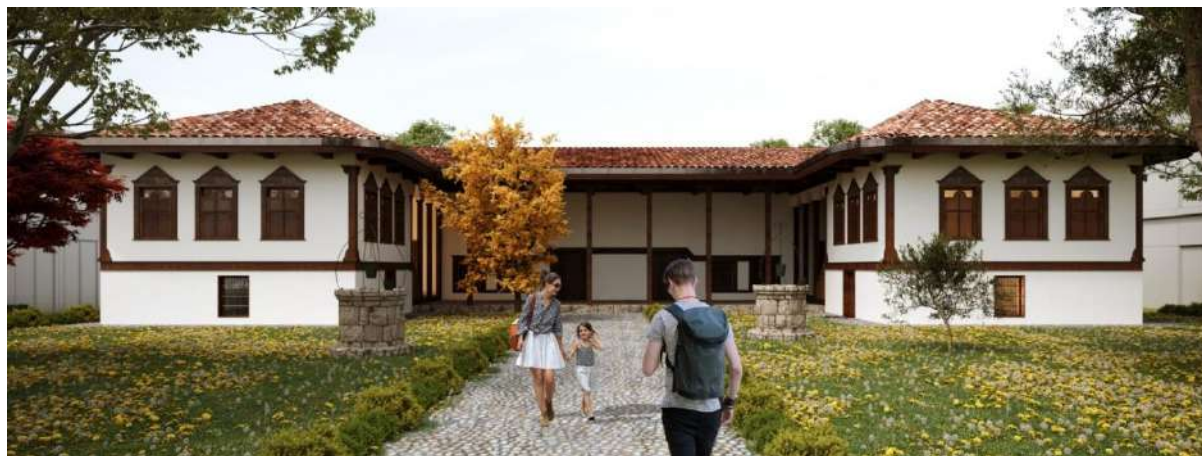
Fig. 41: 3D exterior visualizations after the restoration intervention
