## DESIGN OF INTERVENTIONS

**ETHNOGRAPHIC MUSEUM OF KRUJA**  
**MUZEU ETNOGRAFIK I KRUJËS**

## **ETHNOGRAPHIC MUSEUM IN KRUJA - Components of intervention**

22644-001\_ALB\_EU4C\_RFP\_01 - "Sigurimi i Konsulencës për Shërbimet e Projektimit për Projektin EU4CULTURE - Mbështetje për rijetëzimin e siteve dhe monumenteve të trashëgimisë kulturore të prekura nga Tërmeti në Shqipëri."

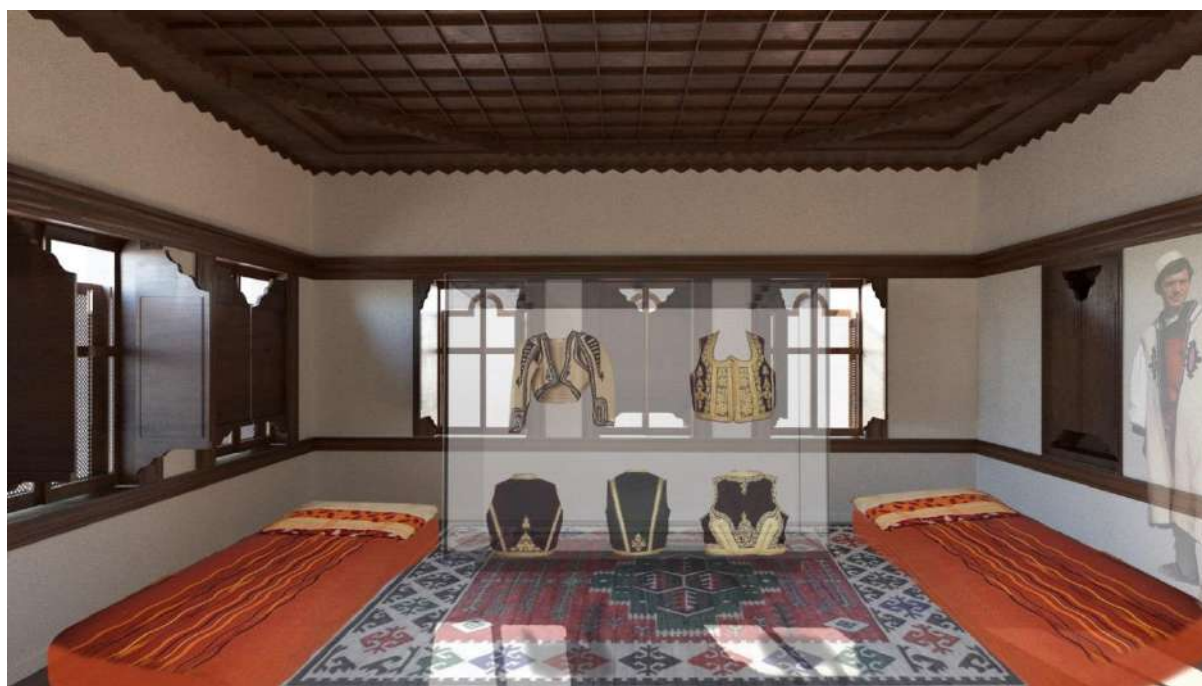
Fig. 42: 3D visualizations of the interior after the restoration intervention

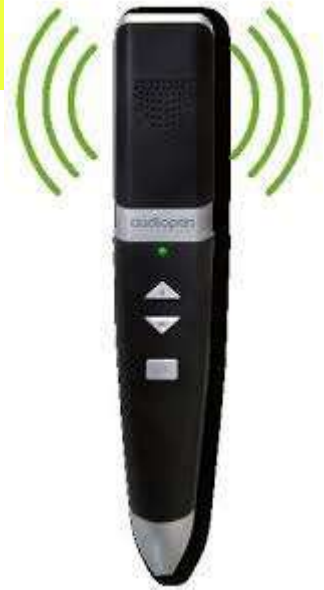
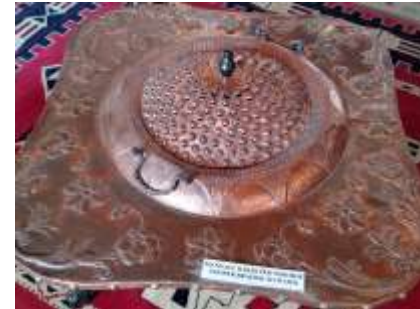
The sensor in the Audiopen tip reads the number and automatically plays the audio that corresponds to the number.  
(e.g. the brazier tell its story, functions, etc.)

Then you will point the Audiopen to other numbers/symbols and listen to the stories of other objects.

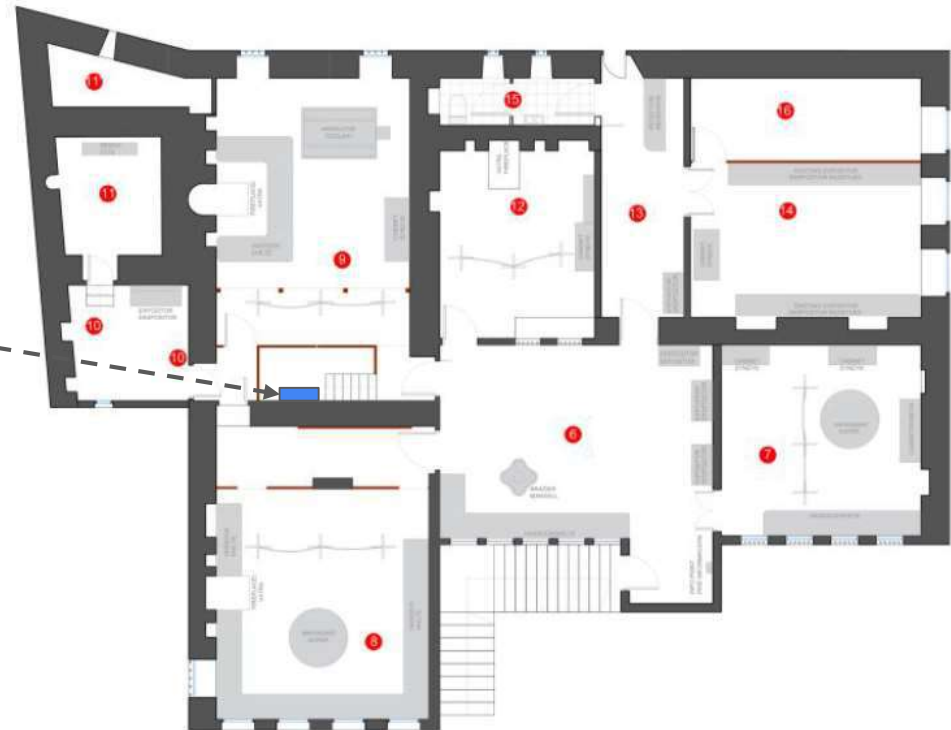
FIRST FLOOR/KATI I PARE

The best position would be in the loft (if it will usable)

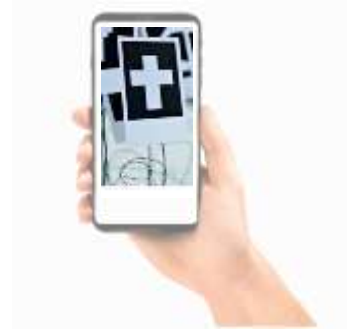
Imagine a sort of flowers made of cardboard (or similar material). In each one there is a different symbol (that works as a QR code)

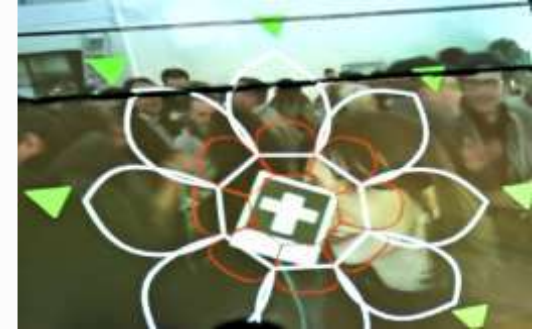
With your smartphone you point to a symbol. The smartphone recognize it.

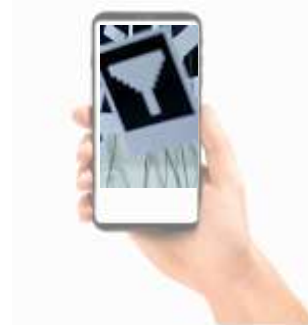
On your smartphone will appear an object (image, animation, etc.). For each symbol a different content.

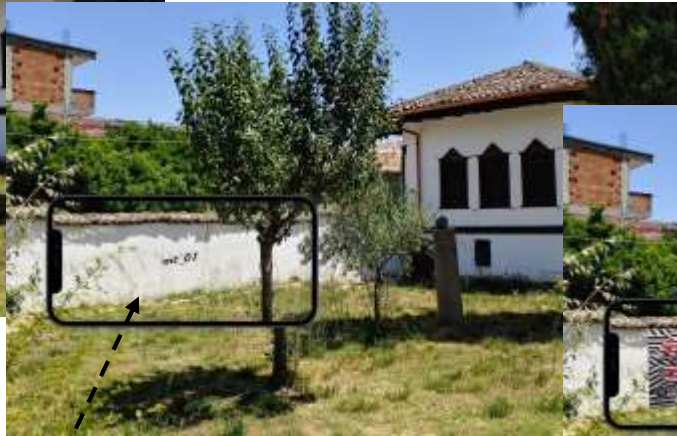
1 Imagine a symbol on the walls

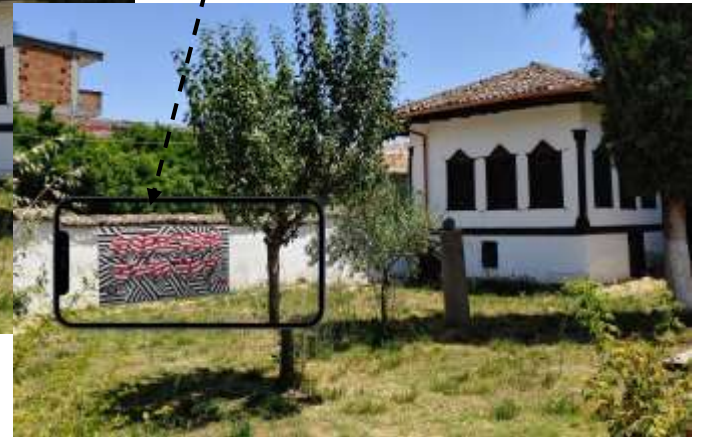
2 Point your smartphone  
to the symbol

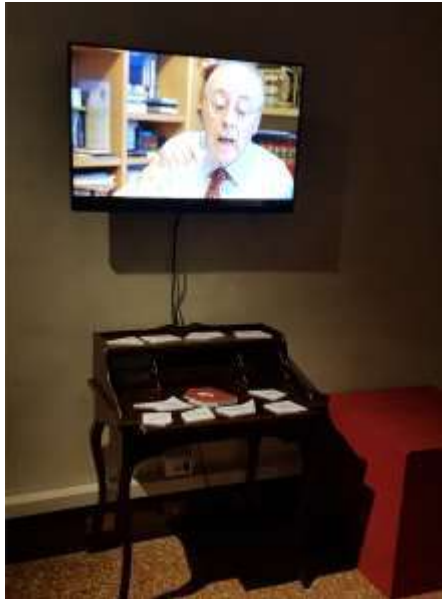
Imagine a structure with a screen and a table.

You can discover contents by choosing the pieces on the table, each one a different content.

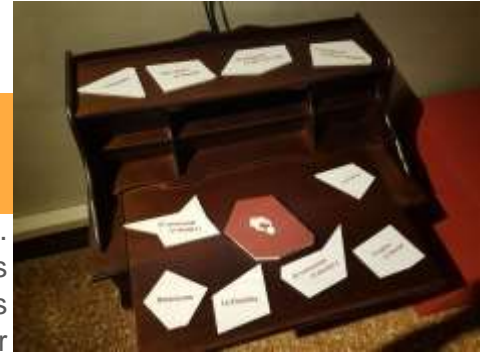
1 Pieces on the table.  
The center point invites visitor to put the pieces on the center

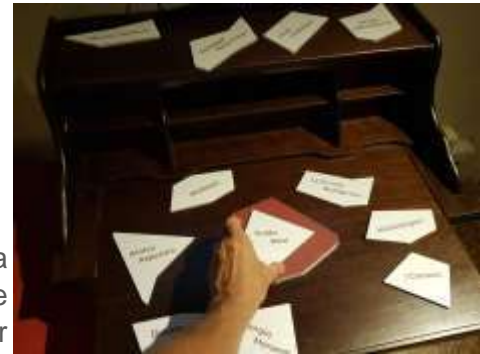
2 The visitors choose a piece and put it in the center

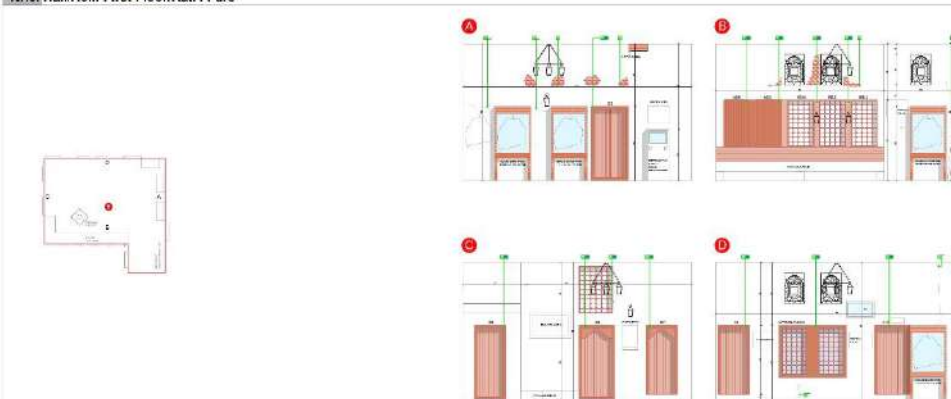
Fig. 11: Interior views, rooms nr. 5 & 6, ground floor, current condition.

-THE OLIVE OIL PROCESSING WORKSHOP (code 5 in the plan): 29.6 m<sup>2</sup>

From the main hall towards the room no.5, the olive oil processing workshop, with a variety of tools and equipment that illustrate the oil processing process such as: the backup mechanism to press the olive, the mechanism for pressing the olive or ceramic jars that were used to preserve olive oil. The floor is paved with harasan, where there are visible phenomena such as corrosion and deterioration of the layer due to inappropriate subsequent interventions over time.

The walls are built with stone, reinforced with wooden slats. Later cement mortar coatings are clearly visible. The woodworking mastery of wooden doors and windows stands out, although they have been damaged over time or due to moisture (some are muffled and others rotten).

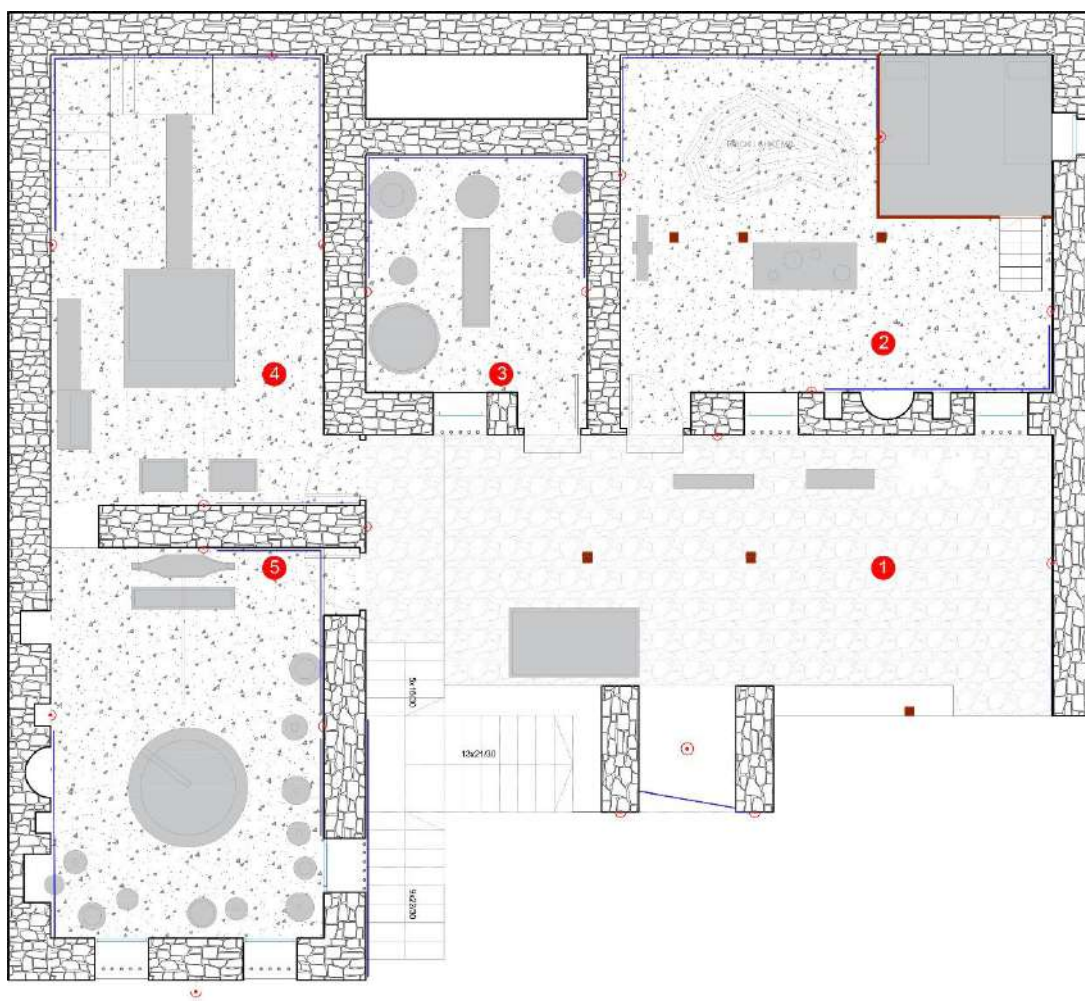
Fig. 12: Ground Floor plan, Current Condition

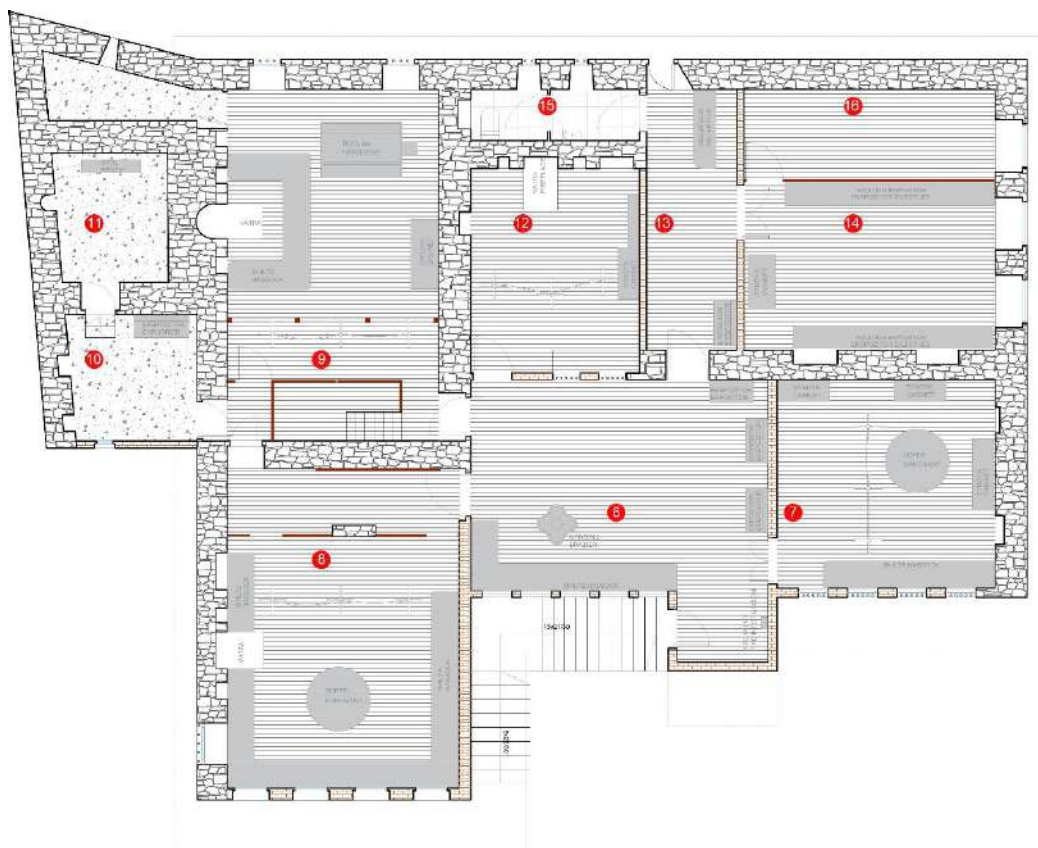
Fig. 15: First Floor Plan, Current Condition

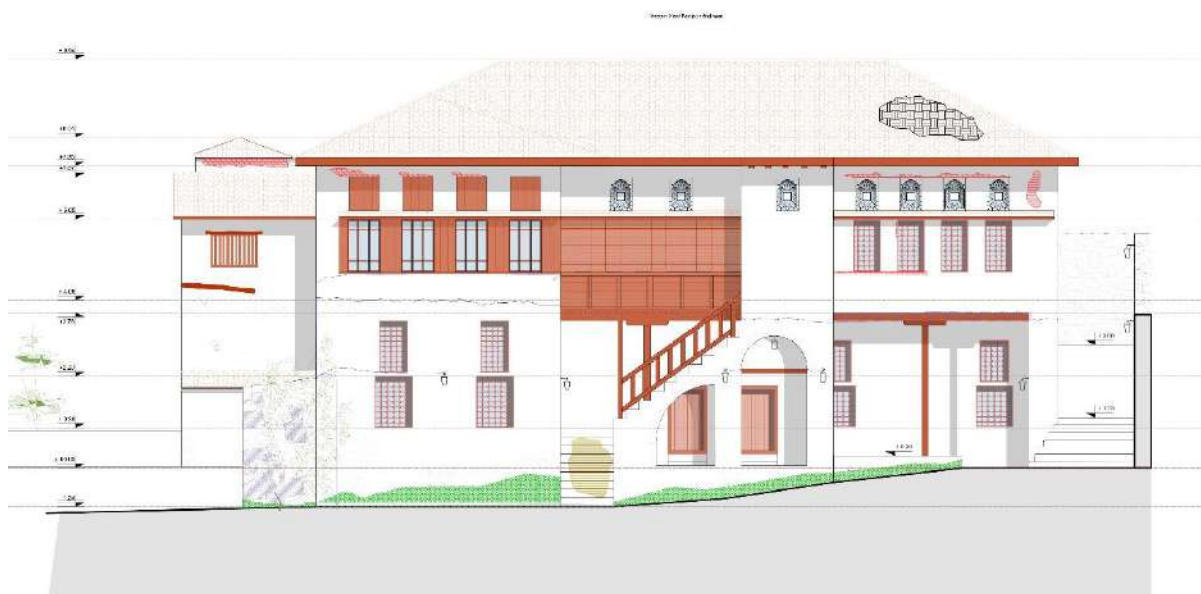
Finally, the ceramic tiles on the facade (roof) are partially broken and partly covered with patine. Overall, the humidity has affected the building by showcasing moss on the ground floor or even on the facades.

Fig. 16: West Facade, Current Condition

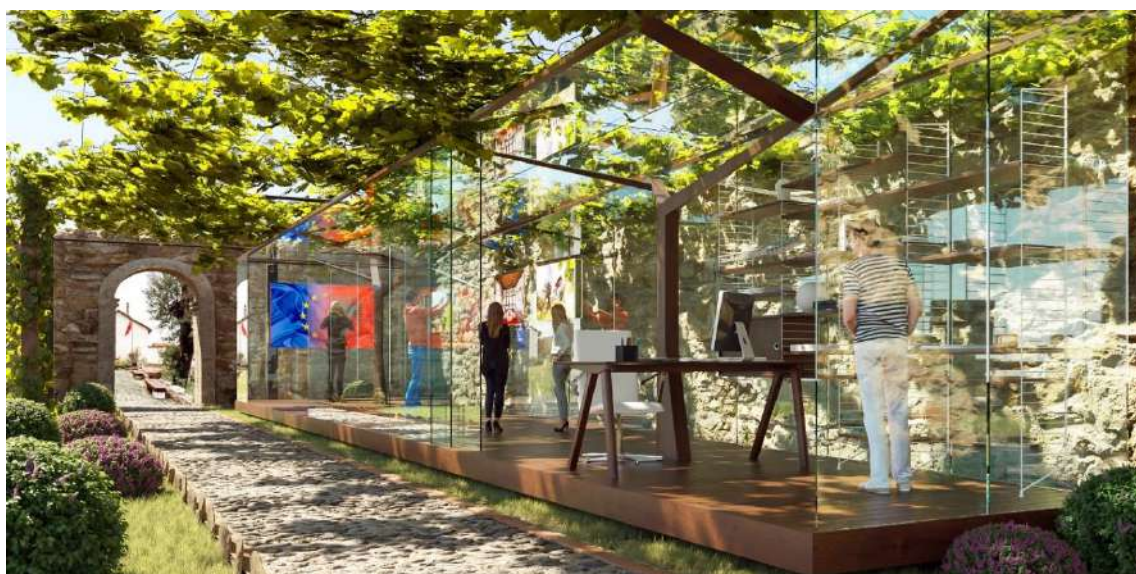
Fig. 29: The new ticket box and gifts' shop, Proposal

- ❖ Creation of a new temporary structure for the organization of events such as fairs and craft exhibitions with the purpose of promoting the local tradition, products and crafts with the perspective of their development and preservation of tradition.
- ❖ Creation of new spaces dedicated to the ticket office as well as the gift shop (souvenir shop) through a light, non-permanent structure, which does not affect the surroundings, using light materials like wood and glass.

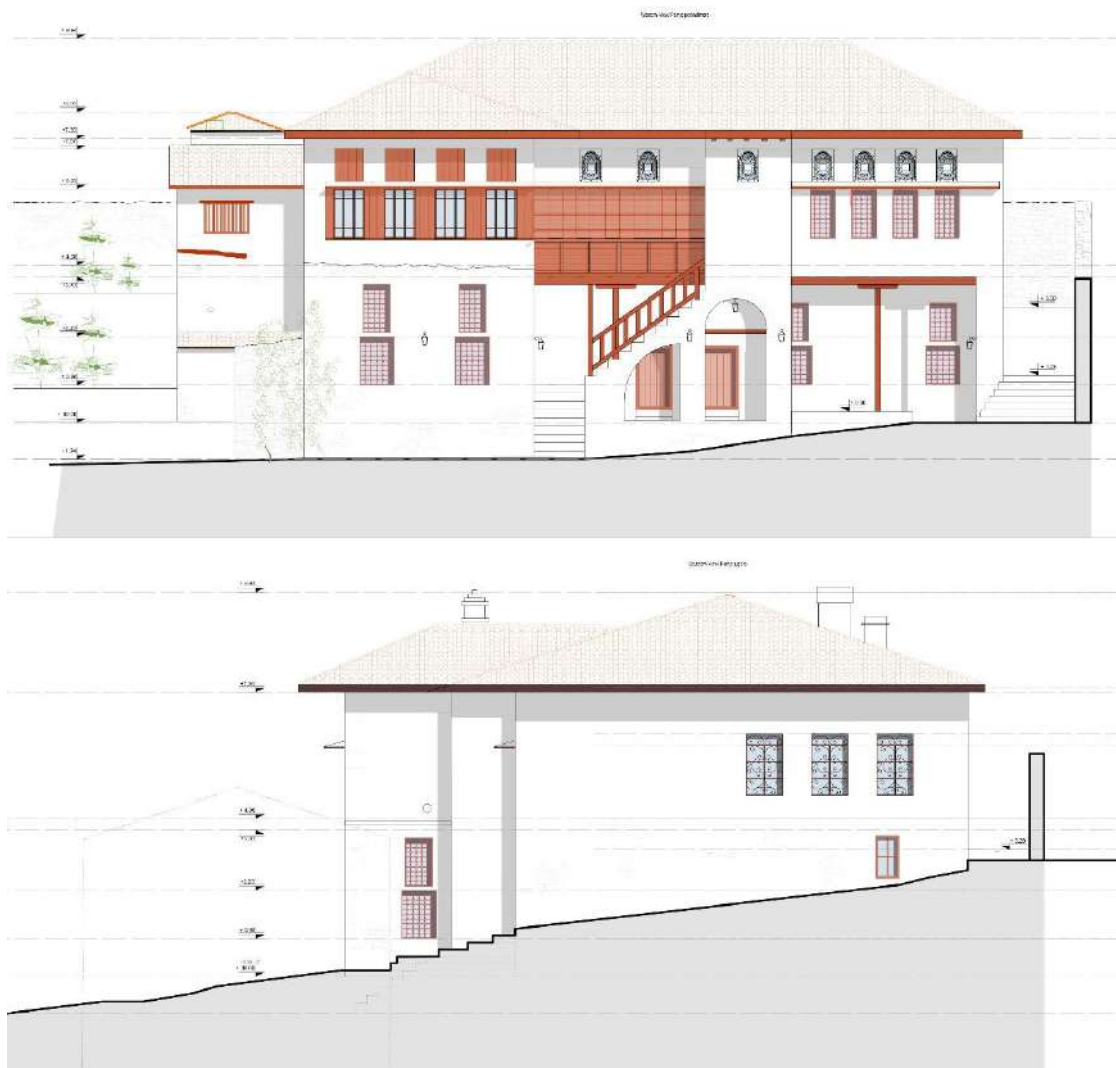
Fig. 33: Western and Southern Facades, Proposal

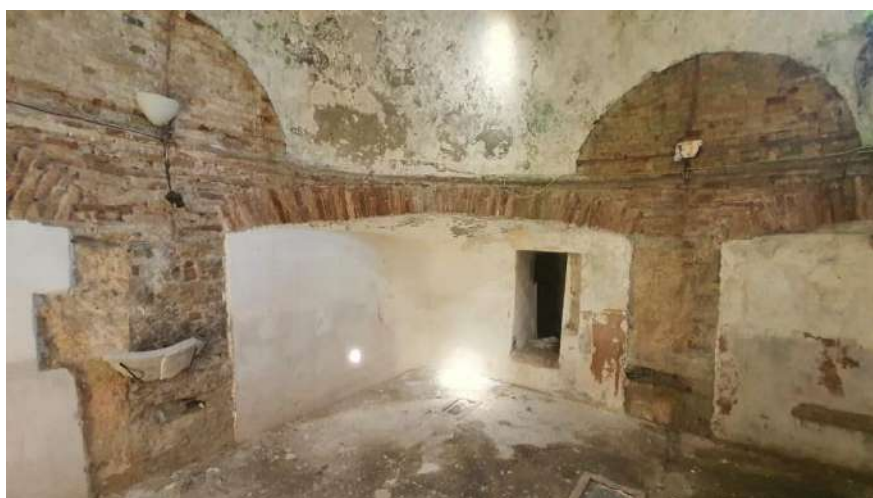
Area 1 (Fig. 7) is the entrance, a quadratic room measuring 6.00x6.00 m. It served as the reception hall. The exchange of clothes and the equipment with the necessary accessories of the hammam like towels, clogs and so on took place here. In this area the clients would relax and have tea (1974, Shtylla.V, Monumetet 7-8, fq.119-137). It is covered with a massive dome and on its top is raised another smaller concentric dome. In the massive dome for lighting purposes are placed 12 holes in quadratic shape and one window, while in the smaller concentric dome are only 3 holes in circular shape.

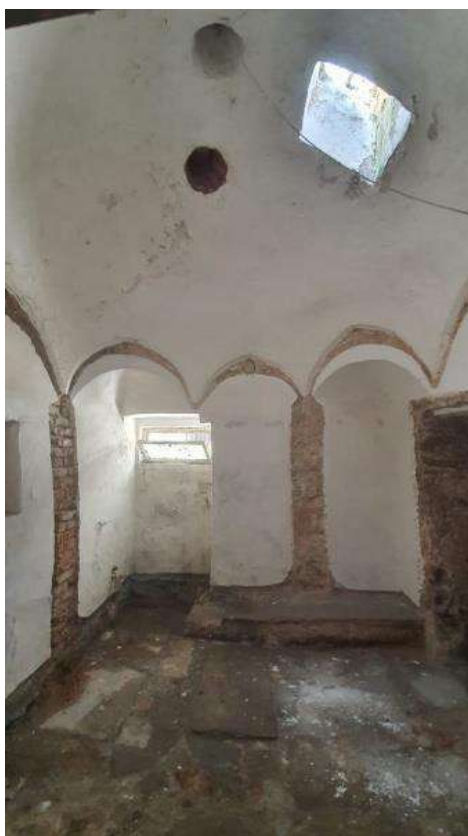
Area 2 (Fig 8) is the intermediary space and measures 3.20x2.65 m. This area serves as a corridor that connects with the hot and warm rooms and the hygiene-sanitary spots. The only function is that of intercommunication. In a little corner is an alcove with a stool where the Tellak (caretaker) would wash the clients who then rinsed in the warm room. It is covered with a hemispherical dome with three circular holes for aëring and lighting purposes and one window.

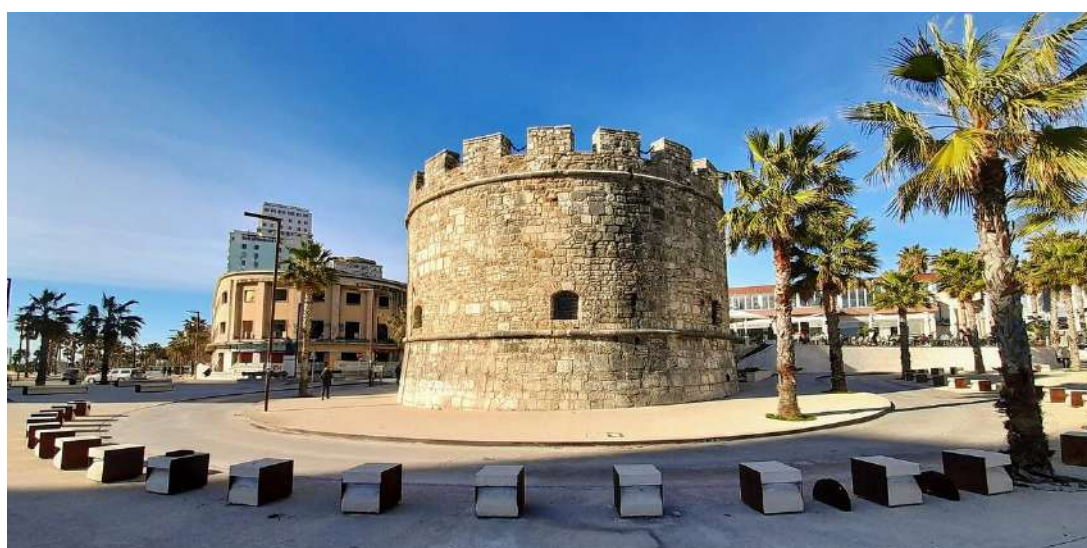
*Fig. 9. Venetian Tower*

The diameter of the Tower is of 9.00 m. and has a height of 9.60 m. There is a basement with a sidewalk partly with stone tiles and partly with bricks. It is important to check with

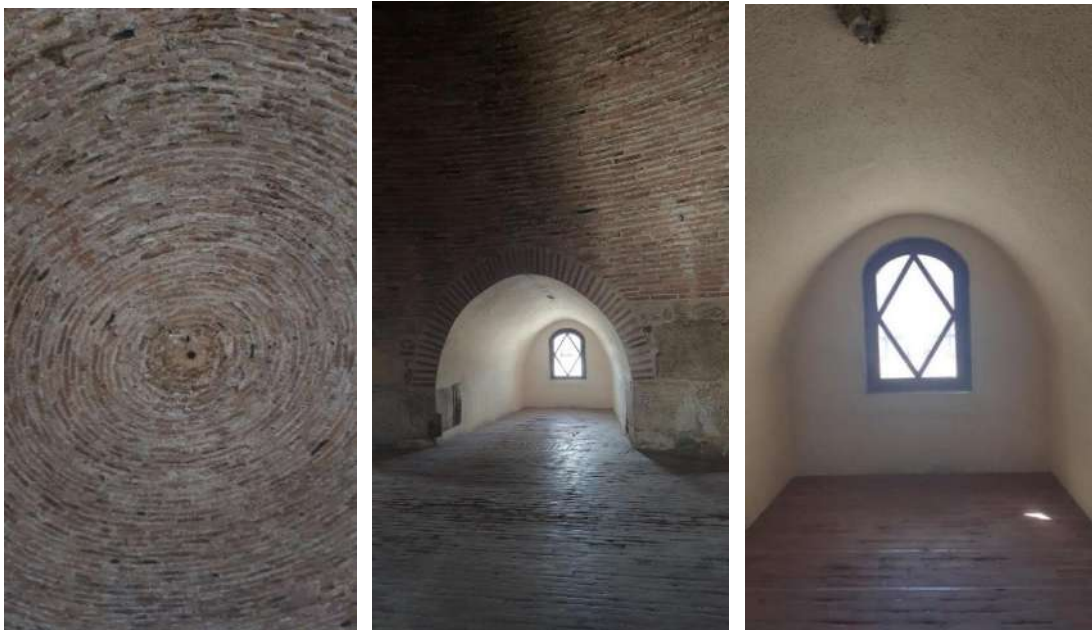
*Fig. 10. Photos of the interior*

- Subsequent additions (volumes) were made, especially to the toilet, which have partially modified the tower configuration.
- There have been carried out subsequent interventions through which have been added layers of non-original materials on the surfaces, such as: ceramic tiles on the floor (the only original piece of stone floor is preserved at the entrance of the tower and on the stone stairs); additional parapet on the terrace (of about 50 cm) with concrete.
- The interiors have been functionally adapted to the bar, as well as the toilet and a storage room.

The predominant materials are stone on the exterior and ceramic tiles on the interior, which clearly hide the original stone. The windows are made of wood with iron railings and are distinguished for their special styling.

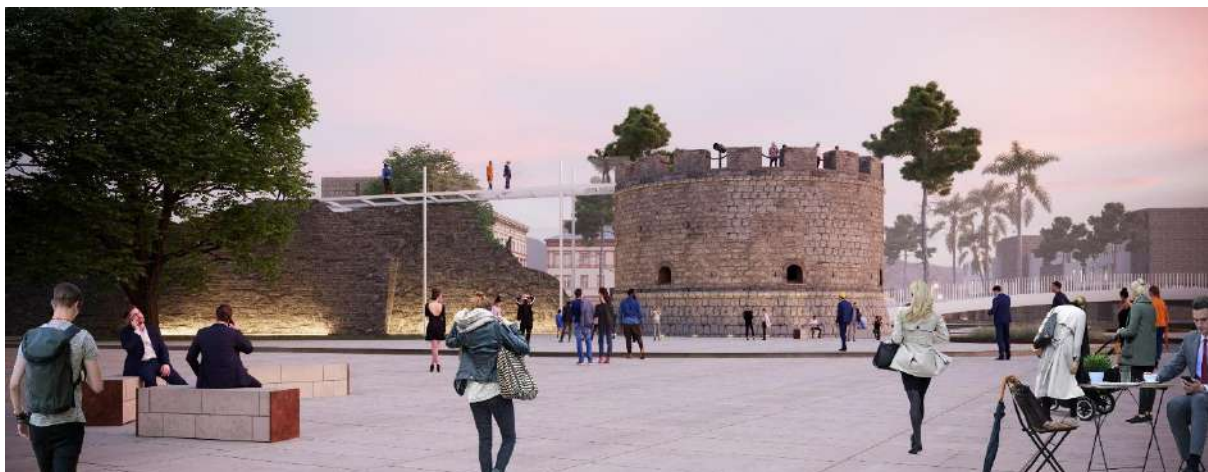
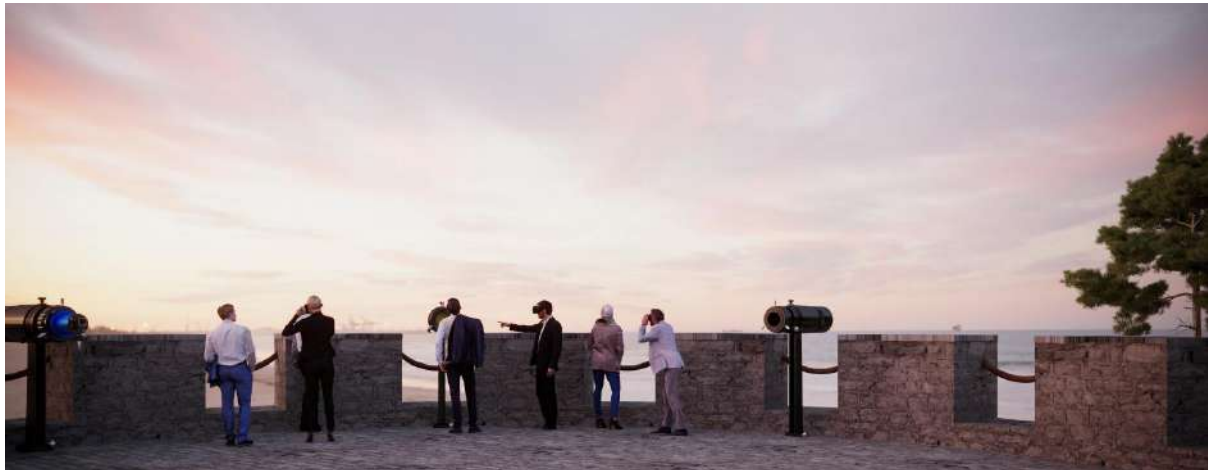
Fig. 13. Three dimensional views

The terrace will be cleaned and restored using its natural and traditional materials. The terrace of the tower carries a potential as a point of view, so the proposal includes the placement of 5 observation points spread through the tower facing the sea, the former King's Villa, Hammam and Ethnographic Museum, Archaeological Museum, Amphitheatre. Specifically, this will be made possible by mounting 5 digital observatories in the direction of these observation points

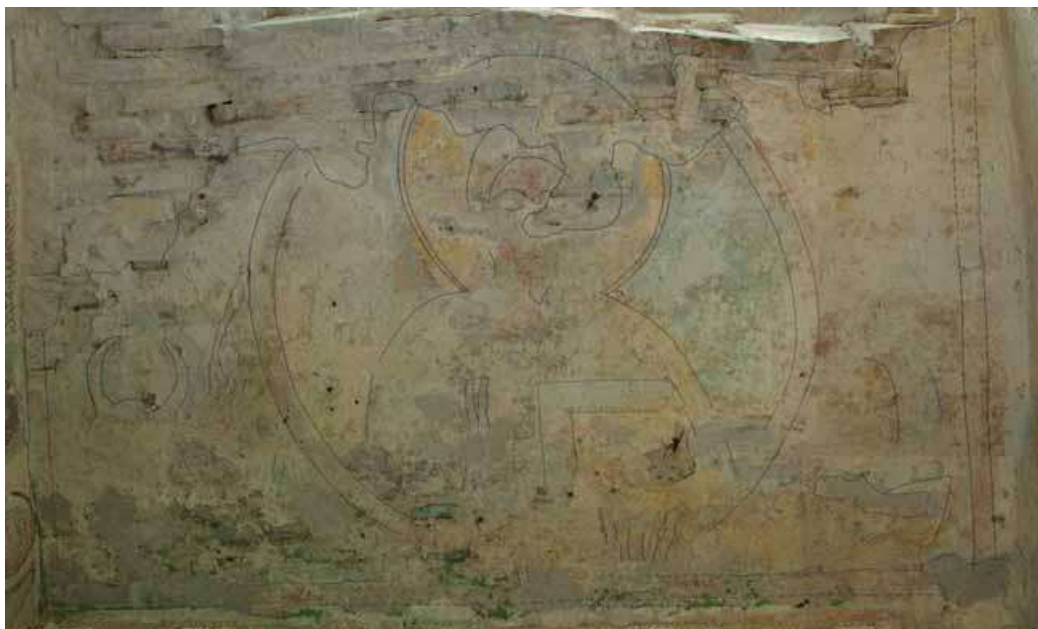
Main chapel, western alcove, ceiling, photo with superimposed scaled line drawing of paintings (S. Diehl, P. Haipi, R. Das) – Credits of Bowes and Mitchel 2009

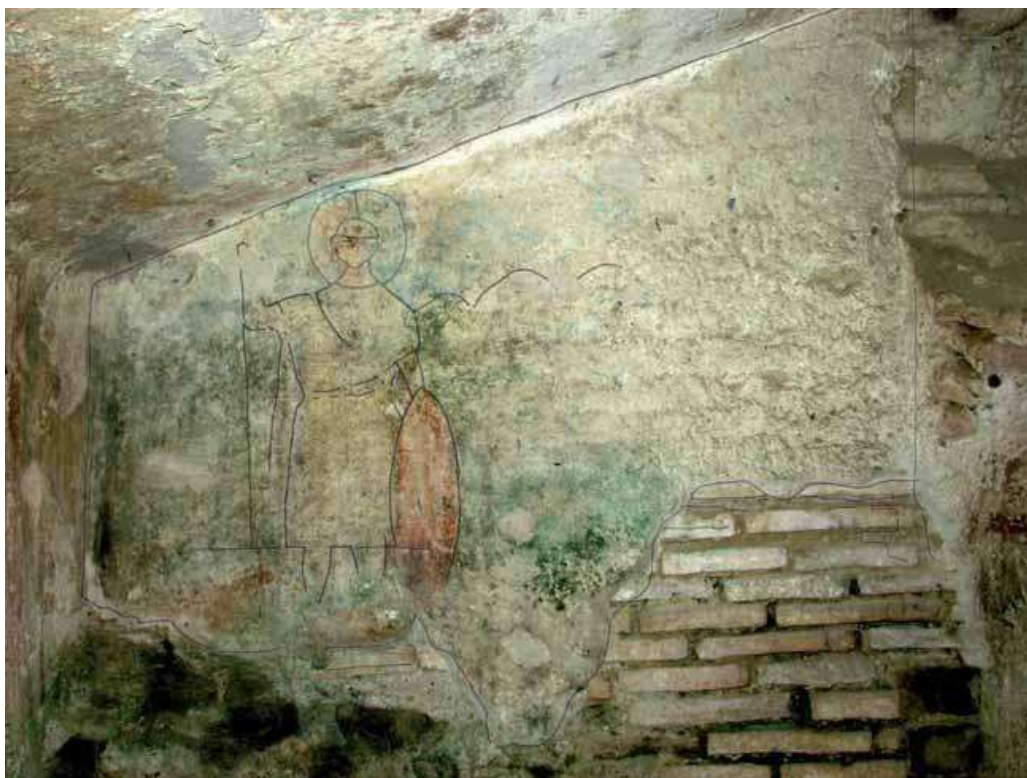
Main chapel, western alcove, north wall, photo with heightened contrast and superimposed scaled line drawing of paintings (S. Diehl, P. Haipi, R. Das) – Credits of Bowes and Mitchel 2009
