TECHNICAL ASSESSMENT REPORT "EMERGENCY CONSOLIDATION OF THE NORTHERN WALL PORTION OF THE CASTLE OF LEZHA"

22644-001_ALB_EU4C_RFP_01 - "Provision of Consultancy for Design services for EU4CULTURE Project - Support for revitalization of cultural heritage sites and monuments affected by Earthquake in Albania."

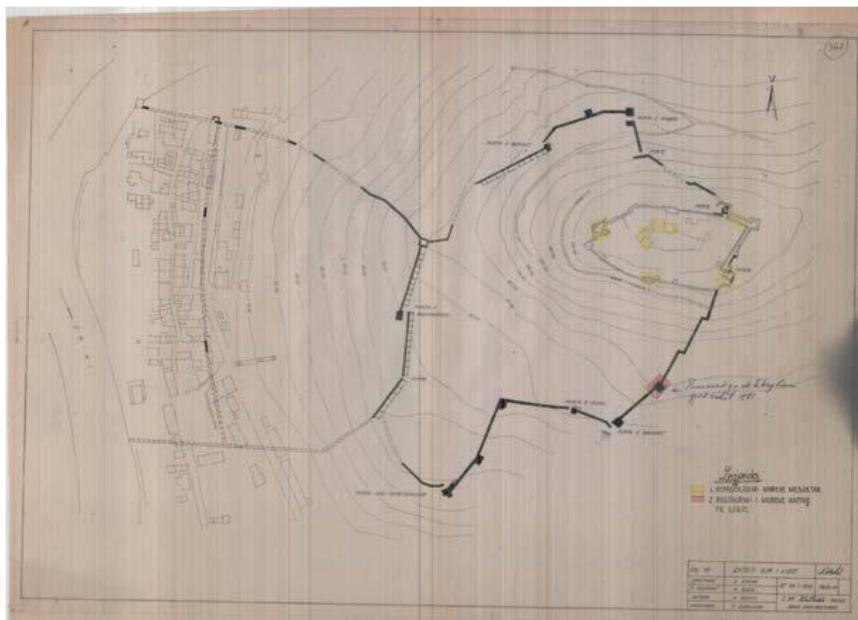
Fig. 1: 1976 Project

Verification of the condition of the medieval wall of the castle of Lezha and the protective measures to be taken: (intervention of 1976)

1. Anchor with two steel towers-buttress, to the right of the collapse, which is inclined on the

outside about 7°, according to the relevant design.

2. Clean the ground in front of the soil and the wall, breaking the latter into transportable masses.
3. Consolidate the internal constructions and the collapse sides between the buttress walls.
4. Attempt to pull the tower in place with argano, after cleaning it from the inside.
5. Take measures for falls on other walls and keep the situation under constant control.

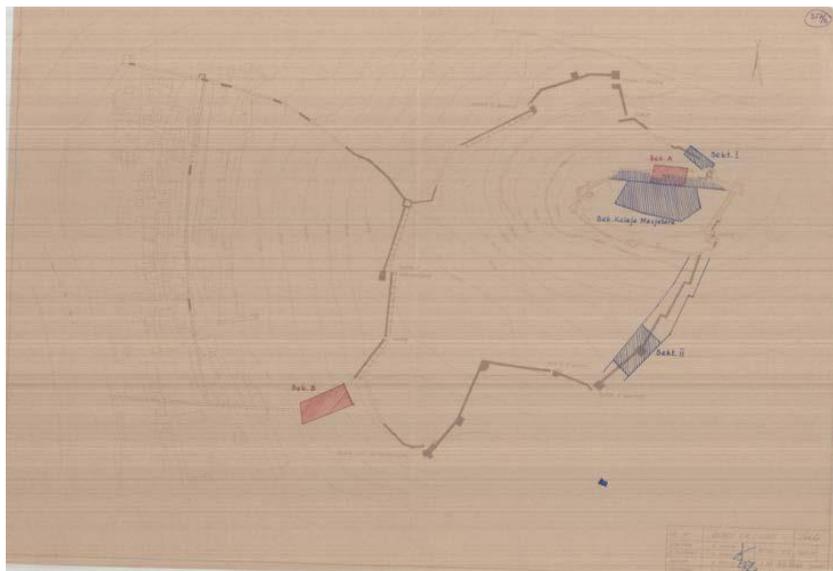
Fig. 3: 1978 Project

Conservation and restoration intervention in the walls of the fence as well as the necessary measures to be taken for the restoration of the walls of the medieval castle and the premises preserved inside it during 1978.

- Restoration of collapsed stone blocks which have not been moved from the crash site. This part of the wall to be restored, thus completing the complete restoration of the northeast wall.

- on both sides of the wall there are blocks of stones that fall from the wall, which for the most part cover each other or are covered by vegetation and small stones sliding from the castle hill.

- restoration of the wall and tower to the height that will allow the material to be found at the crash site.

- the condition of the surrounding walls of the medieval castle of Lezha requires that measures be taken to consolidate their upper part as well as the perimeter walls of the premises that are preserved inside the castle.

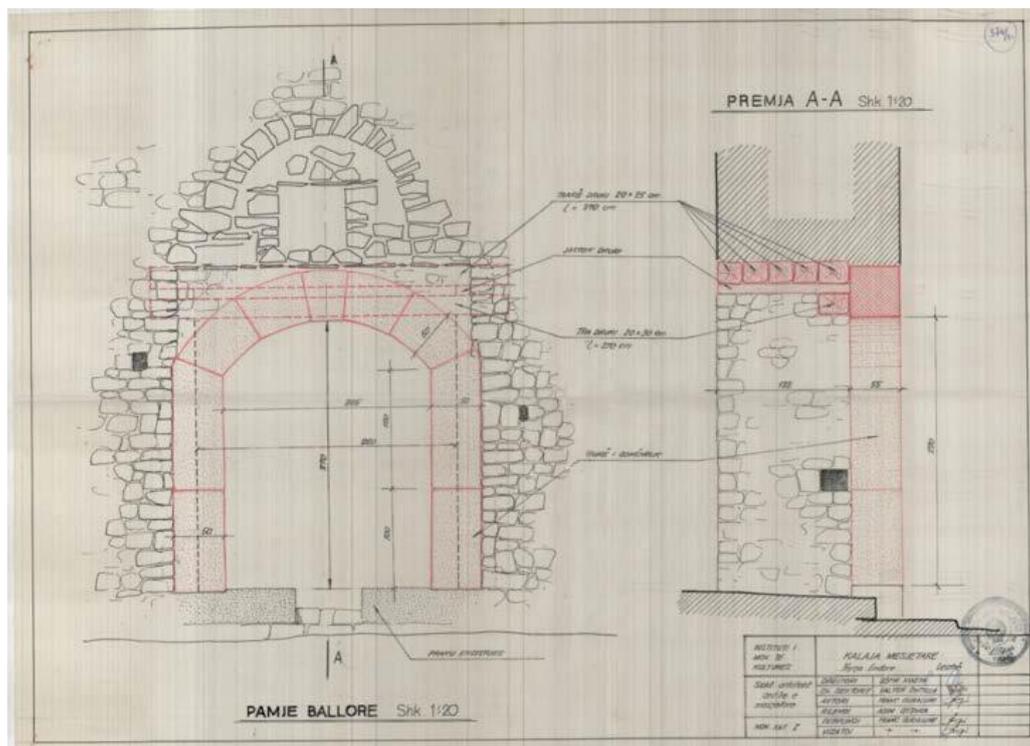
Fig. 4: Drawings from the restoration project of 1986

Continuation of the restoration of the wall from the round tower to the south-west entrance.

This sector also includes the extraction and release from the soil of the square tower covered by the extraction of soil during the construction of the water depot in 1971.

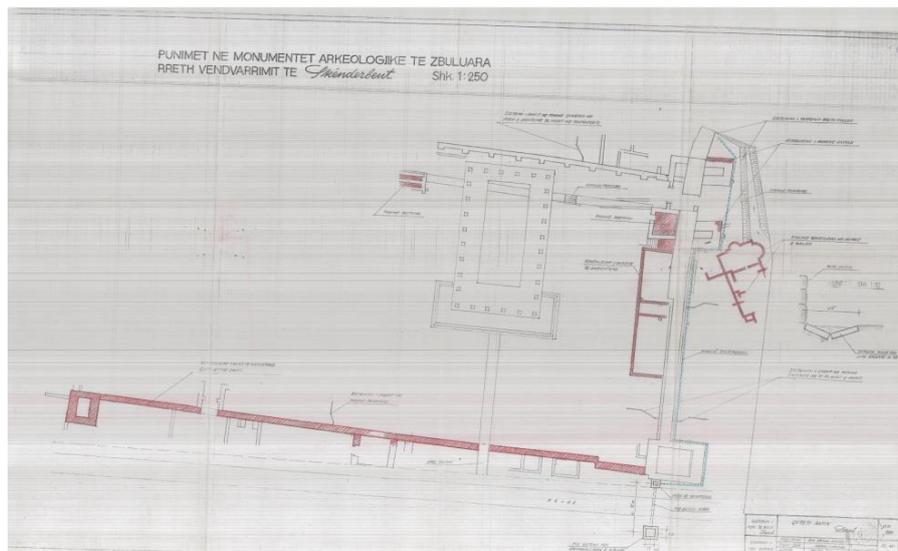
Fig. 6 Drawings from the restoration project of 1999

- Cleaning and consolidation of the medieval western wall along its entire length.
- Consolidation and cleaning works of the southern entrance complex, including the cobblestones of the road.
- Reconstruction of the well for the removal of water coming from the upper part of the city.
- Patrol of the existing canal along the entire length of the western wall.
- Construction of wells for water collection and disposal

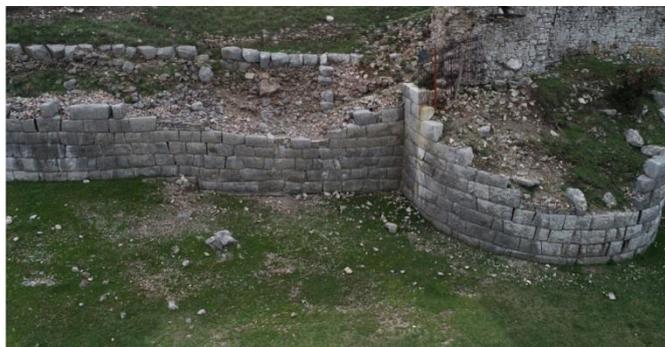
Fig. 8 Hellenistic period walls

The medieval castle was built on the Hellenistic walls that were located on the site. It is generally The Hellenistic walls are mostly positioned in the eastern and northern area of the castle, on the outside. Being retaining walls they are always subject to destruction as a result of ground pushing. This is best seen in the northern area, where the polygonal wall has always had problems and damage, documented from time to time in various restoration projects and inspections.

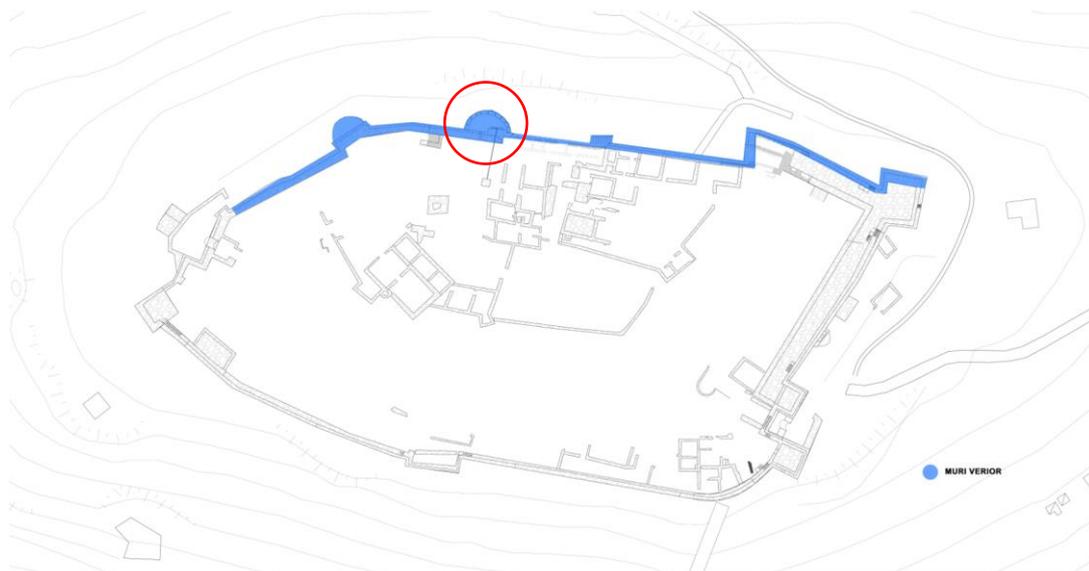
Fig. 10:North Area

After the earthquake of 26.11.2019, the castle suffered a partial collapse of the stone masonry and antique blocks. There is also a loss of verticality of the stone wall in its northern part. The structural elements have suffered significant damage.

This area presents the biggest structural problems. In zone V-2 (refer to the graphic sheets) it is noticed that in the north wall near the circular tower with polygonal stones, there is a deep crack in the entire height of the wall and its inclination. This has also led to the inclination of the tower over the circular tower. This area has always been problematic, for this reason the square tower has been fortified with metal cables by an old intervention carried out by the staff of the Institute of Monuments. In addition to the wall near the quadrangular tower, landslides and terrain, occasional collapses of the V-3 polygonal wall are also observed.

The intervention that will be carried out on the retaining wall consists of three stages. The first phase begins with the excavation of a part of the soil located below the retaining wall, this will be done to lighten the wall a bit and not cause negative effects. After the first phase process is completed, we move on to the realization of the second phase, which will be the anchoring of the iron rods in the plane perpendicular to the wall, since it is the plane most at risk of collapsing. Also, the angle should be as vertical as possible to enable the exercise of vertical force. At the end of the first two phases, soil reinforcement will be done at the base of the foundation with grouting. The end parts of the wall which are damaged will be replaced with a new wall which will have the same materials. After the completion of the intervention phases, periodic checks should be carried out, which monitor soil movements/slides.

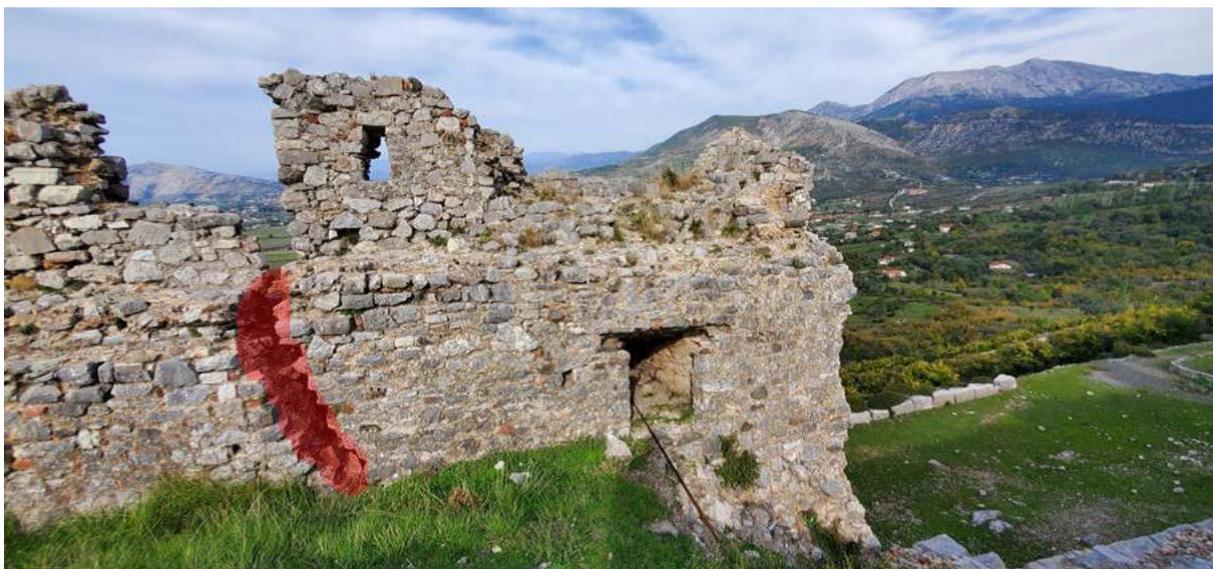
Fig. 12 Structural cracks in the walls

- Damage to stone masonry
- Vertical, horizontal or diagonal cracks in the walls
- Inadequate filling with mortar - cement of the grouting of the walls
- Uncontrolled growth of plants and biological debris
- Light cracks
- Lack of binding material
- Destabilization of the heads of the walls
- Masonry areas with cavities or missing stones
