# HERITAGE IMPACT ASSESSMENT REPORT EMERGENCY CONSOLIDATION OF THE NORTHERN WALL PORTION OF THE CASTLE OF LEZHA

**22644-001\_ALB\_EU4C\_RFP\_01 - "Provision of Consultancy for Design services for EU4CULTURE Project - Support for revitalization of cultural heritage sites and monuments affected by Earthquake in Albania."**

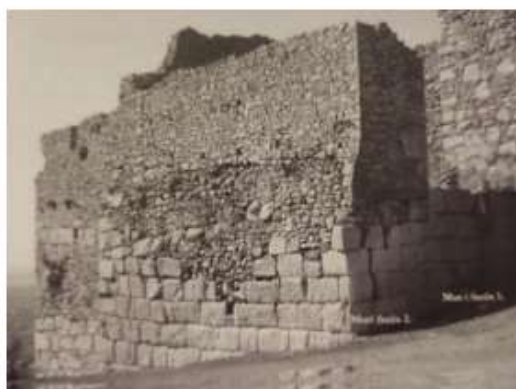
Fig. 2 – Fragment of wall where all stages of construction are visible

In the surrounding walls of the acropolis, it can also be seen a third phase, the medieval one. In this period, another surrounding wall was added to the fortification of the acropolis. This wall rises above the route of the walls built during the second phase, 3<sup>rd</sup> century B.C. The medieval phase is very clearly distinguished from the earlier ones. The technique of building walls in the Middle Ages was quite different from that of ancient walls. Again, the walls were built with two side walls with filling in the space between them. But the side walls of the medieval walls are built with small-sized stones, worked only on their front face, placed in irregular horizontal rows and connected with lime-mud mortar (see fig. 2). The thickness of the medieval walls reaches up to 1-1.2 m.

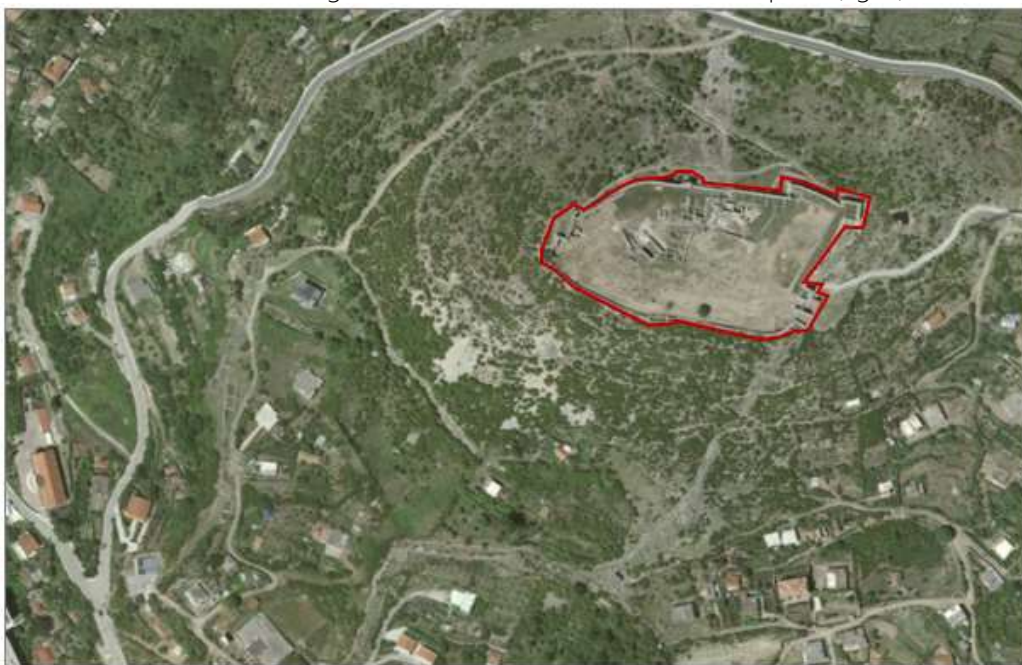
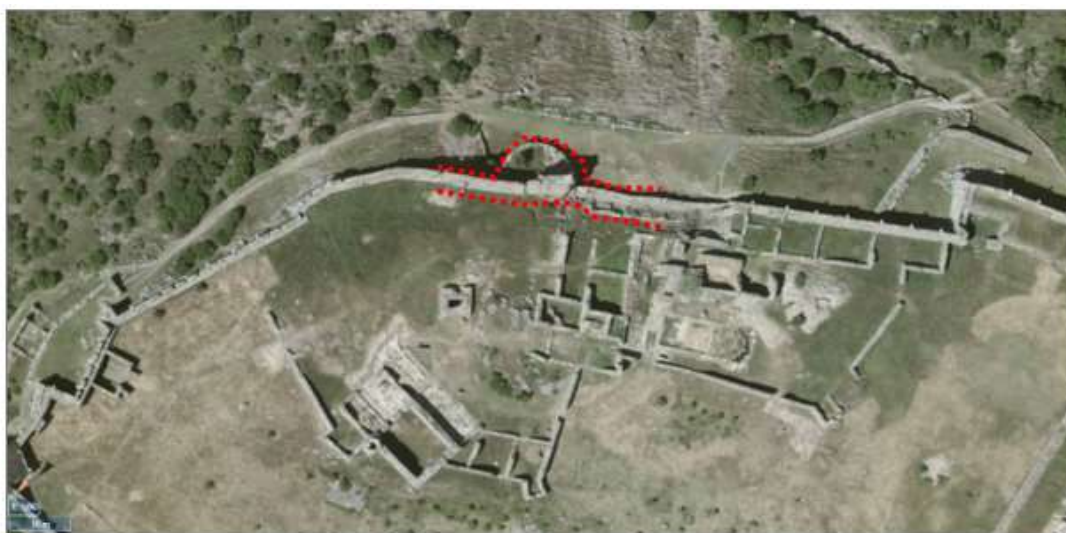
*Fig. 3 – The acropolis and the fragment of the northern wall where the interventions will be carried out*

The project design "Emergency intervention for the stabilization of a part of the northern wall in Lezha Castle" focuses on the study of the state of conservation as well as the necessary stabilizing interventions for the central fragment of the northern wall of the acropolis. (fig. 3)

Due to the loss of horizontal connections as well as the loss of stability, the current situation is presented with very damaged medieval walls; some fragments have shown strong deviations from verticality, risking the complete collapse of these fragments. See fig. 3.

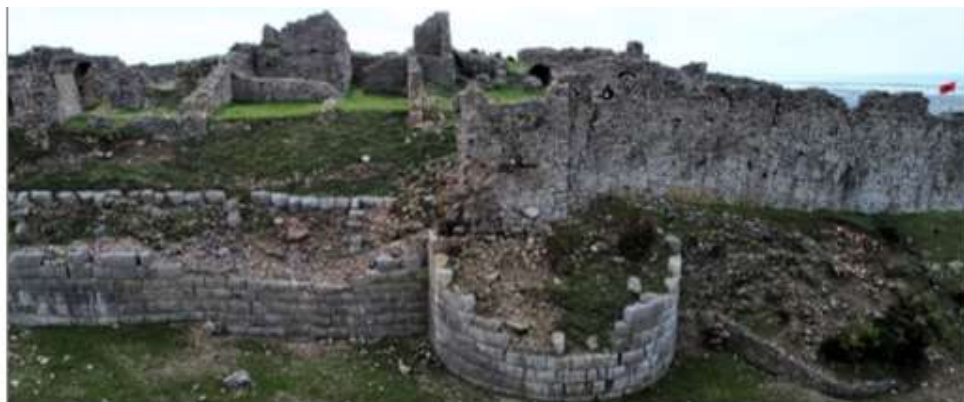
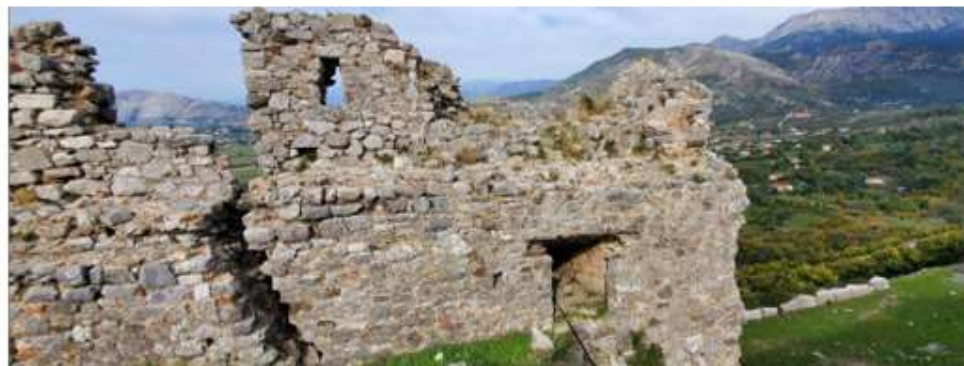
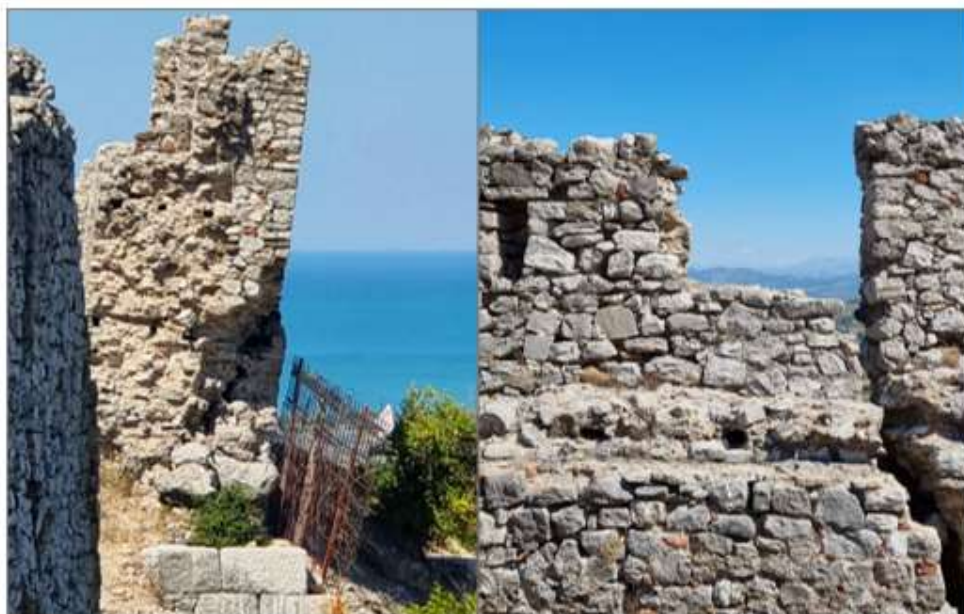
Fig. 4 – Damages on the fragments of ancient and medieval fortifications

The transversal connections have lost their function for the wall's fragment under consideration. Due to the alteration of the fill material, which according to the original technique should have been ballast to enable rainwater filtration, currently this fill material is mainly natural soil and some ballast. Under these conditions, rainwater is not easily and completely filtered, but it accumulates and stays in the area between the two side walls of the fortification wall, exerting pressure on the outer wall and on the connecting transverse walls.

The weight of the medieval walls built on the route of the ancient walls is another reason for the fractures that the latter manifests. (the weight exerted by the medieval walls in the state they are in today, which have lost their verticality)

- The observation tower which is built from a single wall with a width of up to 0.7 m. According to the original technique, the inside of the tower had to be filled with ballast to enable the filtering of rainwater as well as to increase the resistance of the tower. Currently the tower is filled with soil. In these conditions, rainwater is not filtered easily and completely, but accumulates and stays inside the tower exerting high pressure on its wall.

Also, the weight of the medieval tower built on the ancient circular tower exerts pressure on the latter due to the damages that the medieval tower manifests itself.

- The wall of the medieval fortification has lost its continuity thus losing its horizontal connections.

Also, the accumulation of soils in the upper part, where the path should have been leveled with ballast, causes the medieval walls and their rectangular tower to also face the pressure coming from the accumulated soils, further causing the loss of stability of the walls.

- a- Unbanking of a part of the soil that exerts a negative pressure force on the wall
- b- The creation of a positive horizontal force, the value of which is calculated to be 110 kN/m (see the report of structural interventions). This will be done by tensioning the wall with metal ties which are anchored in the upper part of the acropolis ground. This intervention aims to restore the verticality of the fragment of the wall, as a result its stability.
- c- The injection of grouting in the part of the base of the wall from which it risks collapsing. This kind of intervention is done to reinforce the base of the wall and to give a positive impact to the bearing capacity of the wall.
- d- Removal of the damaged wall in the end part and its repair

- a- To eliminate the soils located in the inner part of the walls, to replace these soils with ballast.
- b- To eliminate the soil located inside the two walls of the ancient wall and replace it with ballast
- c- Consolidate the ancient wall and the circular tower (in separate fragments it will be necessary to apply the anastylosis technique)
- d- Consolidate the transverse connecting walls between the two side walls in the ancient walls.
