REPORT OF THE ARCHAEOLOGICAL TRIAL  
TRENCHES IN THE FRAMEWORK OF THE  
PROJECT “EMERGENCY STABILIZATION OF A  
PART OF THE NORTHERN WALLS OF THE “LEZHË  
CASTLE” ARCHAEOLOGICAL PARK OF LEZHË

DEVELOPER: UNOPS – EU FOR CULTURE

**PREPARED BY: LORENC BEJKO**

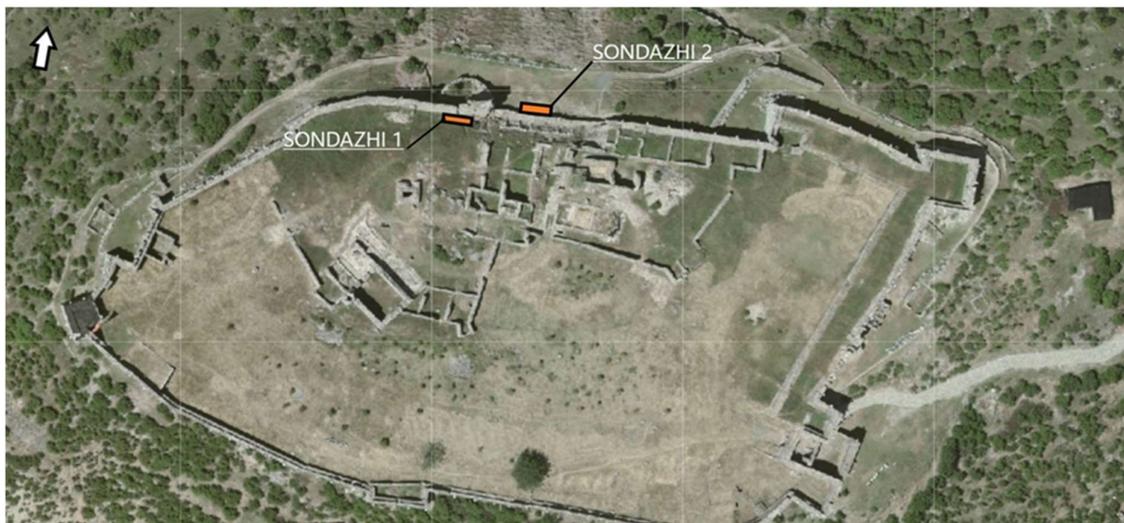
*Location of the archaeological trial trenches in relation to the city walls*

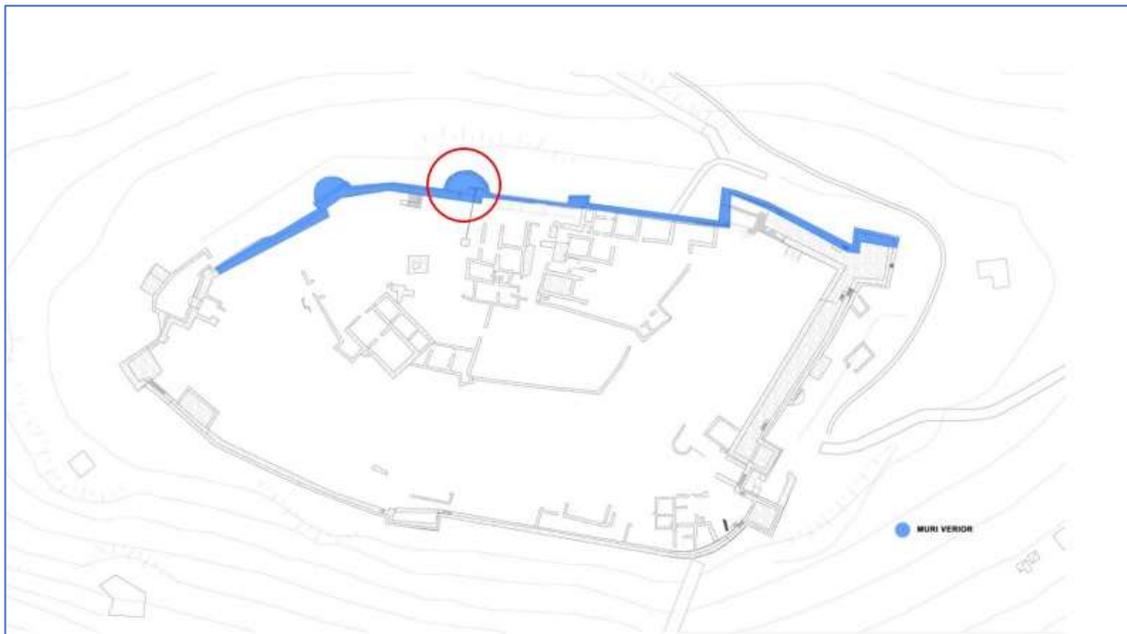
*Plan of the North Wall*

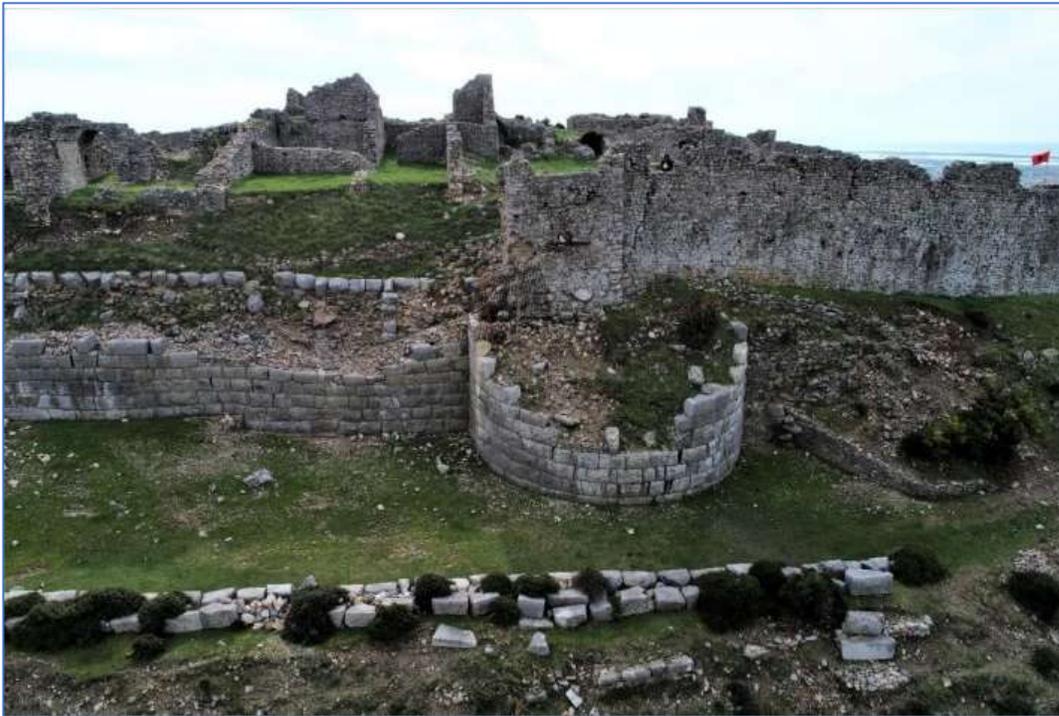
This area presents the biggest structural problems. It is noted that in the northern wall near the circular tower with polygonal stones, there is a deep crack in the entire height of the wall and its slope. This has also led to the tilting of the tower over the circular tower. This area has always been problematic, for this reason the square tower has been reinforced with metal cables from an old intervention carried out by the staff of the Institute of Monuments.

*Current condition of the Northern Wall*

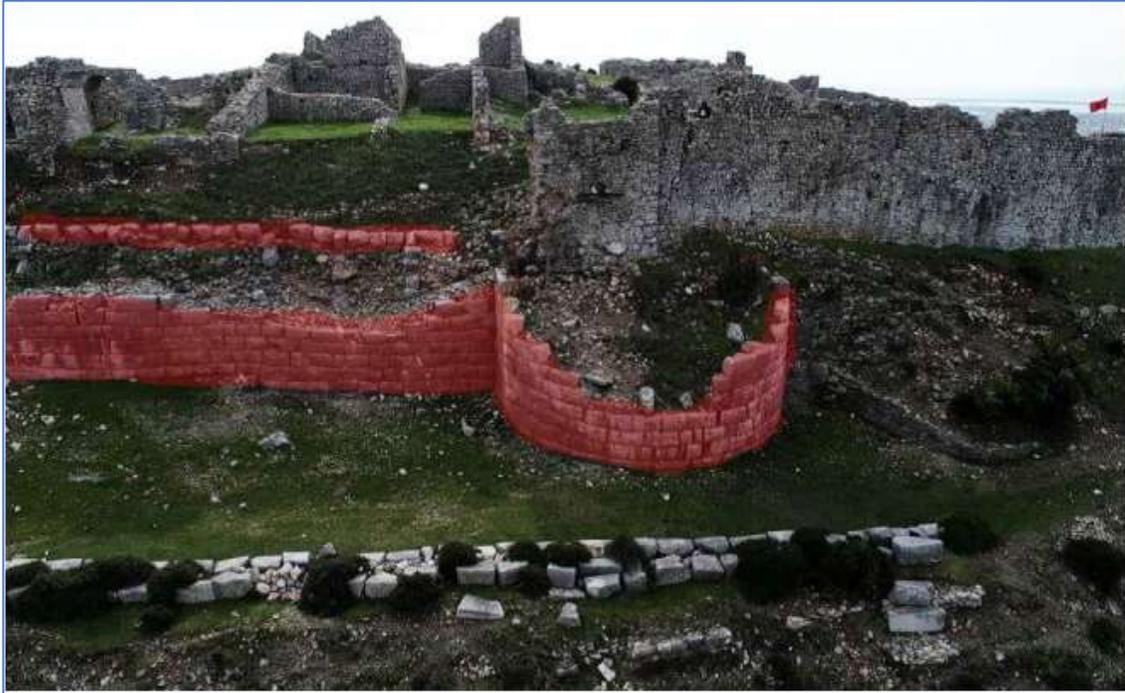
*Identification of wall damages*

Since the object is located in a plain area with unstable geological formation, the most frequent forms of degradation are closely related to the problem of increasing humidity and lowering of the object. This is also noticed by the fact that part of the walls of the castle are located underground. A phenomenon that has occurred over the years as a result of the geological formation of the area where the monument is located. For this, it will be envisaged to design a drainage system as efficient as possible to remove rainwater in cases where there is flooding in the area.

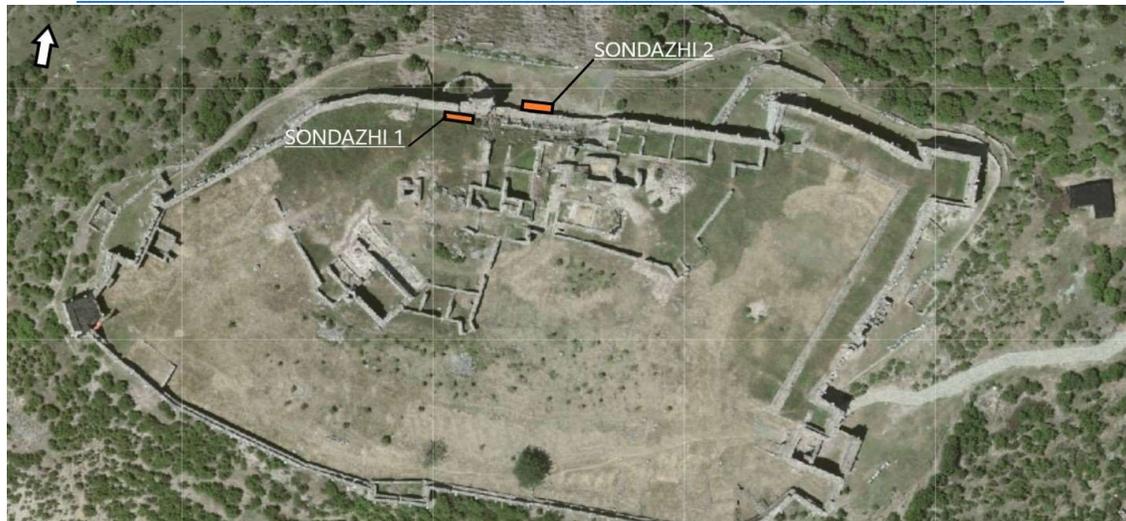
*GIS map of the archaeological trial trenches in the area of the Northern Wall*

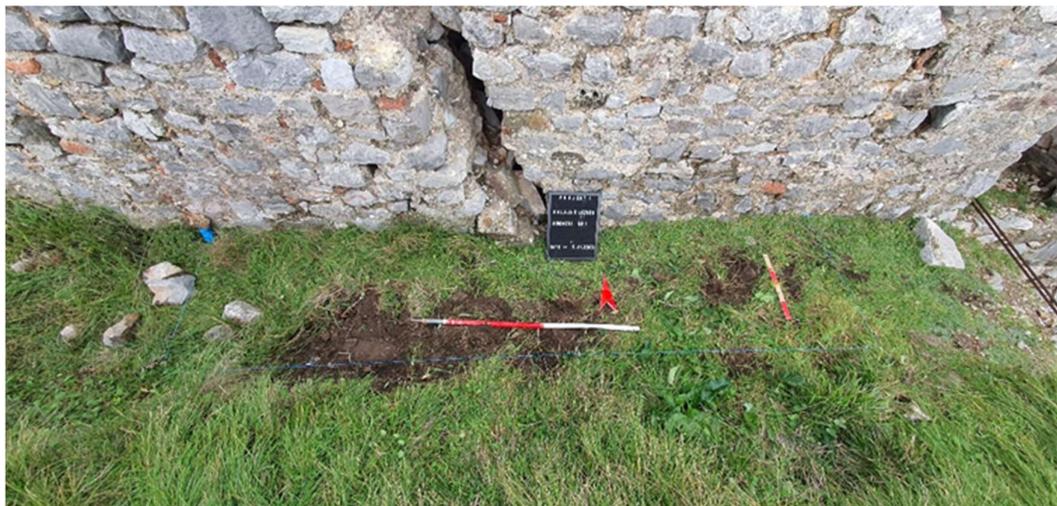
*Archaeological trench layout*

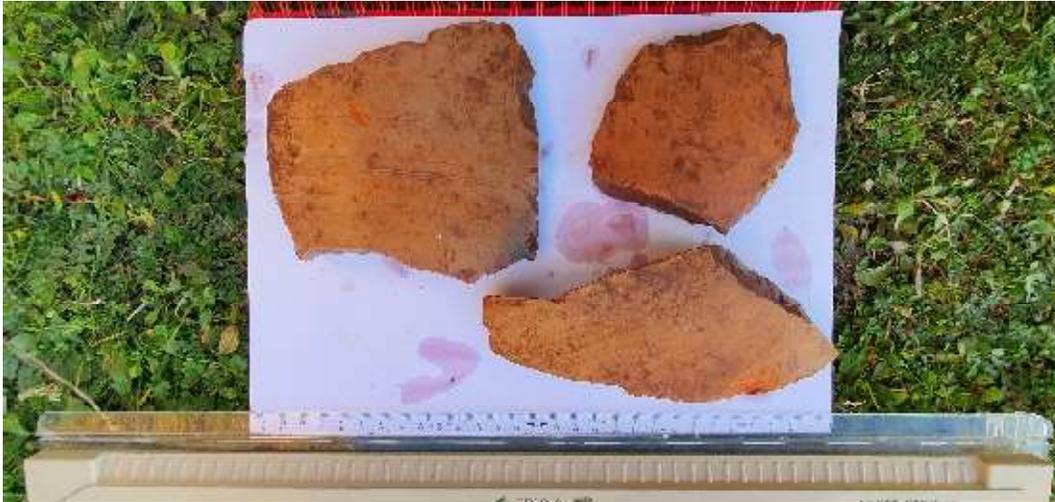
Pottery sherds from the stratigraphical unit No. 2

The second unit (NJ.S 002) is a layer of red color with mixed stones of different sizes. This layer is covered by unit no.1. Non-compact layer that extends along the entire length of the profile. This unit has a thickness ranging from 0.85 - 1 m. Some ceramic fragments were found in this unit.

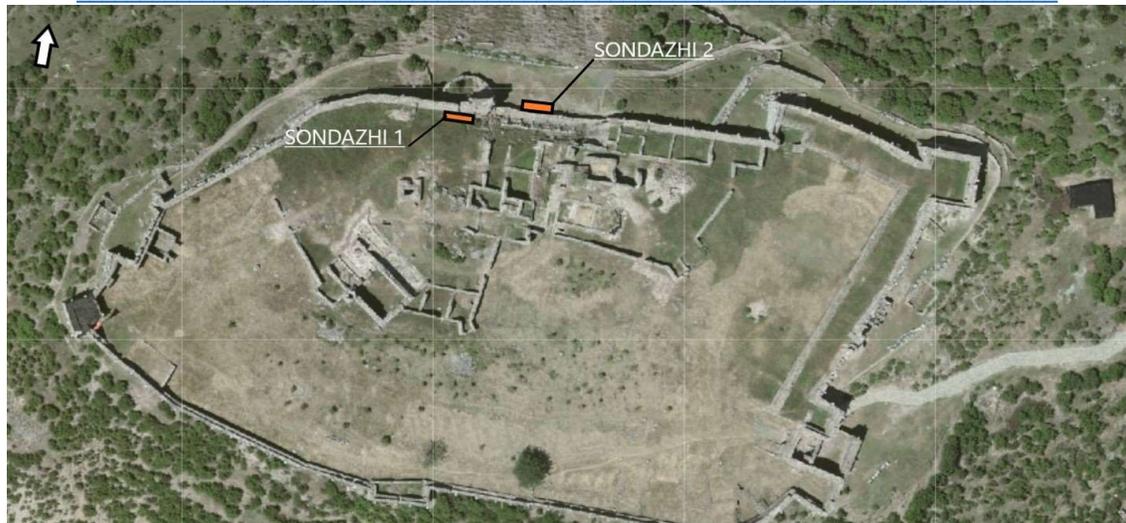
According to the field observation, based on the condition of the medieval wall in the northern part of the castle, the team of archaeologists decided to locate trial trench 1 inside the surrounding wall, with the aim of verifying the crack that the tower of the medieval wall suffered. In this case, the trench had dimensions of 5m x 2m and was excavated to a depth reaching the foundations of the wall.

*Location of trial trenches 1 and 2*

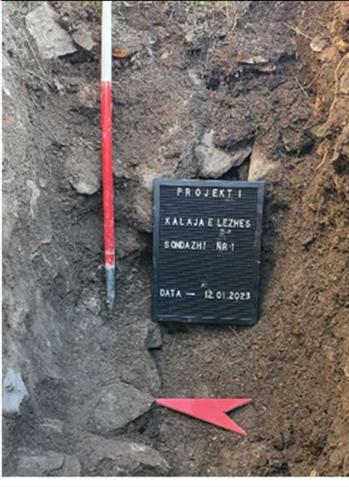
<p><i>Stratigraphical documentation of the excavated profiles</i></p>	<p><i>Hand-excavation process</i></p>

In addition to the process of hand excavation of the archaeological deposits, an integral part of the archaeological excavation was the step-by-step documentation of the situation through scale drawing: Profiles 1:20 and General Plan 1:50. The working tools used included pickaxes; shovels; hand-carts for earth transportation; trowel; brushes; draft paper A4-A3; A4 - A3 tracing paper and Total Station/GPS System.

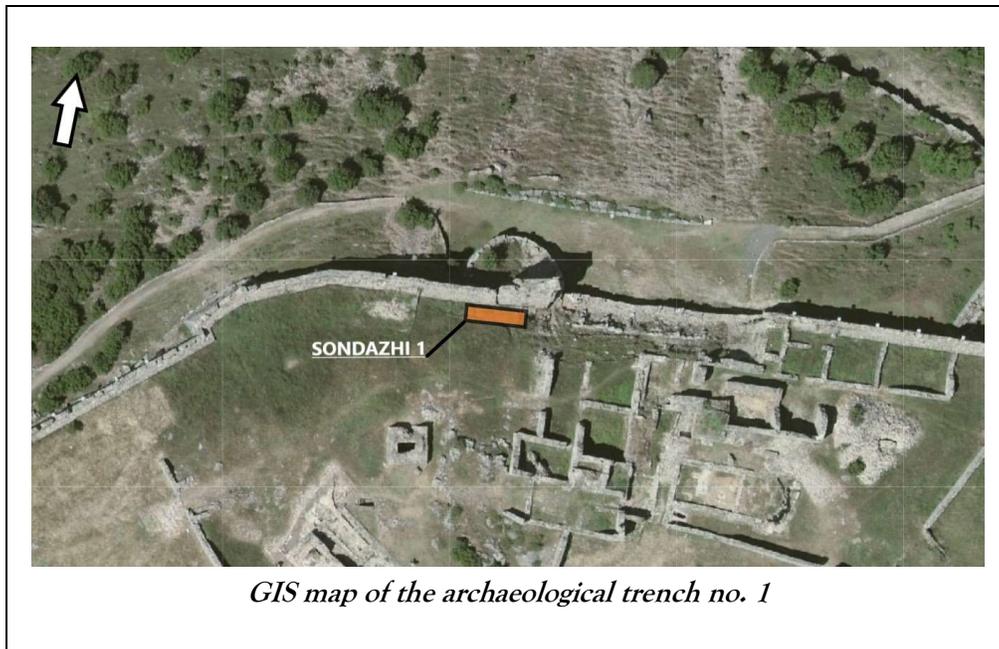
The trench was defined and targeted according to the concept approved by IKTK. Trench direction: EAST-WEST, measuring 5 m x 2 m x 1 m. In this trench, excavation began normally under the supervision of archaeologists. The soil was divided into two categories: Topsoil and Subsoil. A safety distance of 1.5m from the trench profiles was also maintained. The deposits excavated from the trench were checked systematically to identify any ceramic objects or other artefact fragments. The maximum depth of this trench reached 1.1 m until the appearance of the foundations of the northern wall of the castle.

*View of the area where trench 1 was located*

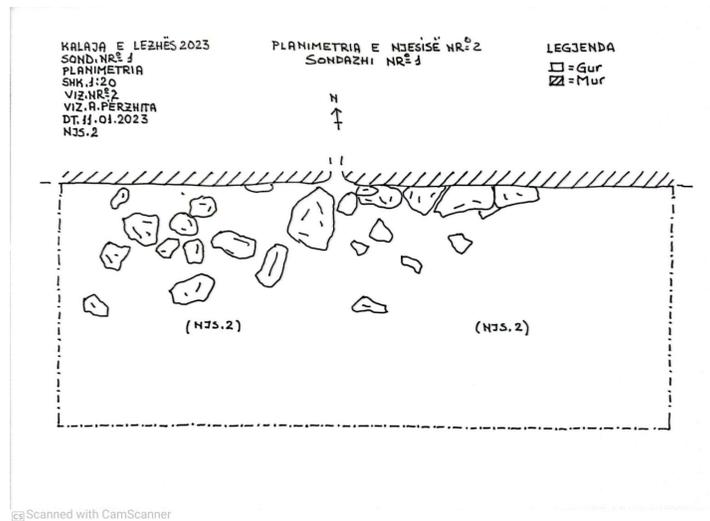
*Plan of Stratigraphical Unit 2 in Trench no. 1*

The second unit (NJ.S 002) is a dark brown silty clay layer. This layer is covered by unit no.1. Non-compact layer that extends along the entire length of the profile. This unit has a thickness ranging from 0.7-0.8 m. No archaeological findings were found in this unit. It is noted that up to the foundations of this wall, the crack in the wall continues from the inner side of the wall.

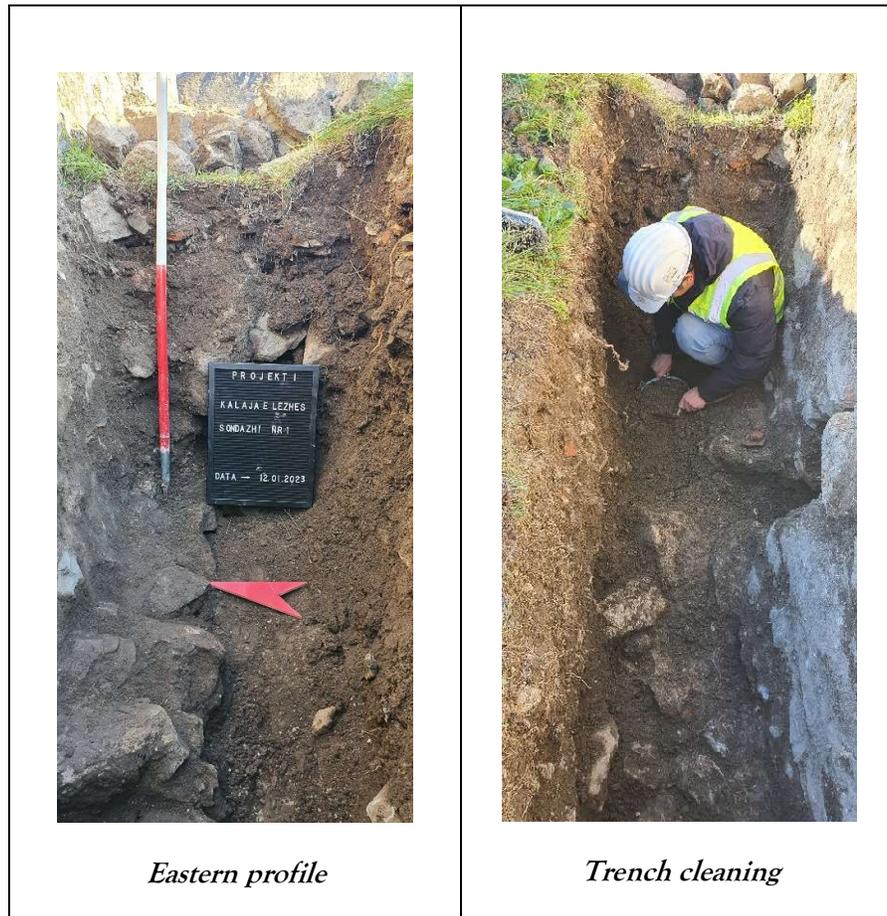
Two stratigraphical units have been identified during the excavation of this trench. They are described below:

The first unit (NJ.S 001) is a dark brown layer. This layer covers unit No. 2. Non-compact layer that extends along the entire length of the profile. Humus layer. No finds or archaeological material were found in this layer. This layer is 0.3 m thick.

- Survey 1 made it possible to document deposits that we think have accumulated near the deep fissure wall as a result of many post-depositional processes (adjustments, squares and early conservation interventions). The archaeological material there is very scarce, non-diagnostic, and re-deposited. The crack in the wall is deep (as is clearly visible on the outside) and is observed with the same width throughout the depth of the survey opening.

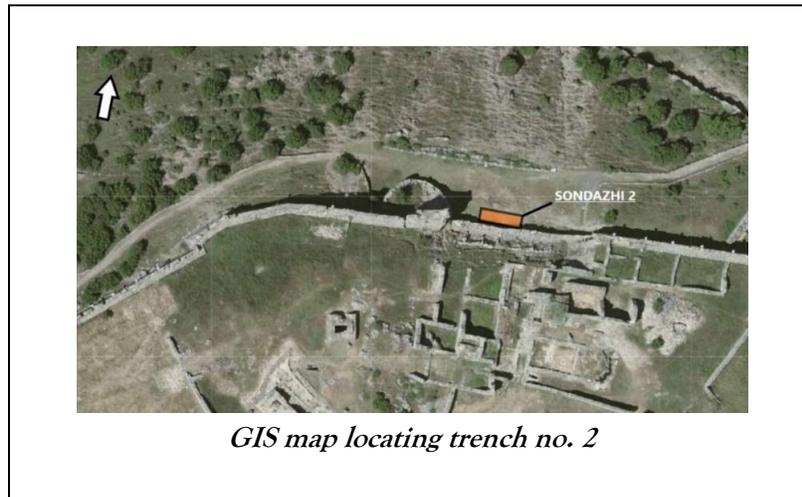
*GIS map locating trench no. 2*

This trench was also defined and targeted according to the concept approved by IKTK. Trench direction: EAST-WEST. It was excavated measuring 5 m x 2 m x 1 m. In this trench, excavation began normally under the supervision of archaeologists. The soil was divided into two parts Topsoil and Subsoil. A safety distance of 1.5m from the trench profiles was also maintained. The soil excavated from the trench was controlled systematically to identify any ceramic objects or other artefact fragments. The maximum depth of this survey reached 1m as natural limestone formations appear.

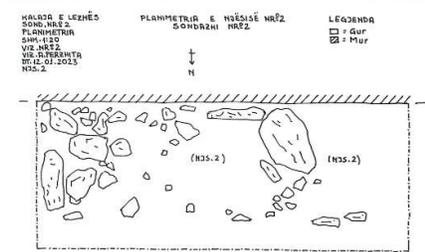
*Plan of Nj.S 2, Trench no. 2*

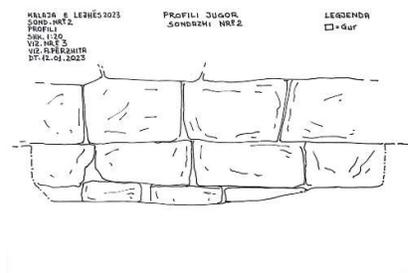
*Elevation of the southern profile*

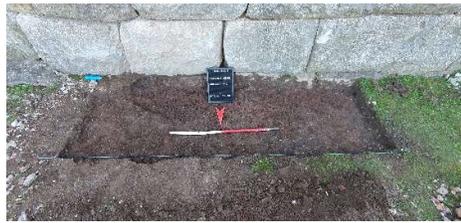
*Nj.S 1*

The first unit (NJ.S 001) is a dark brown layer. This layer covers unit No. 2. Non-compact layer that extends along the entire length of the profile. Humus layer. No finds or archaeological material were found in this layer. This layer is 0.15 m thick.

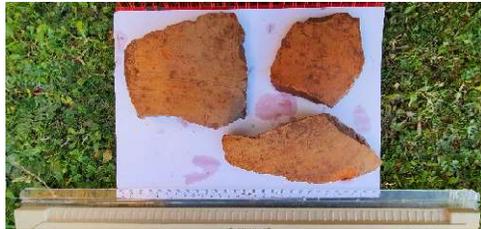
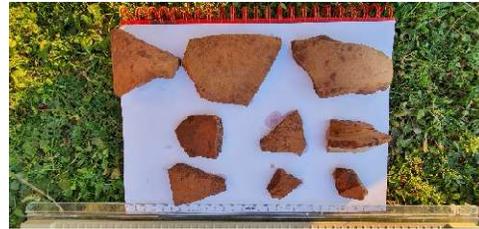
*Pottery from Nj.S 2*

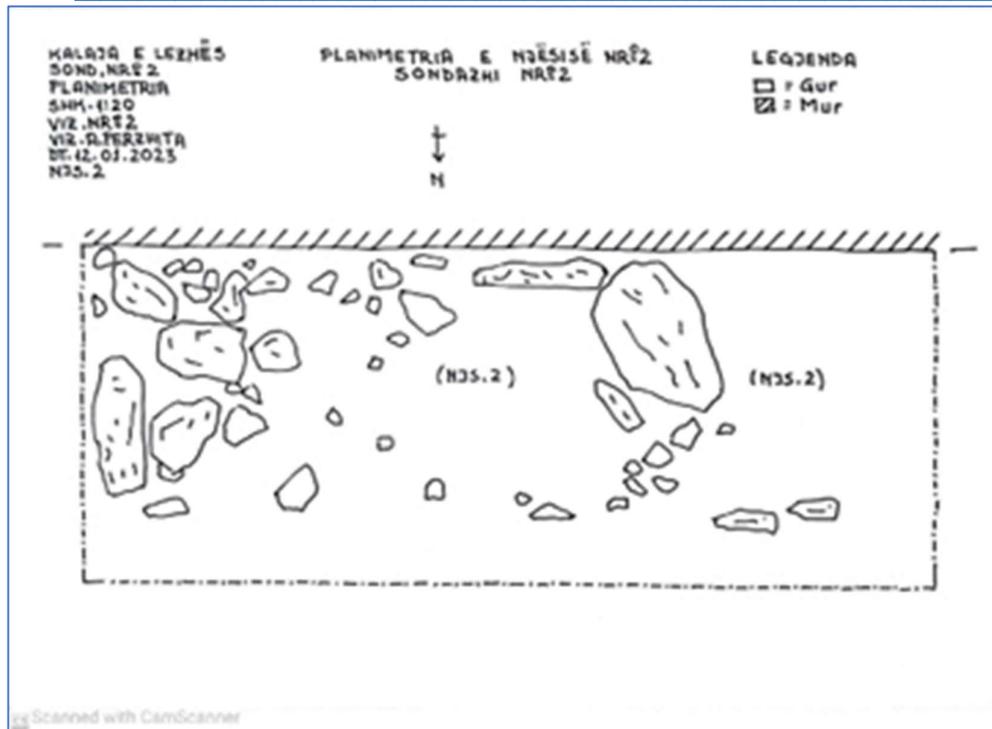
*Plan of Nj.S 2, Trench no. 2.*

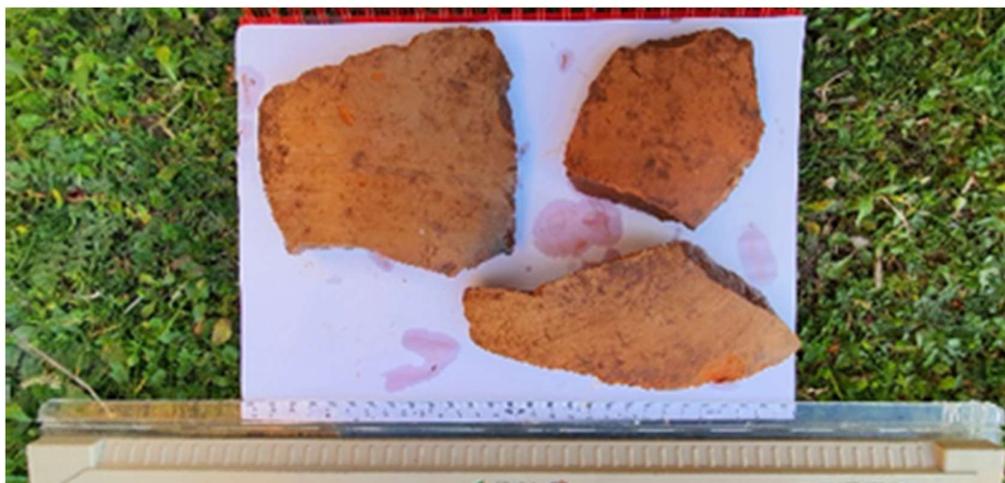
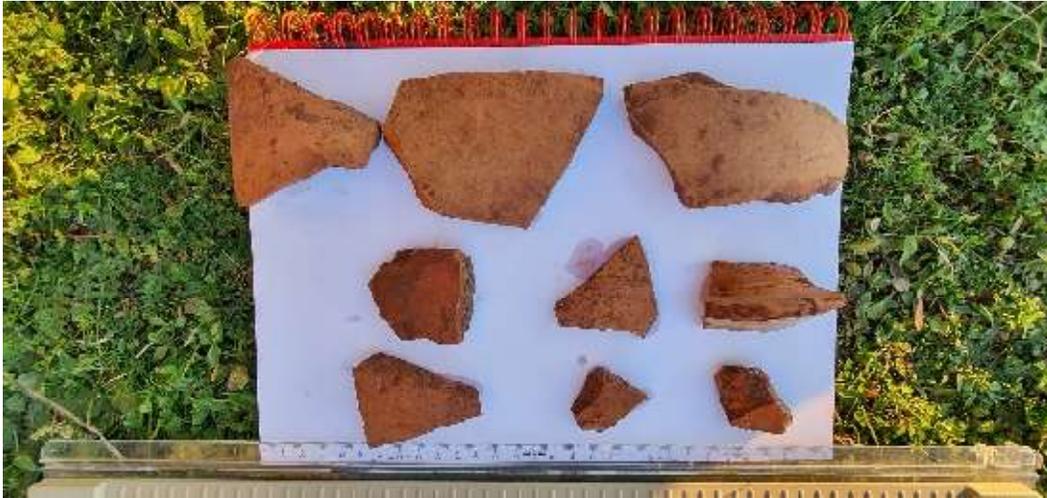
*Pottery fragments from layer no. 2.*
