ST ANTHONY'S CHURCH

Cape of Rodon

Conservation design for wall paintings

Tiranë, Mars 2022

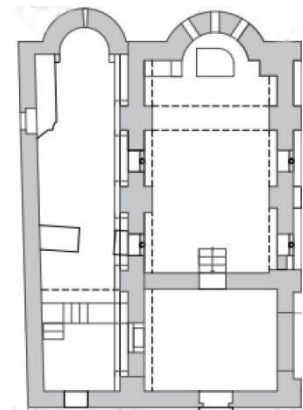
fig. 4

The church is known as the church of St Anthony (dedicated to St Mary through antiquity) and its plan is a regular rectangle. The architectural composition of the church is made of narthex, nave and presbytery. (fig. 4)³.

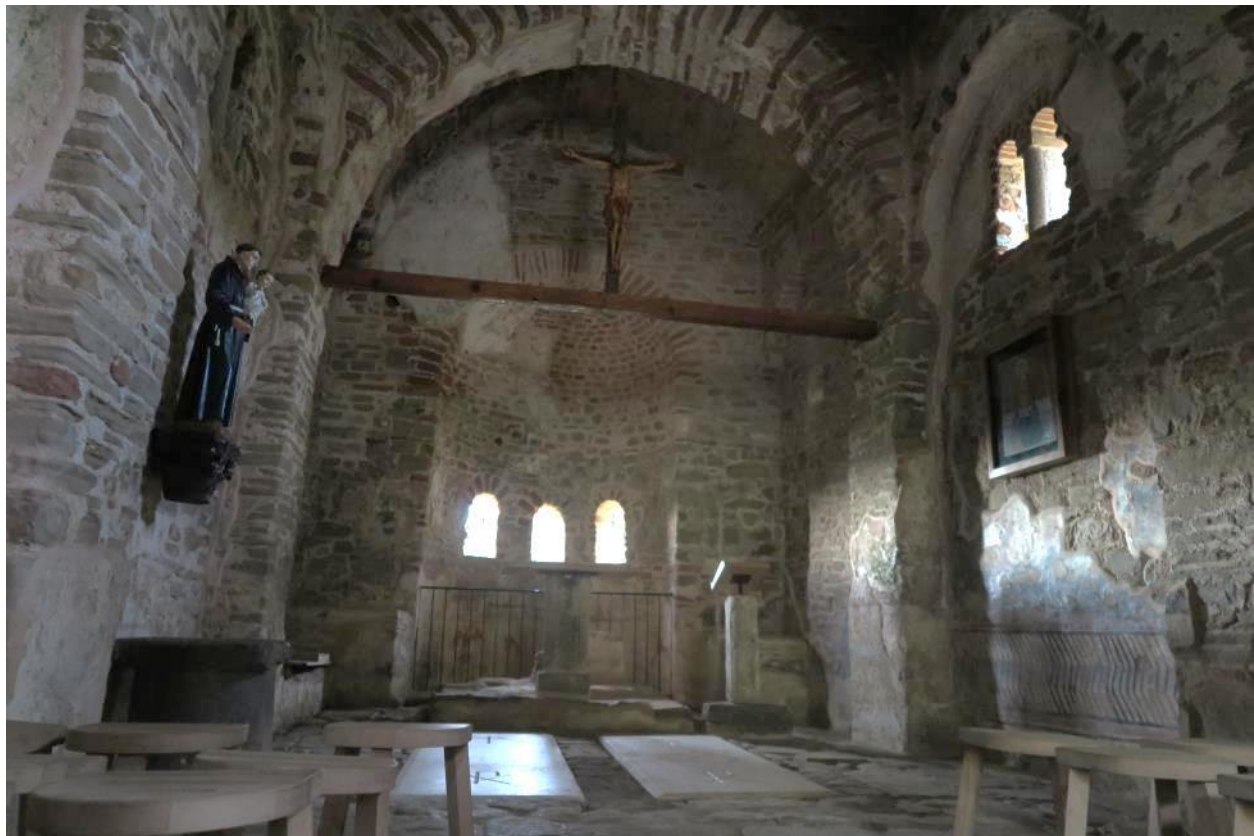
fig. 5

The wall painting which still exists at the interior of St Anthony's church is of a relatively small surface when compared to overall surface of the walls of the interior where we see it applied. However and since the church did not have a roof until the year 2000, the wall paintings must have suffered from exposure to elements, and therefore were badly damaged. Majority of the walls of the interior do not show any longer any traces of earlier existing wall paintings.(fig.5).

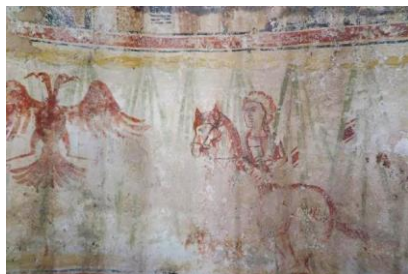
fig. 6

On the surface area of the apse one can evidence a portion painted containing a not usual composition of three different decoration motifs. On the left hand side, we can see a double headed eagle with open wings which resembles the motifs of heraldics and the whole composition is painted with red ochre pigment on the base colored in dark brown color. (fig.6). In the center of the semicircle of the apse we can see a figure of a rider. The rider does not have neither the beard nor the armaments. It is drawn in red color, with a touch of black as to distinguish the horse reins of a clucking horse advancing boldly from the right side, with a difficulty of restraining itself (fig. 6).

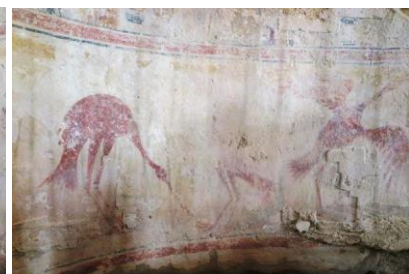
fig. 8

The northern section still safeguards the fragments from the original painting, where on the major part of it, the typology of used motifs is not discernible. Located primarily in the corners of the lower sections (fig.9), we can easily observe two phases of the wall painting in fresco technique and which are applied one above the other (fig.10). The motifs shown contain the three crosses of the cavalry. (fig.11).

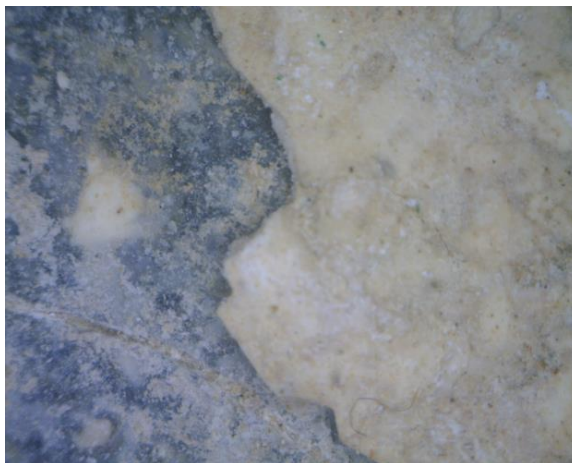
fig. 15

Independently that the remains of the wall painting in the Church of St Anthony are few, the technique of application is easily identified. The wall paintings evidenced in site belong to the third phase of the painting that church used to have throughout the time.⁹ One or the other of the phases can as well be evidenced, however the remains of them can only be seen in portions where the surfaces of the third phase are damaged and reveal the traces of other phases below. (fig. 12,13). As we see the paintings, we immediately can identify them to be made in fresco technique. The painted layer are well connected to the base layer, even in the cases of earlier phases, no matter that in some segments they seem to be mechanically damaged (the damage is a result of their abrasion as to secure the final layer of painting to sit securely on the surface) (fig.14). The base layers seem solid. Seen with the portable microscope, one can discern the lime as a connecting material. Lime is mixed with sand of a differing granulation. (fig. 15).

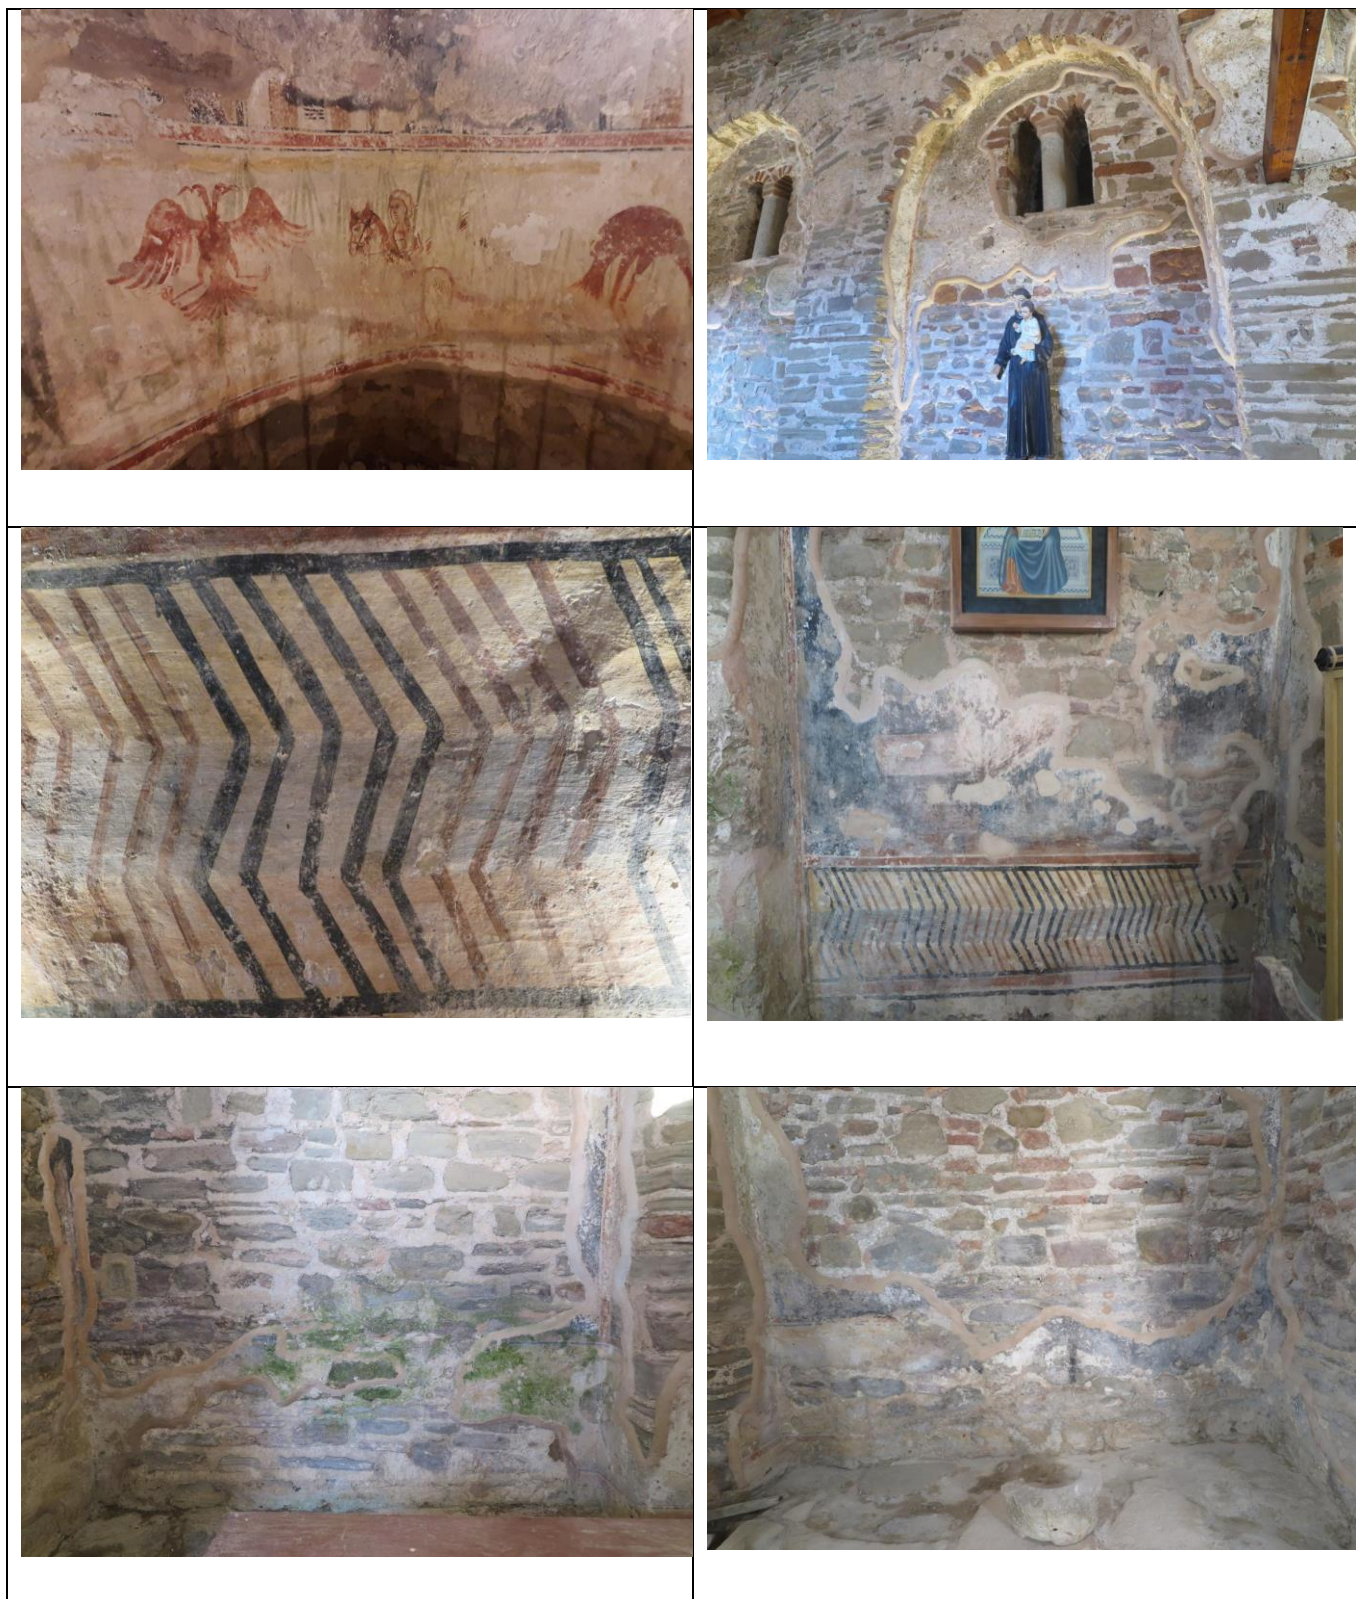
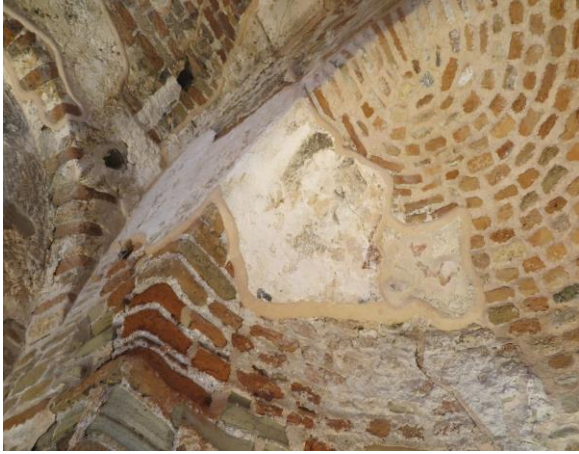
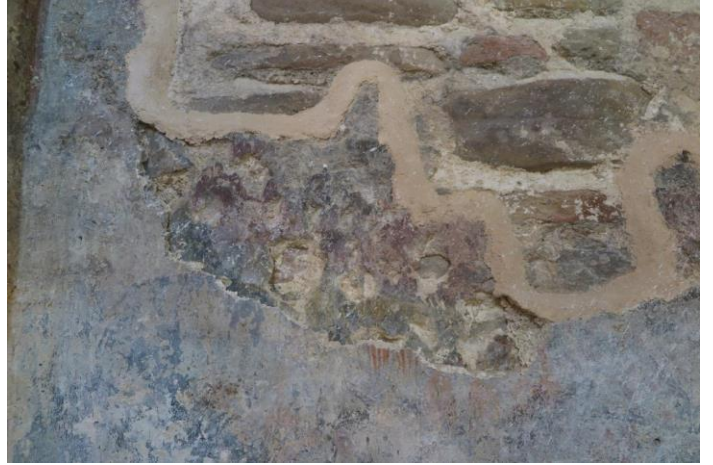
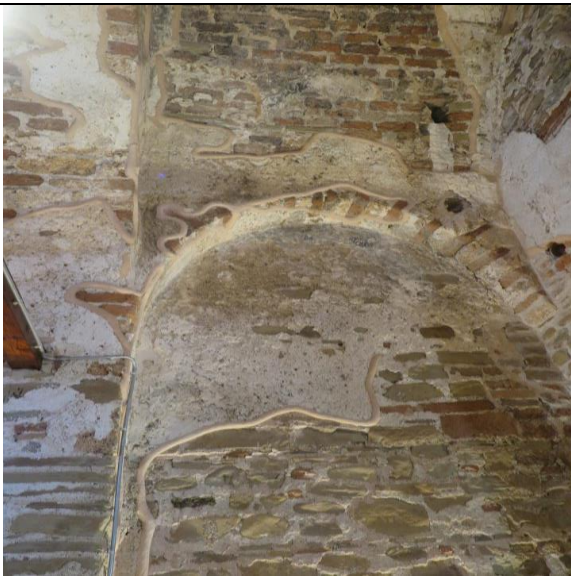
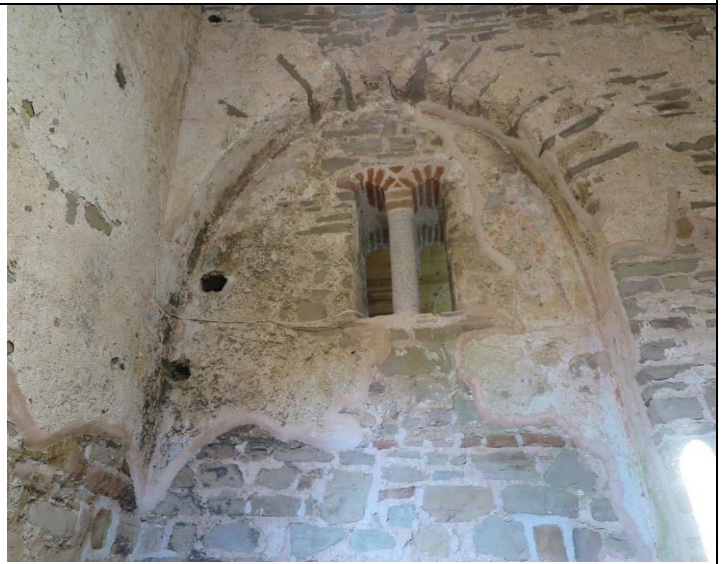
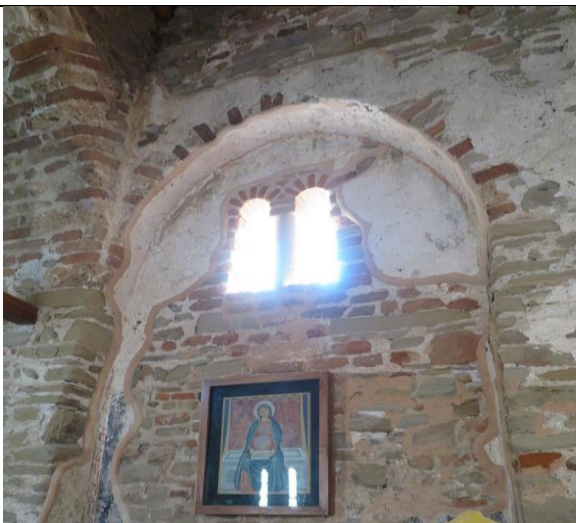
Annex 1 Photos of wall paintings as well as as layers:

The wall painting in the interior of the Church of St Anthony reveals complex problems to be taken into consideration for its conservation. Darkening of the painted surfaces is limited to the northern section of the apse. The abrasion of the painted layer is widely spread across all the painted remaining surfaces. The reason for this are the elements to which the painting was exposed while the roof was missing. Abrasion of the painted layers is a pathology that is evidenced in the

sublayers, meaning in the base layers for the latest painting phase. The missing roof over a long period of time has as well affected the partial detachment of the base layer from the masonry.

The presence of capillary humidity has as well resulted in creation of layers of stains of moss which is still active and which can be easily observed on the remaining painted surfaces and especially on eastern and northern portions. The painted layer appears fragile, and in several of the zones of the apse as well as on the northern sections of the walls is risking to detach from the base layers. The presence of salts is also one of the problems that have affected the painted layers in the Church of Rodon, where approximately 70% of the painting is affected. Additionally, on the surface of painted layers the layers of overlapped plastering from earlier maintenance interventions are as well present and visible.

The voids in between the base and masonry are as well present. The superficial deposits are as well evidenced on the painted surface, and those deposits are of different nature. (some are solid while some are not). Mechanical damages are as well evidenced on the painted layers below the layers of the 3rd phase. The new plastering made in 2000-2001 is still preserved as well as consolidations of the edges of the remaining portions of painting. The consolidated edges however are often found not to carry on with its function, since plastering together with painted layers are detached and have fallen off. There are very few repaintings evidenced and are primarily in the area of the apse (Annex 1 – showcases pathologies and damages)

- 1.The stabilization of painted layer
- 2.The consolidation of the base layer against mechanical damage and abrasion
- 3.Establishing cohesion among the base layer while being extra cautious in the areas where there are layers of former periods.

Regarding the consolidation of the base layer, abrasion and the damage to base layer and the painted layer, the Nanorestore shall be used. It is important that the materials used in the consolidation operation do not change the chemical and physical characteristics of the original materials and constitute a cause of chemical degradation of the original material, neither at the time of injection nor in the subsequent stages. Based on the conversion of hydroxide to calcium carbonated by the action of atmospheric carbon dioxide, Nanorestor is the "par excellence" consolidator compatible with frescoes but also with other materials with a carbonate based material mixture. As such, Nanorestor has excellent permeability to water vapor, does not imply chromatic variations or glossy effects, and maintains hydrophilicity and the absence of hydrophobic surface films.

The cleaning intervention consists of a series of operations aimed at removing foreign substances from the surface of the painting, which cause additional layers of impurity (such as recent surface deposits, stains, chromatic changes, biological deterioration and unsuitable materials) and therefore affect the aesthetic appearance of the painting. The cleaning needs to be undertaken and to remove the remains of lime currently observed at the painted layers.

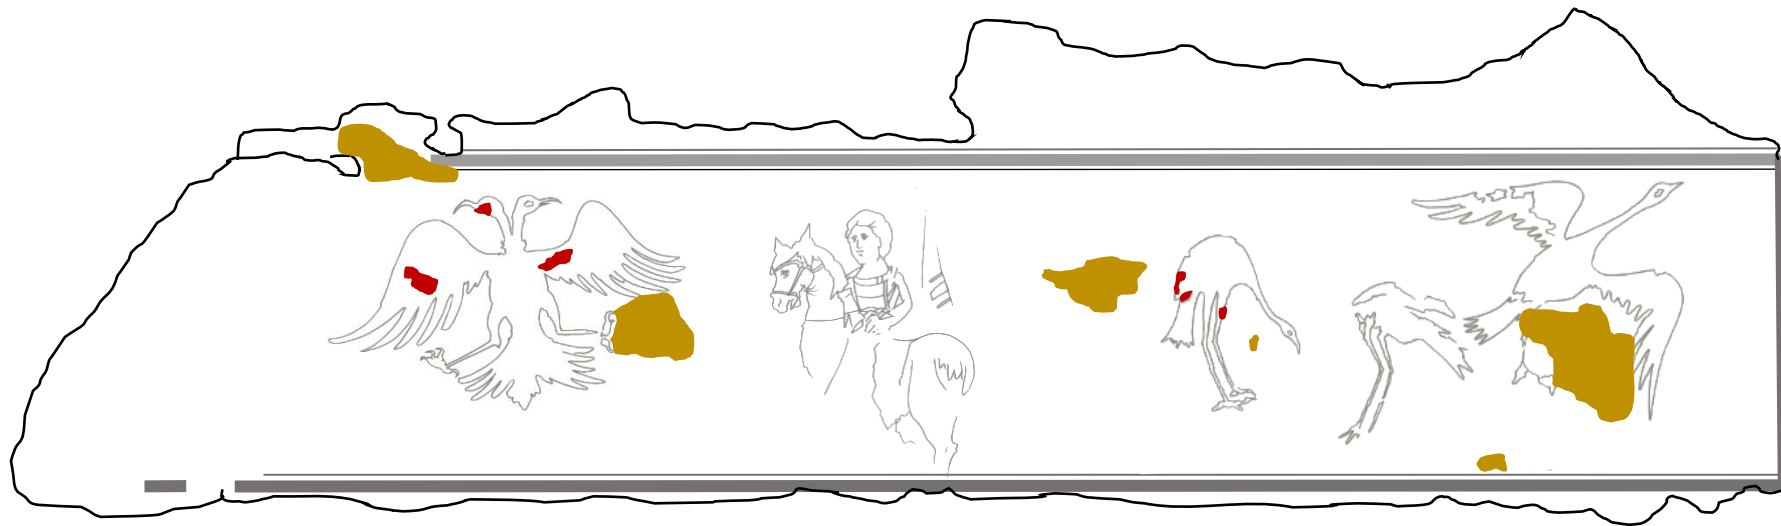
Fallen base layers

new plastering

After stabilizing the surface through consolidation, as well as after cleaning of the surface, the necessary filling of lacunae and voids shall be undertaken. As currently observed the different stages of restoration have brought a number of different interventions and materials to appear on the surface. The removal of old plasters and the infills of gaps and surfaces with a new plaster similar to the original plaster shall be undertaken. Removing the old infills shall secure the structural stability of remains of the wall painting and will make the surface more readable.

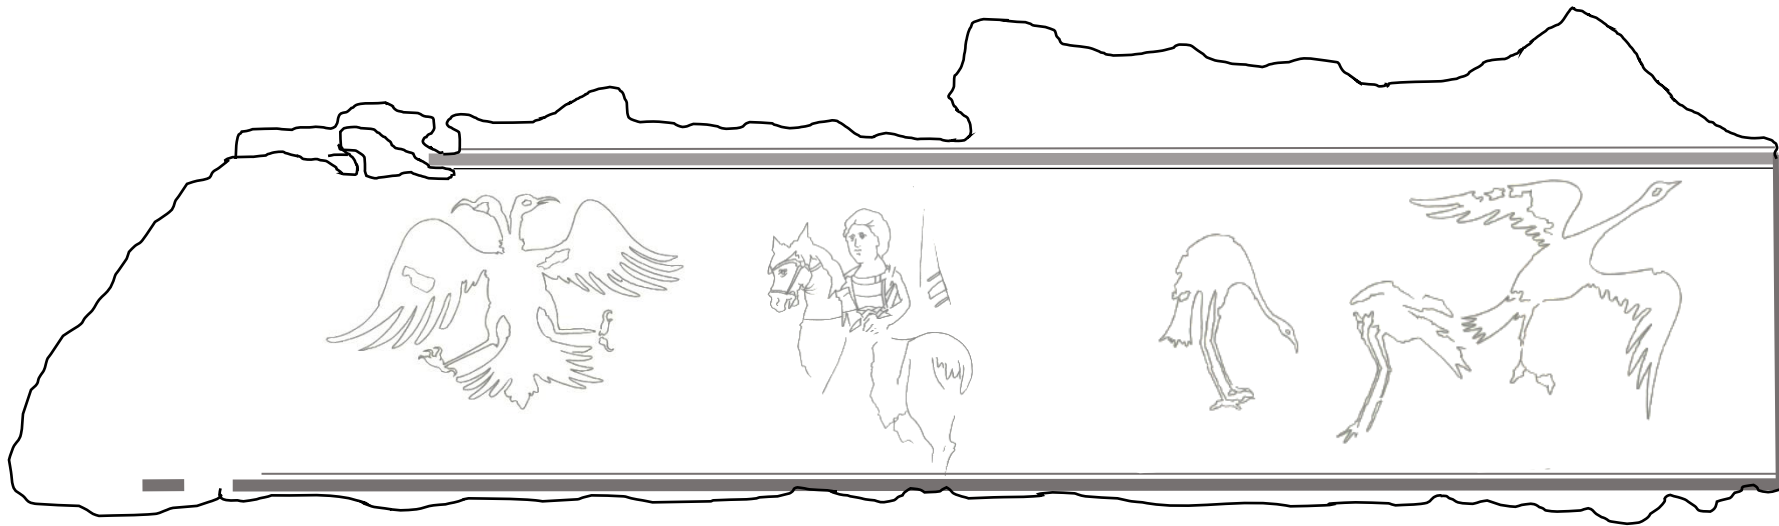
Edges of the wall paintings

Regarding the edges, those are added during the restoration interventions of 2000-2001 and they are added to all remaining portions of painting. Independently from the fact that sometimes they appear to be very thick and not very well aesthetically integrated they did perform their protective role. And the ones we can evidence are well connected with the masonry base, while the layers added on top of them have degraded in time.

Regarding the stucco, those are limited and only evidenced on the eastern portions. The application of stucco for filling the lacuna of painted surfaces shall be undertaken as well as their unification with each other. The removal of the edges of the remaining painted layers shall be considered, especially in cases where they are resulting to be too hard and too wide.

It is evident that some of the edges are not having a protective role, as part of the preparatory layers they were carrying has fallen and no longer exists. On the other hand, they are not suitable from an aesthetic point of view, attracting more attention than the very part of the remaining painting for which they were created.

As for the edges or the remaining painted layers, those would be consolidated using the same mortar composed of lime and aggregate, while respecting the materials and ratios of the original plaster.

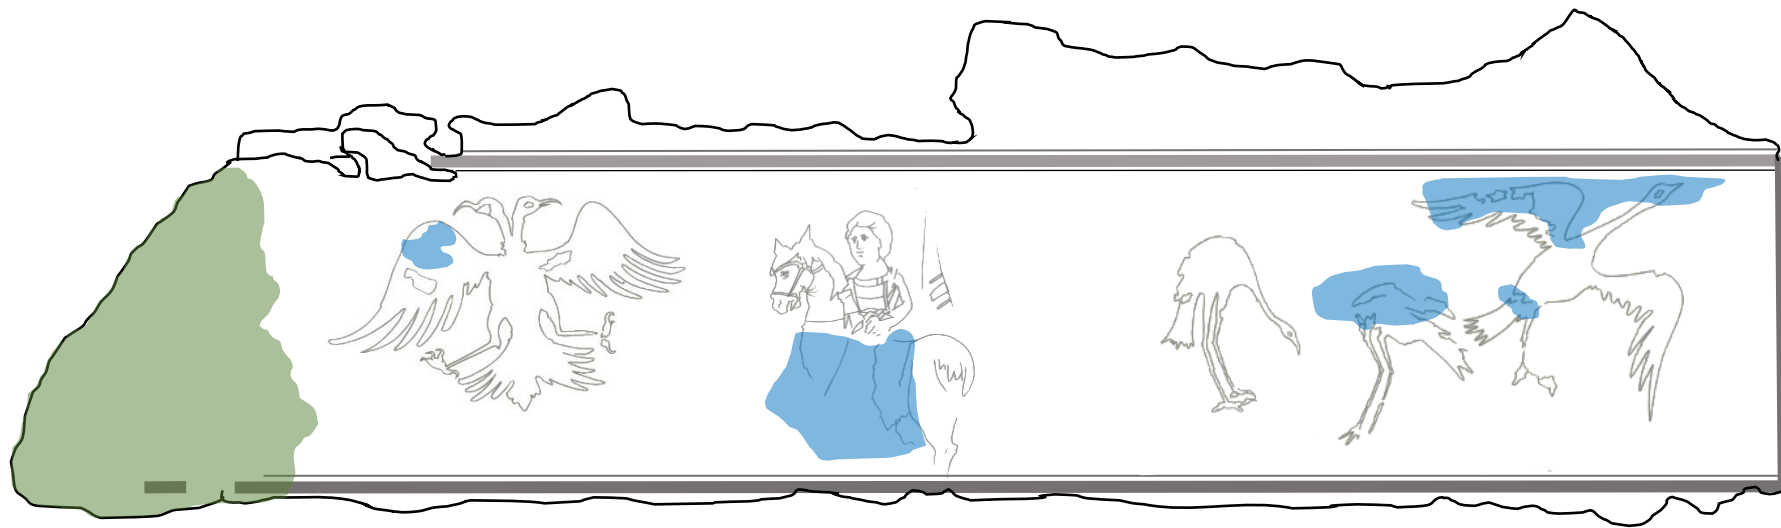
Darkening of the painted layer

Abrasion of the painted layer

be treated with Tween 20 - neutral non-ionic surfactant derived from ethylene oxide. Tween 20 is soluble in water, alcohol (ethyl, methyl, isopropyl), ethylene and propylene glycol.

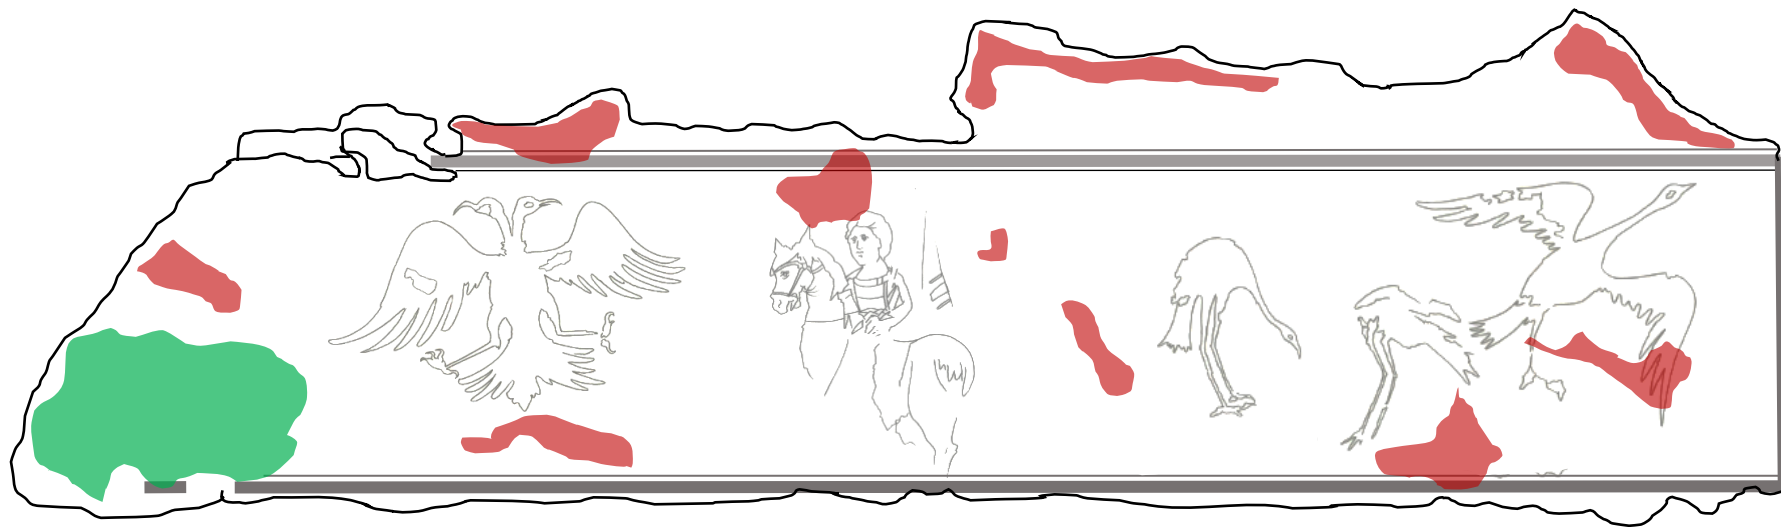
Biological patina

Detachment of painted layers from the base

Biological deposits as well as numerous salt deposits evident on the surface are meant to be treated with the solid homogenized gel obtained from the double baking of AgarArt (Nevek) usually used for cleaning of the surface of the fresco in this case. Nevek in this case can also be mixed with suitable solutions such as ammonium carbonate in different percentages (according to the situation on site). Nevek strongly retains water and can be used to absorb dirt even from moisture-sensitive surfaces.

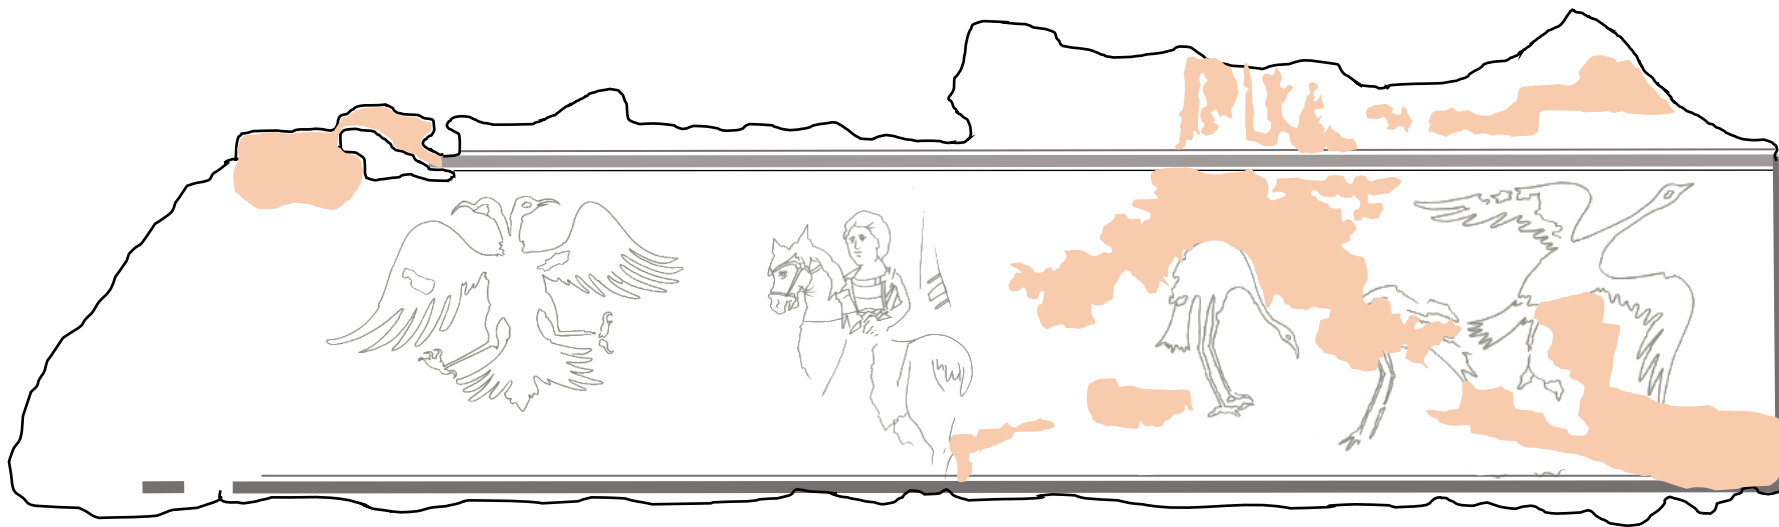
Layers above the paintings (remains of lime wash and plaster)

The removal of materials firmly attached to the surface (layers of lime or superimposed plaster) will be carried out mechanically using spatulas and scalpels. Darkening of painting surfaces will

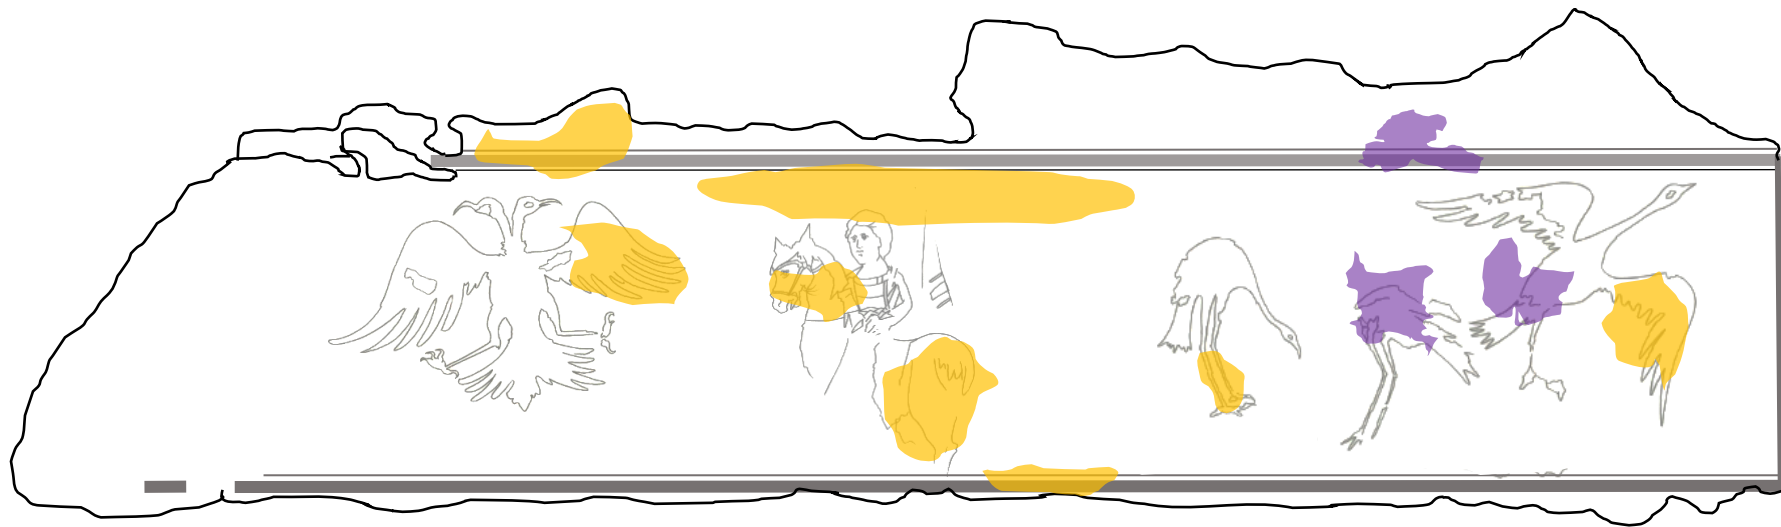
Presence of calcium salts

Detachment of painted layer
