Rmeil 358 Sursock Palace

Scope of Work (SOW)

for Restoration of the Lateral Elevation in Sursock Palace

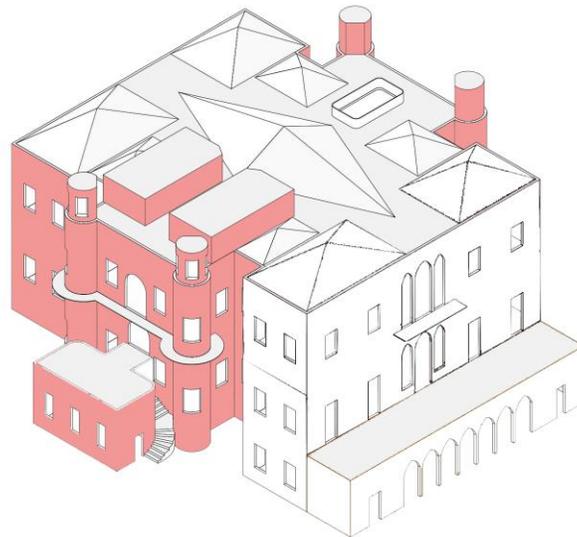
Figure 1: Axonometry highlighting the lateral elevations

The main works will be covering consolidation of wall-to-slab connections in the two lateral elevations including consolidation of wall-to-wall connection and restoration of facades lime plaster and protruding typical joints, restoration of doors (21) and windows (87) carpentry included in these two elevations, windows crowns and molds, restoration of marble slabs balconies and related balustrades and corbels, restoration of entrance stairs, access terraces and related balustrades.

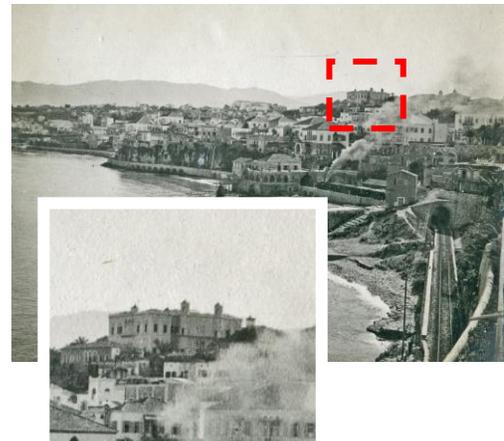
Figure 2: Historic photo showing the Sursock Palace and the towers on the side elevations, 1910s, Web source
