ARCHITECTURAL REPORT KURCAJ BRIDGE

22644-001_ALB_EU4C_RFP_01 - "Provision of Consultancy for Design services for EU4CULTURE Project - Support for revitalization of cultural heritage sites and monuments affected by Earthquake in Albania."

1. GENERAL

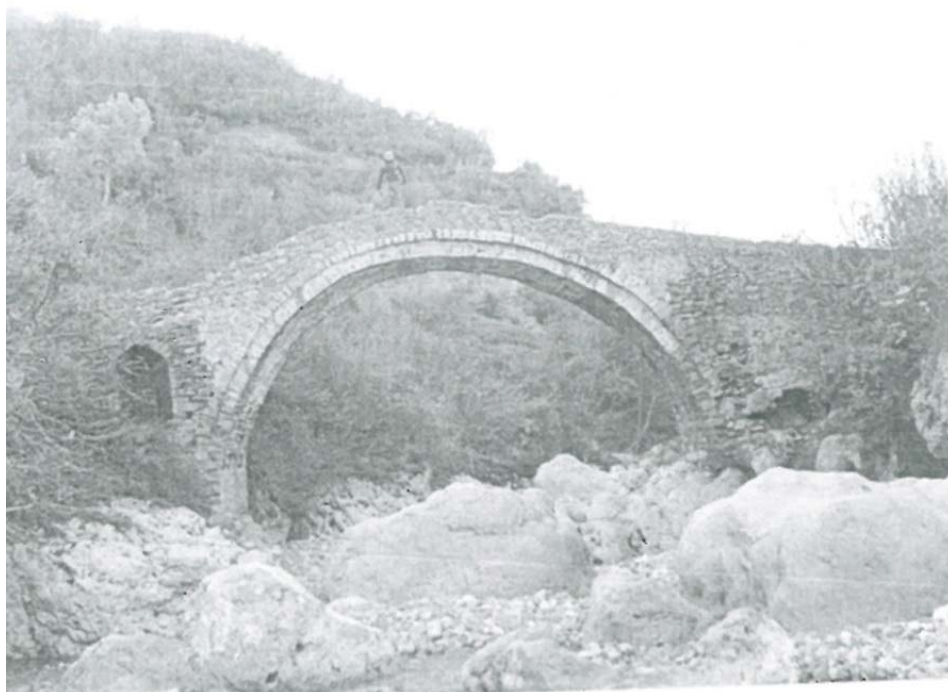
Fig. 2. Photo of 1982

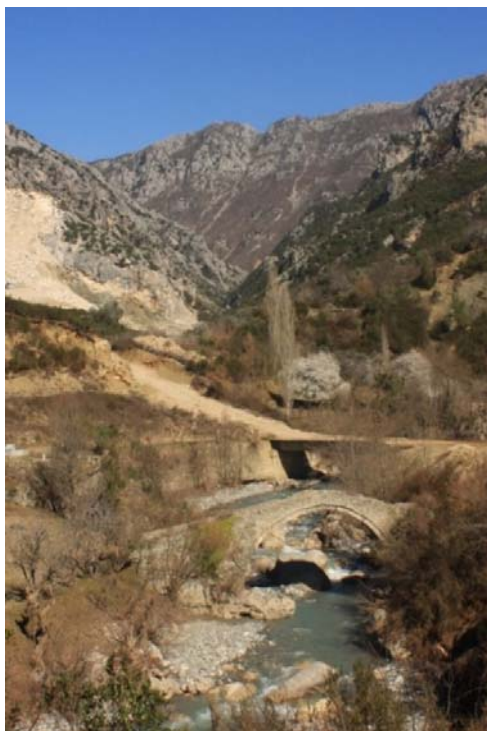
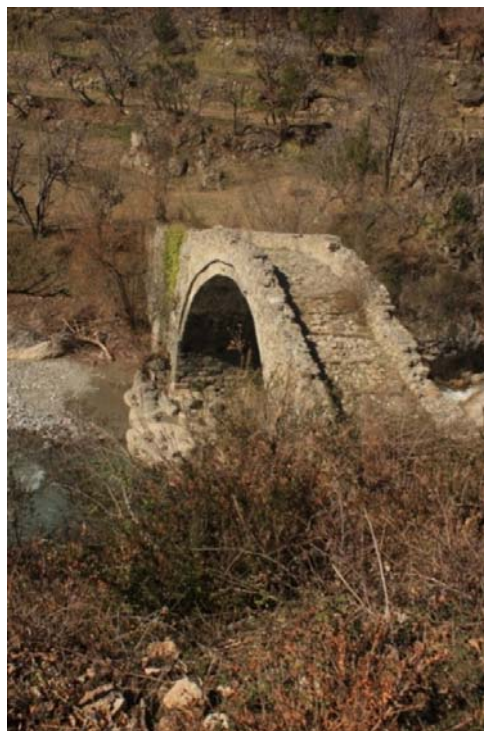
However, in its structure, except for the need of immediate reinforcing interventions in its left wing as well as consolidations and repairs of the "extinguisher", conservation of walls and arches and keeping the vegetation under control. Fortunately, no cracks in the outer part of the arch have been identified so far, although some detachments of its second vault should be repaired as soon as possible in order to avoid breaking the static balances of the structure. Referring to the photos from 2010, the right arm of the bridge was connected to the ground.

Fig. 7. Photo of the year 2010

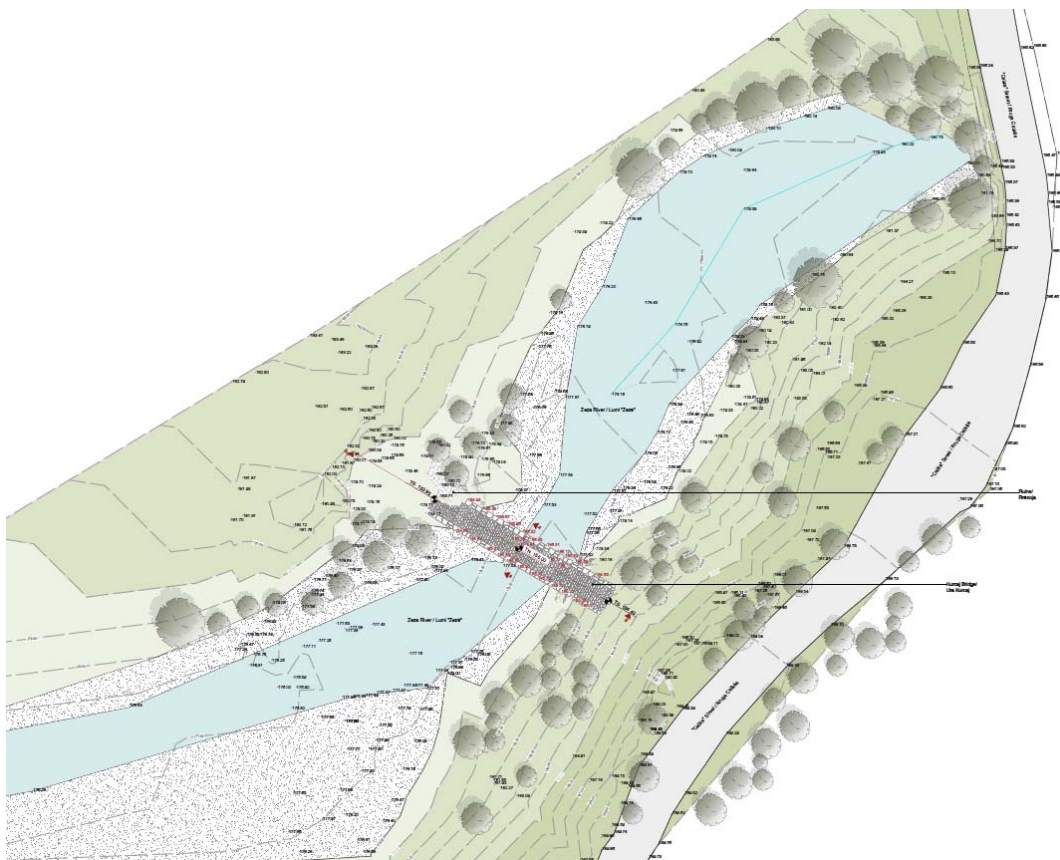
Based on the data obtained, the river flows have caused damage to the foundation of the bridge, which has affected its structural stability. As mentioned above, the Kurcaj bridge showed problems in access, which is further reinforced by its lack of stability or the degradation of the essential reinforcing elements / wear over time.

Fig. 8. General site plan-current condition

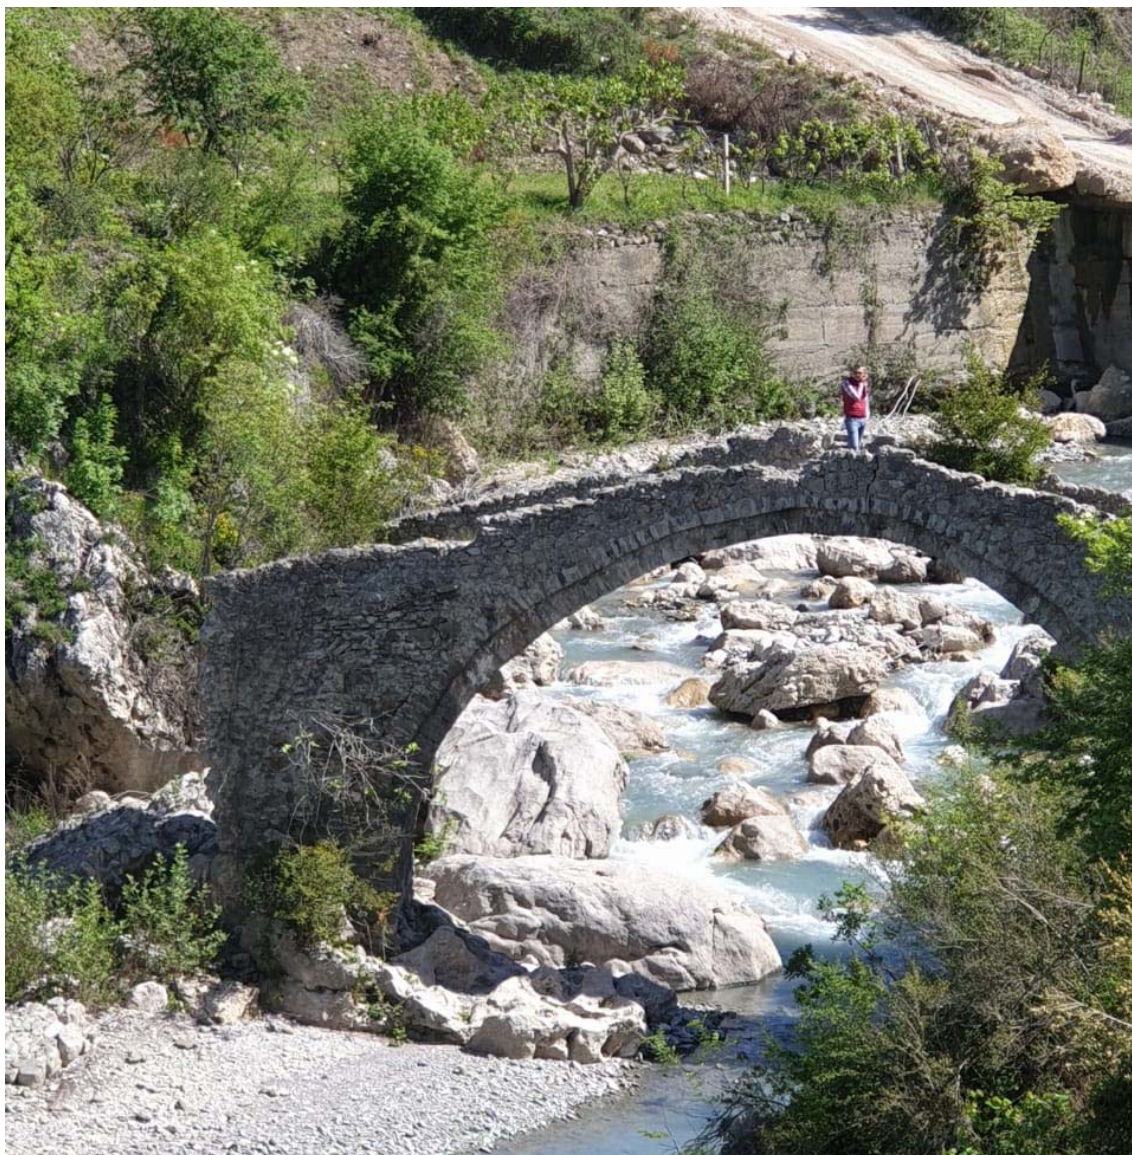
Fig. 10. Photo of the Kurcaj bridge

The cobblestones of the bridge are partially deteriorated and need maintenance, although it can be said that it preserves well the composition and its basic elements. The slope of the cobblestone is at levels 10-20%.

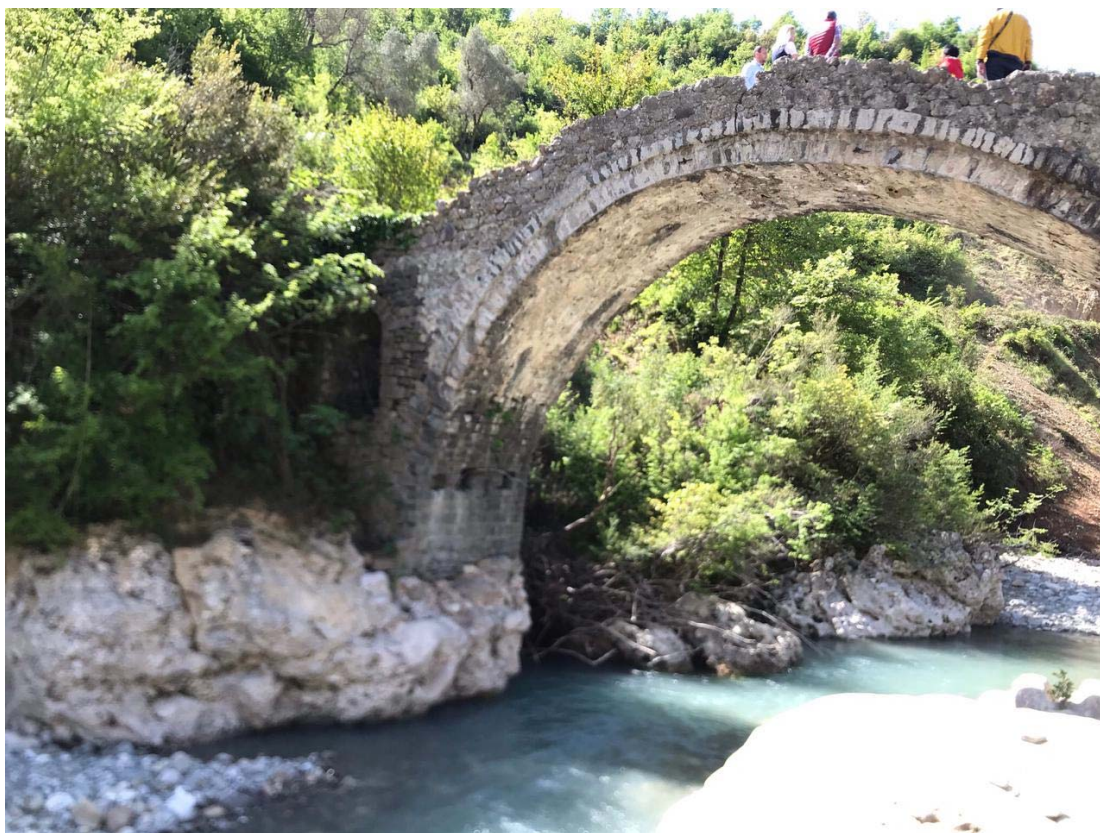
The bridge's pathway's parapet is built with vertical blocks of stone embedded every 0.6-0.7 m in the wall of the bridge with spaces in between, with vertical blocks of the same section supported on cobblestones. The vault is built more carefully than the interior of the vault with carved stone slabs. The front parapets of the retaining walls are built with regular stones that create distinct horizontal joints.

Fig. 11. Photo of the bridge, visible elements: the vault, the right niche, the parapet and the frontal retaining wall.

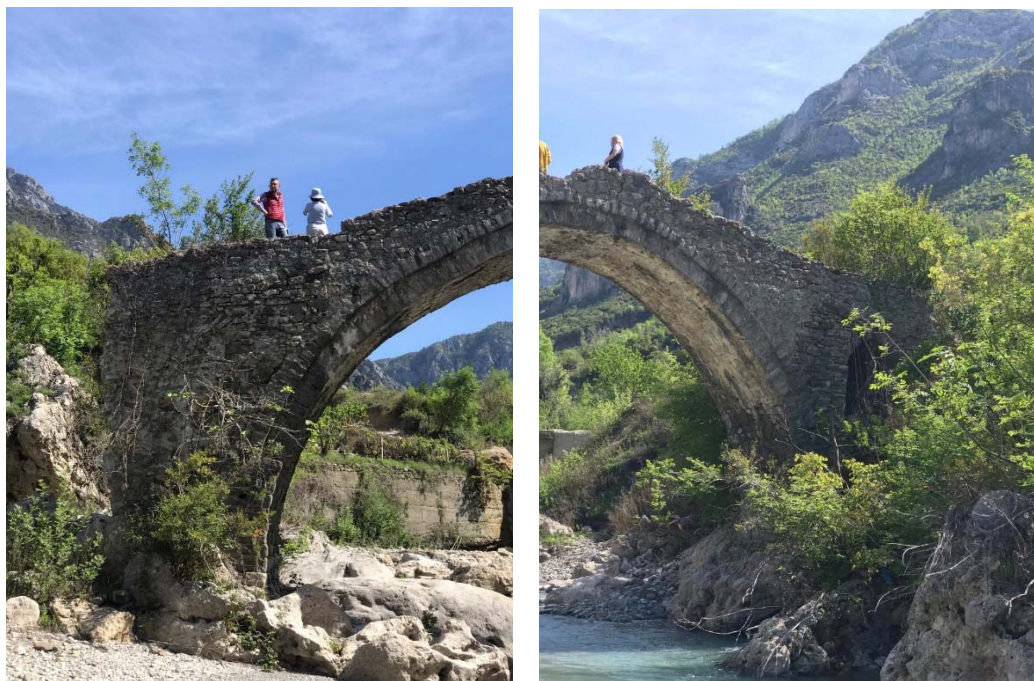
Fig. 12. Photos of the bridge wings.

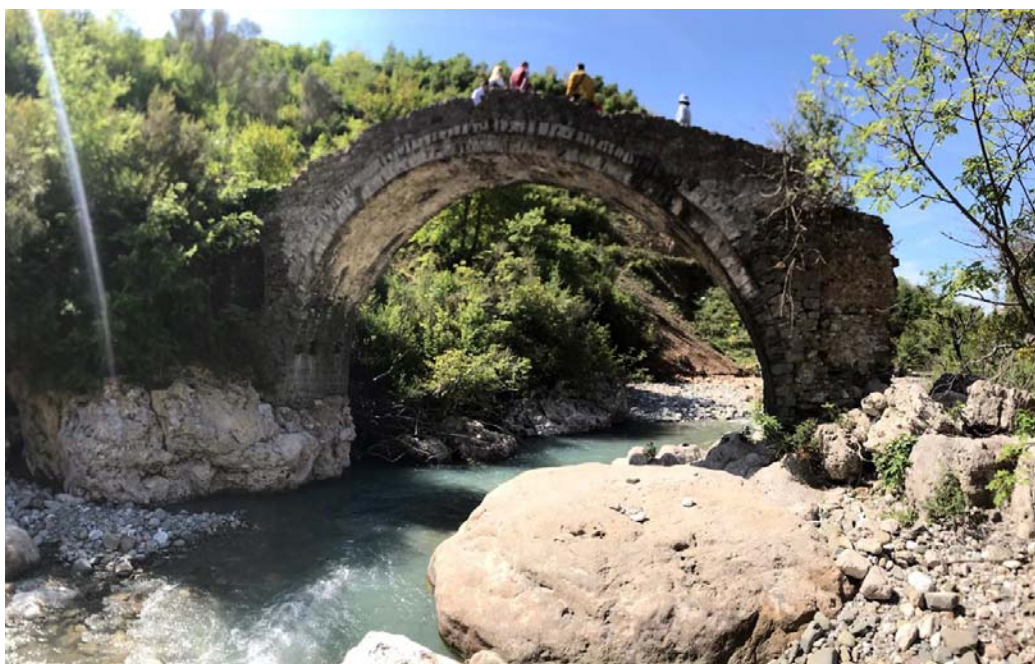
Fig. 13. Photo of the bridge, current condition

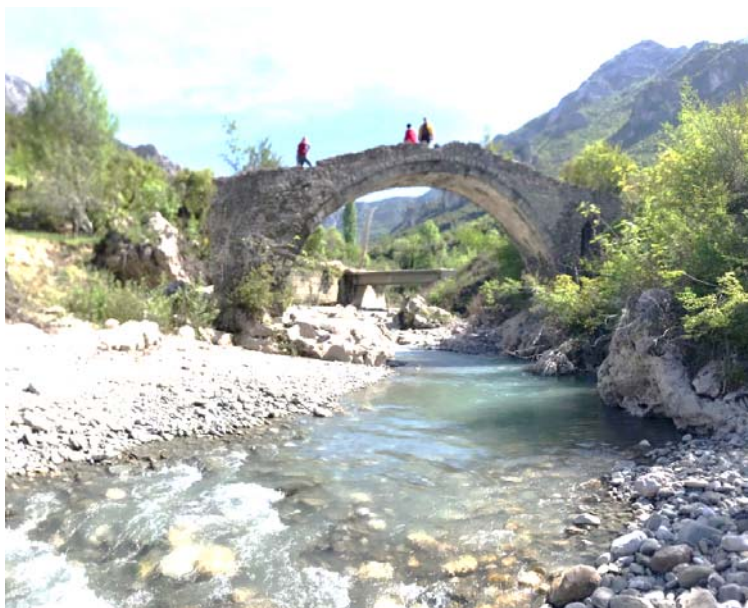
the bridge, as well as the partial the collapse of the bridge parapet. The lime mortar layer has suffered deteriorations which will be explained in further details in the chapters below. LikewiseThe presence of vegetation on the bridge is noticed. Over the years, low and high greenery has sprouted on the cobblestones and on the sides of the bridge. There is a lack of cobblestones in a part of the bridge. There is generally a lack of elements and constant consumption of the material.

Fig. 15. Kurcay Bridge view

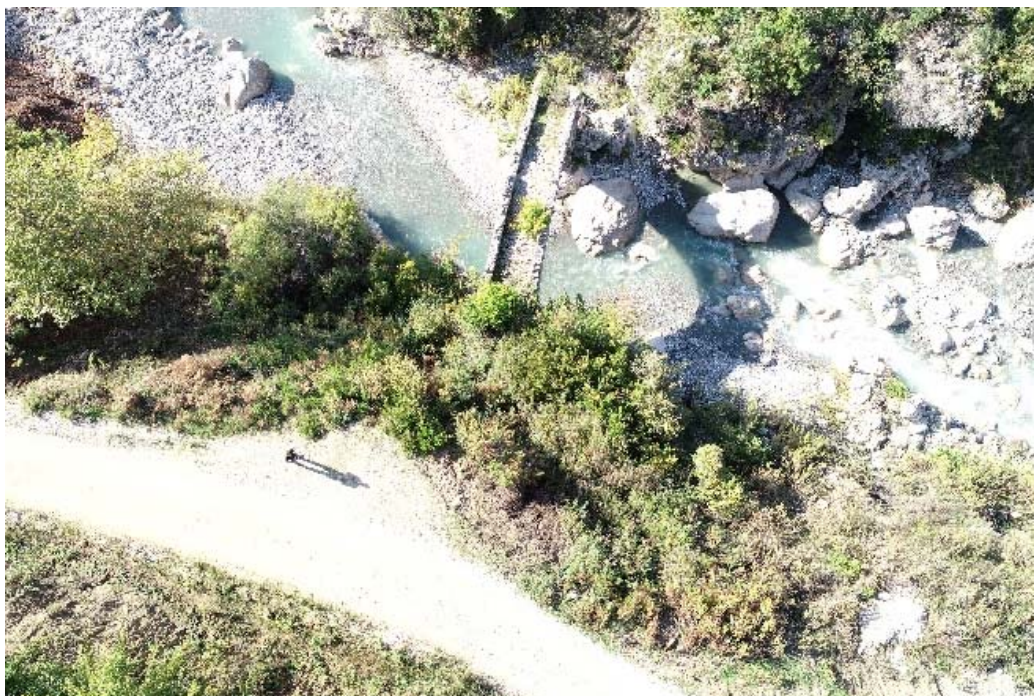
The monument can be accessed by a partially damaged road which makes it difficult to access the bridge without the minimal infrastructural conditions. This is emphasized by the terrain, which also makes it difficult to access.

Fig. 17. The unpaved road that connected the Kurcaj bridge in the south

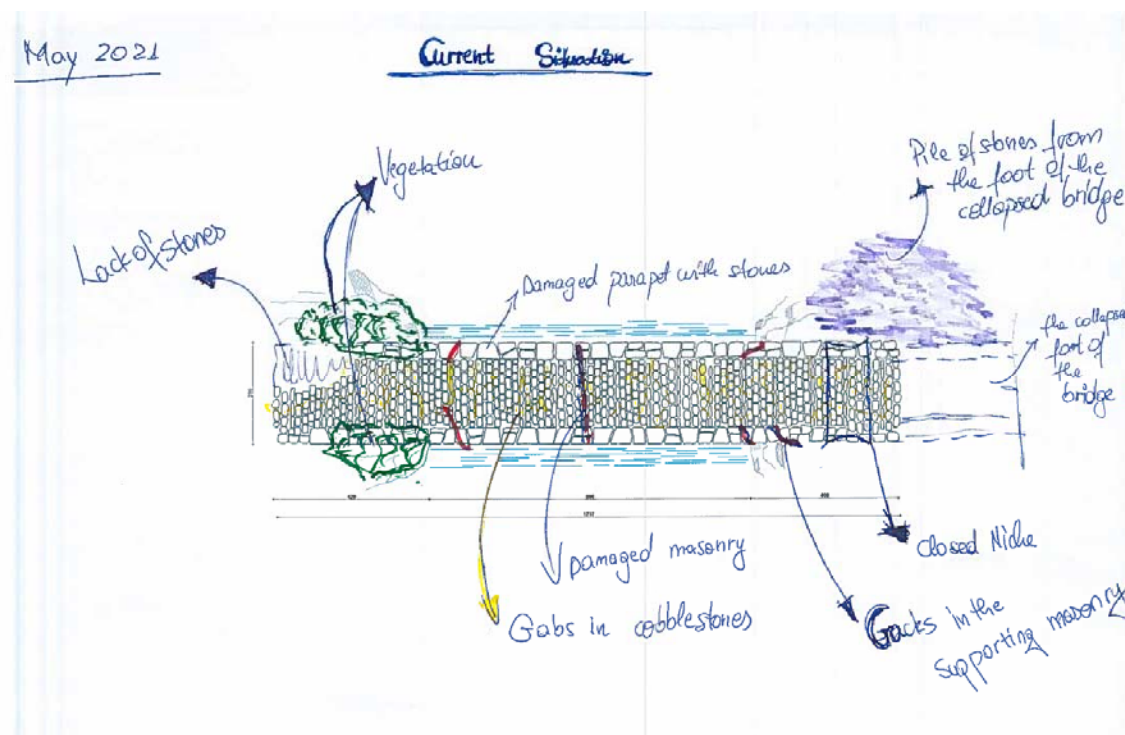
Fig. 19. Current condition of the Kurcaj bridge

The current condition of the bridge (plan wise) is not good due to the deterioration of the cobblestone, the parapet, the presence of low and high vegetation as well as the presence of biological patina. Also, comparing the current plan of the bridge with the plan extracted from the archive, one notices the collapse of the bridge on both its sides. On the left side, 6.11 m of the bridge collapsed and on the right side 0.68 m.

By observing the current condition of the bridge, there have been identified some problems due to the lack of maintenance over the years, the interaction between many agents such as: the atmosphere, the humidity, the river bank activity and the low and high vegetation, which have damaged the foundation of the right wing of the bridge, as well as the front walls and the fillings between them.

The conservation and restoration interventions are related to restoring the bridge to its original state of construction. As it was found in the analysis of the existing condition, a part of the bridge has collapsed and will be rebuilt implementing traditional techniques, using traditional materials such as local stones and hydraulic lime mortar. The 6.11 m bridge on the left side and 0.68 m on the right side will be rebuilt.

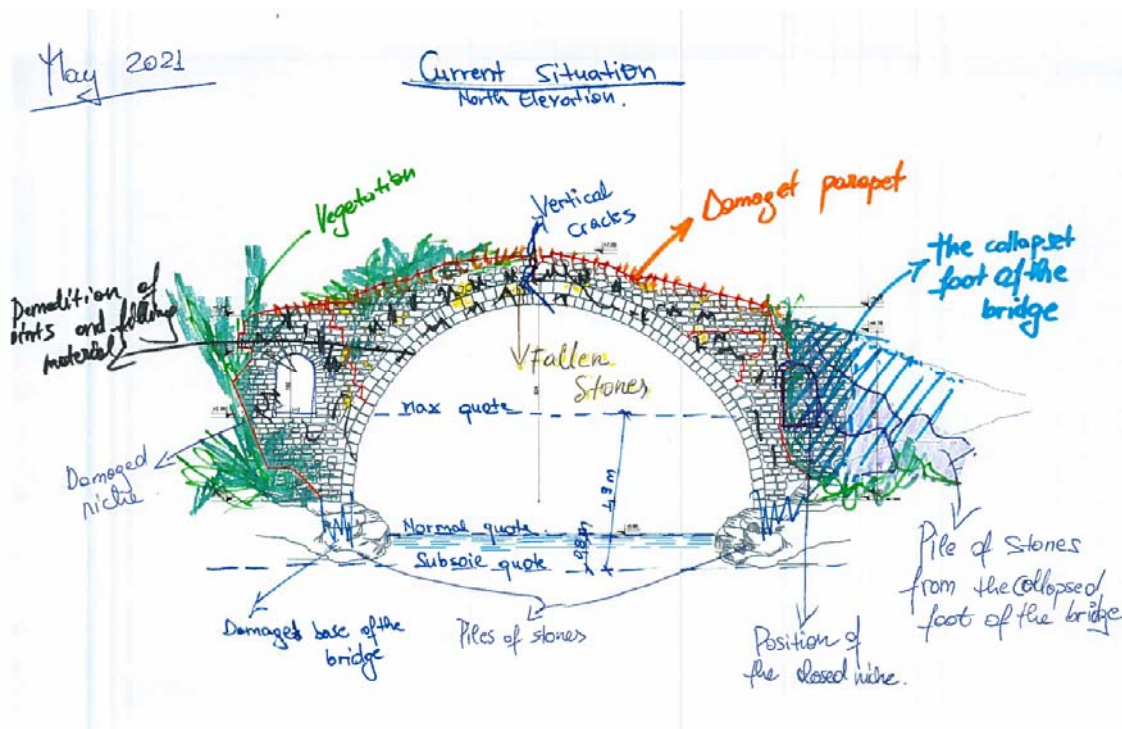
Fig. 24. Current Condition of the Bridge

The presence of moisture is noticed especially in the vault of the bridge. Decomposition of joints and filler material is observed on almost the entire surface of the bridge. In the upper parts on both sides of the bridge there is the presence of cement mortar in the joints between the stones, which is an unsuitable material for the bridge.

During the site visit, few cracks were found in the walls of the bridge and in the vault, as well as partial collapse of the walls or detachment of the integrity of the elements.

Damage to the building has come mainly as a result of successive degradations over time. Major events such as earthquakes, floods, etc. have contributed to the aggravation of the existing situation.

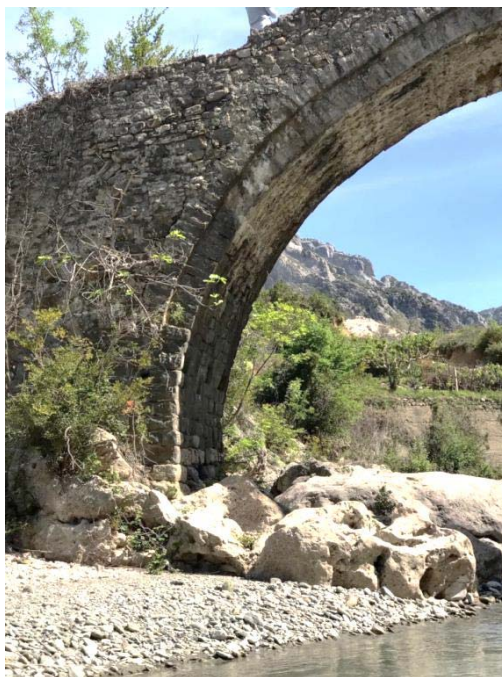
Fig. 25. The left arm of the bridge rests on the stone foundations

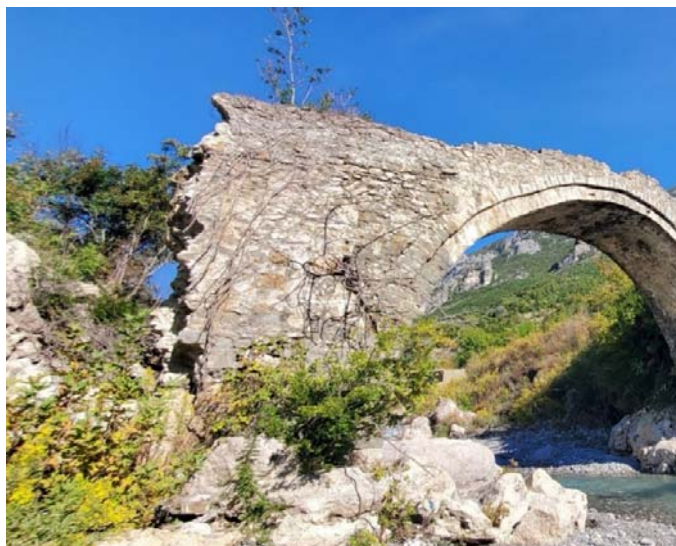
Fig. 30. The right wing of the bridge over the sole of the Black River

Based on the data obtained at the site of the facility, river inflows have caused damage to the bridge foundation. It is proposed to place on both sides of the bridge, without compromising the integrity of the monument, on its right side, protective stone walls.
