# THE ARCHITECTURAL REPORT HAMMAM, DURRËS

**22644-001\_ALB\_EU4C\_RFP\_01 - "Provision of Consultancy for Design services for EU4CULTURE Project - Support for revitalization of cultural heritage sites and monuments affected by Earthquake in Albania."**

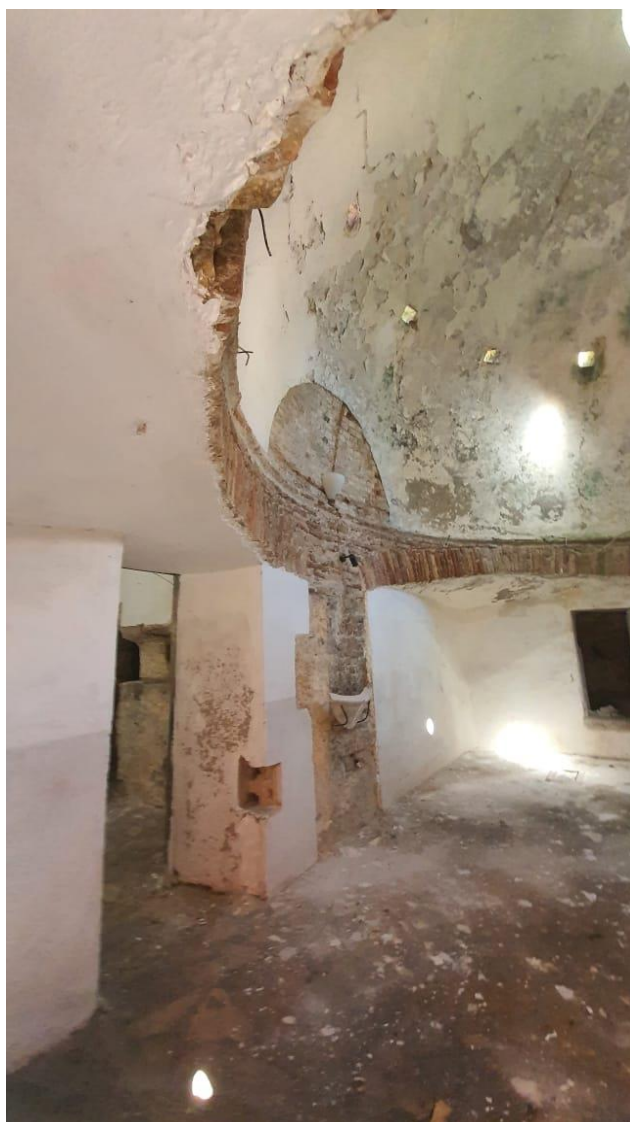
*Figure 21. Photo of the entrance environment, existing condition*

- In the first room (the waiting room), there is plaster masonry, a layer of degraded cement and openings in the floor where the pipes that transmit heat between the rooms (intermediate room and hot room) are distinguished.

- The openings in the Living Room floor will be stored, cleaned and highlighted (glazed) in order to bring back images from the past of the hammam.
- The dome will be restored, will be replaced with Shamot insulating mortar according to the original.

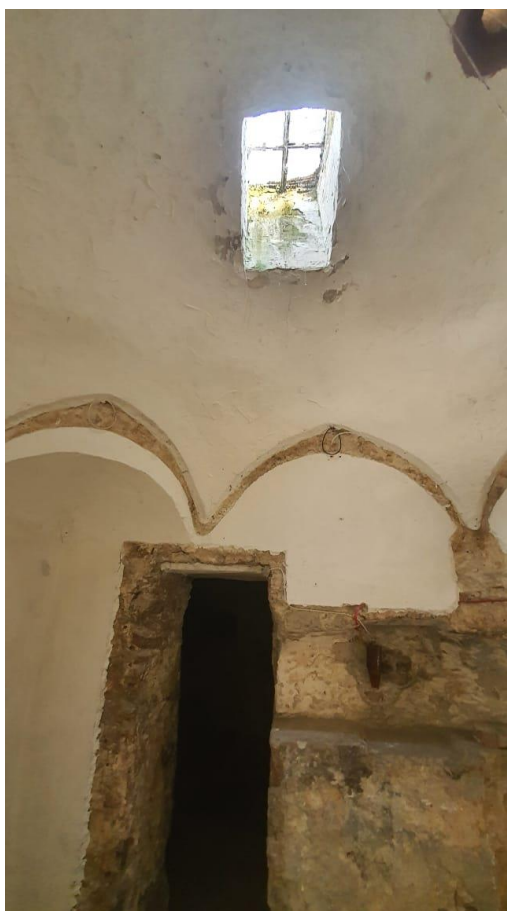
Figure 22. Photos of the intermediate environment, current state

- In the intermediate environment there are problems such as: degraded cement layer, plaster masonry and non-original wooden windows in the north façade (as mentioned above, there are subsequent unintentional interventions).

- Glass globes for lighting and ventilation chimneys will be replaced according to the original model
- Doors and windows will be replaced according to the original model with wooden material.

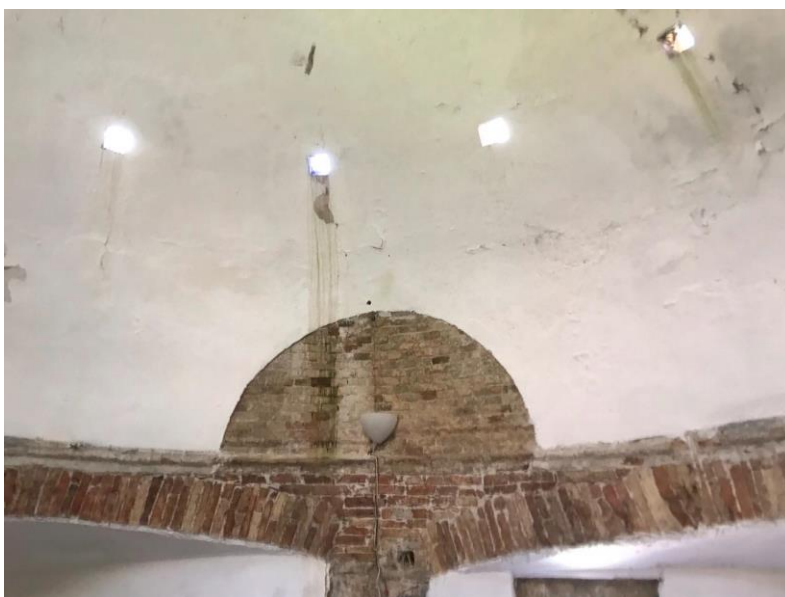
*Figure 25. Stone masonry combined with brick in the waiting room of the hammam, the current condition*

- Removal of plaster skating of stone masonry, restoring the wall and joints.
- It is important to build a drainage system as a solution for excess moisture present in the hammam.

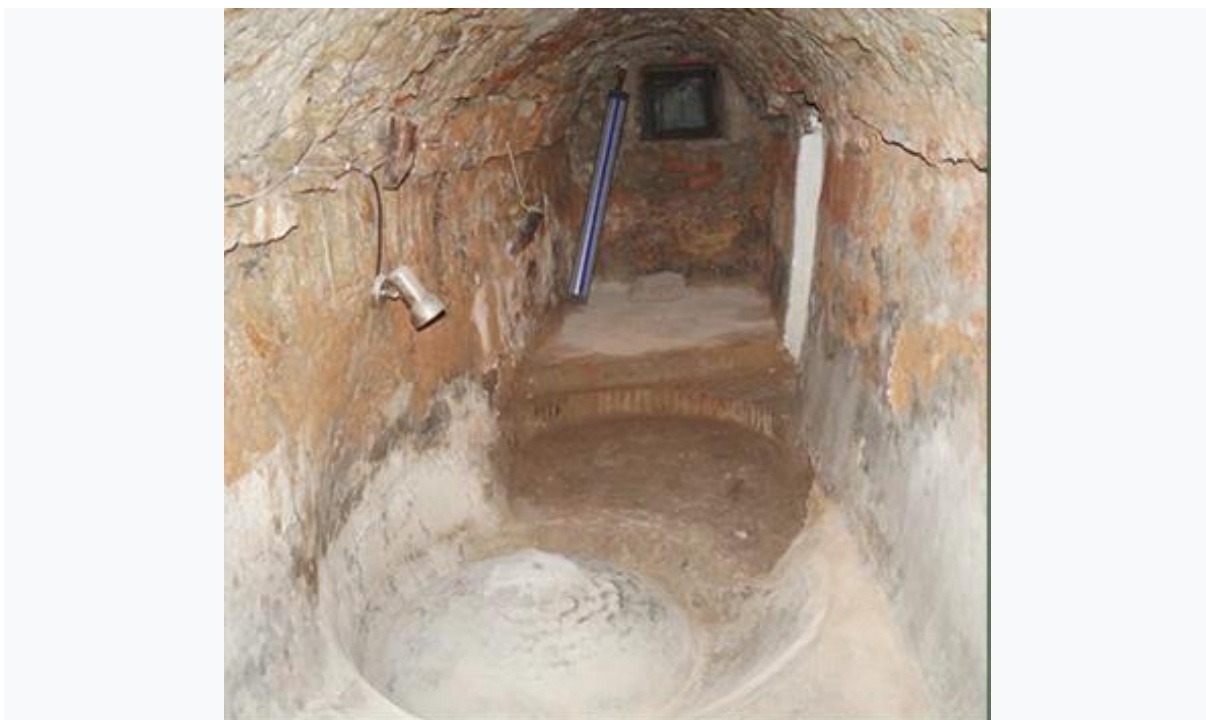
*Figure 26. Stone masonry, present in the hammam stere, current condition.*

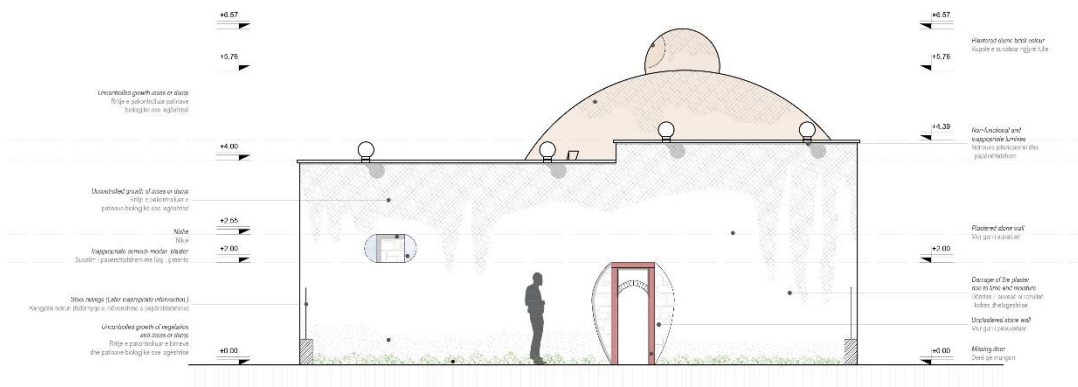
Figure 27. Existing Condition, West Facade

- o Mold and moisture : especially in the upper part of the hammam. This is due to the moisture present in almost the entire structure of the hammam. Moisture is present along the walls and in the vicinity of the floors.
- o Cracks in the stone masonry, as a result of its depreciation over time.
- o Moisture problems arising from lack of drainage or improper realization.
- o The growth of vegetation on the walls, windows and in the dome, blocking the view while at the same time damaging the walls. This is due to lack of maintainance for a long time, as well
