ARCHITECTURAL REPORT THE ARCHEOLOGICAL MUSEUM OF DURRËS

22644-001_ALB_EU4C_RFP_01 - "Provision of Consultancy for Design services for EU4CULTURE Project - Support for revitalization of cultural heritage sites and monuments affected by Earthquake in Albania."

REPUBLIKA E SHQIPËRIË
MINISTRIA E KULTURËS

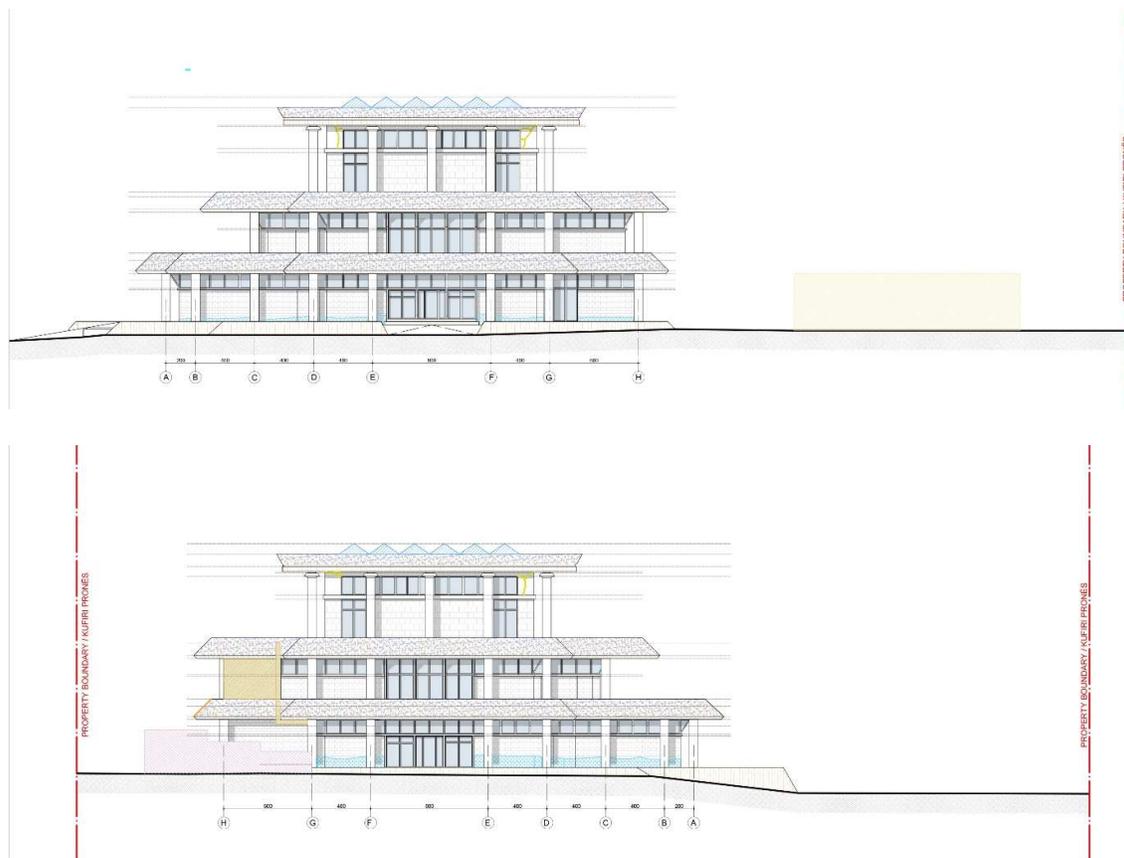
Fig. 19: The Southeastern and Northwestern facades of the museum, Current Condition

- Granite marble tiles from Saranda, of local material, preserved for the most part according to the authentic model. There are several relatively small areas of the facades which display cracks or

shattered/missing tiles. Wherever subsequent interventions have been made (volume additions to cover the mechanical equipments and pipes in the northwestern facade or the visible rainwater drainage pipes in the verandas' floors) there is a difference in the material which has not been preserved according to the original, however appears to be an imitation of the former.

- Cement-based plaster as a finishing layer of the perimetral walls and acrylic plaster finish on the columns. Both have been observed to have suffered the phenomena of efflorescence: caused by the continuous presence of moisture, appearing as patches formed on surfaces of the walls, ceilings, floors etc. It may result in disintegration of the finishing layers off of the surface visible as well as structural deterioration due to the earthquake or damage/ detachment of the plaster finish, likely due to movement or as a result of external factors like impact or damp. Over time it has delaminated or become detached from the surface beneath.

- Concrete balconies that demonstrate the presence of the biological patina: the phenomena of the coloristic and chemical alteration of the building's external surfaces as a result of physico-chemical reactions caused by climatic factors and inorganic pollution.

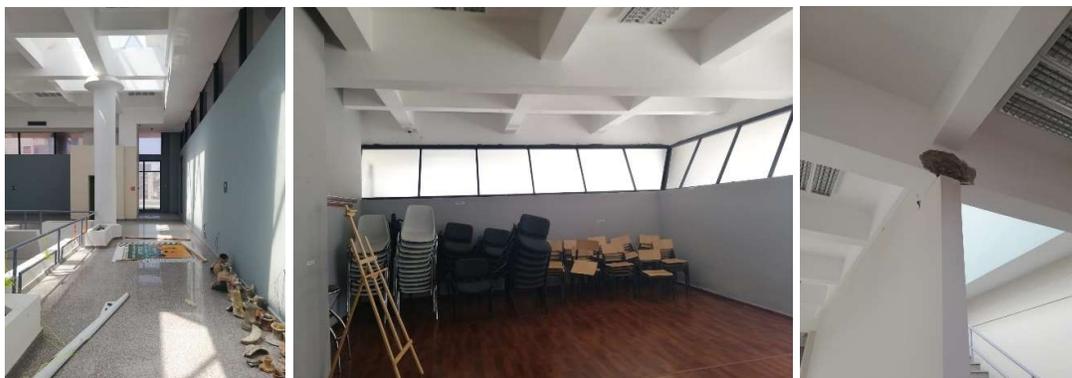
Fig. 21: Materials present in the interior of the museum

- Granite marble tiles on the floors of the museum as well as finishing layer in the stairs. The material is authentic, preserved according to the original model. Several tiles are missing in front of the elevator on the ground floor. The rest are shattered or missing due to the weight of the artifacts, (most of them being heavy), which appears to not have been evenly distributed on the floor surface.

- Gres tiles on the floors and walls of the toilets.
 - Concrete tiles as veranda cladding. Moss is visible on the joints as a result of the moisture.
 - Concrete slabs in the site, where moss is also visible on the joints as a result of the moisture.
- Meanwhile, the interior walls and the ceilings are covered with cement mortar-based plaster and painted with white paint.

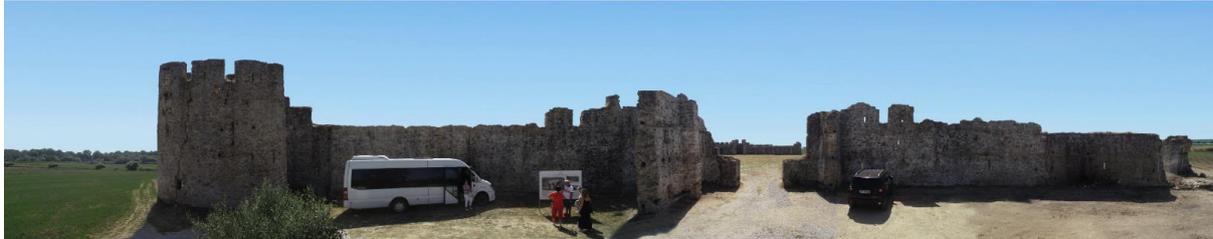
On the north-western interior façade, some of the arches are missing. Additionally, a considerable part of the masonry is detached from the walls' structure. There is moisture along the entire façade, while at the bottom, there is vegetation. The stairs that lead to battlements are damaged and in some cases there are no stairs, making it difficult to climb the walls. The battlements' structure is missing along the entire length of the walls. On the outside of the wall some structural cracks can be also noticed.

Fig. 23: The exterior North-Western View (Current Condition)

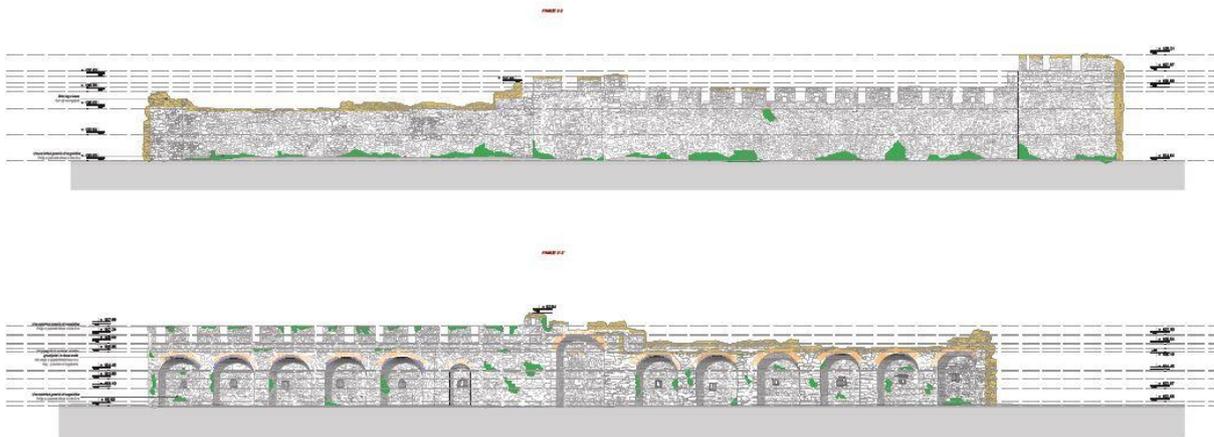
The South-Eastern façade is the most problematic one, as it has the highest presence of moisture and vegetation. The arch near the tower has structural cracks along with the interior of the square tower. Besides, the bottom of the facade is damaged. Moreover, in this facade we have encountered battlements' structures missing. On the exterior, the South-Eastern facade presents structural problems at part of the square tower where we notice several cracks.

Fig. 24: The South-Eastern Wall (Current Condition)

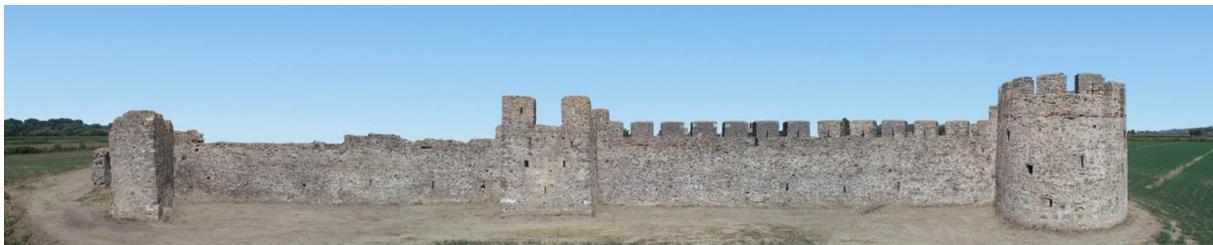
Fig. 25: The exterior South-Eastern View (Current Condition)

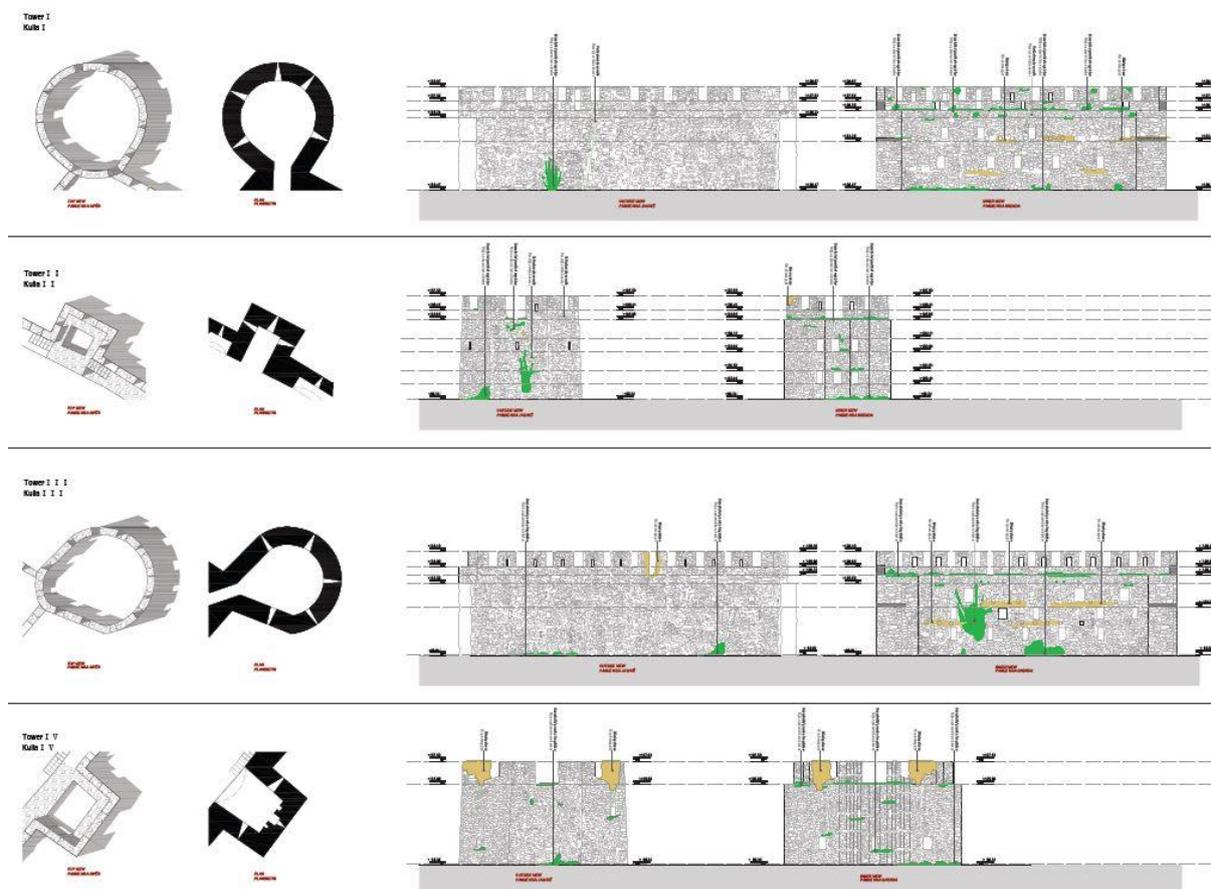
Fig. 26: The towers of the Bashtova Castle (Current Condition)

The tower at the main entrance (the circular tower at the main entrance) has deep structural cracks, the presence of vegetation on the facade, damage to the head of the wall and the bonding material of the stones.

In the circular tower connecting the South-Eastern and North-Eastern façades, the same as in the main entrance, have been encountered several vertical structural cracks, lack of wall structure, deterioration of the wall head and the bonding material in the joints.

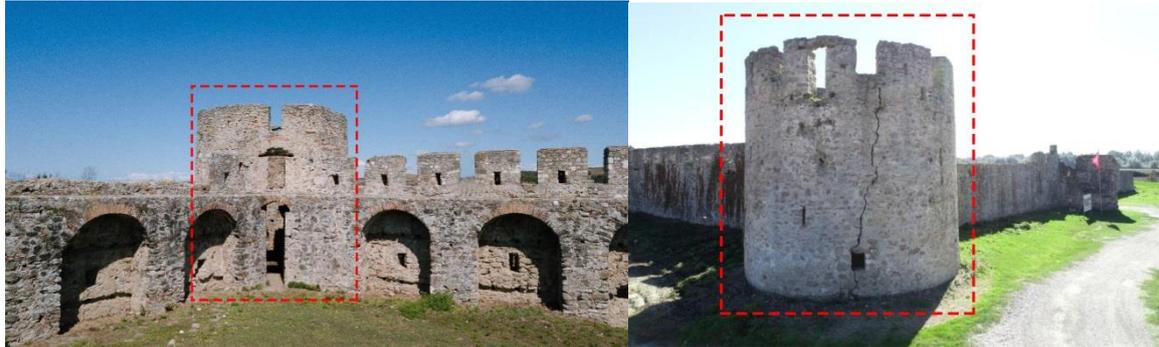
Fig. 27: The Tower I (Current Condition)

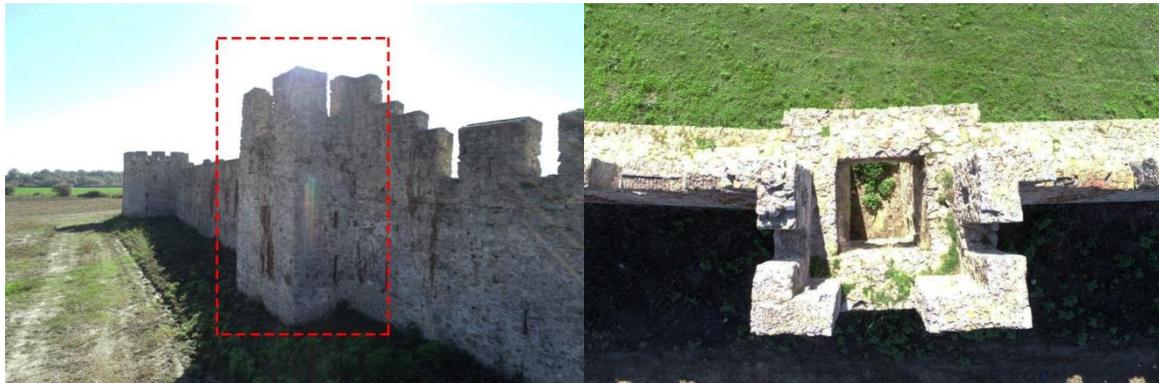
Fig. 28: The Tower II (Current Condition)

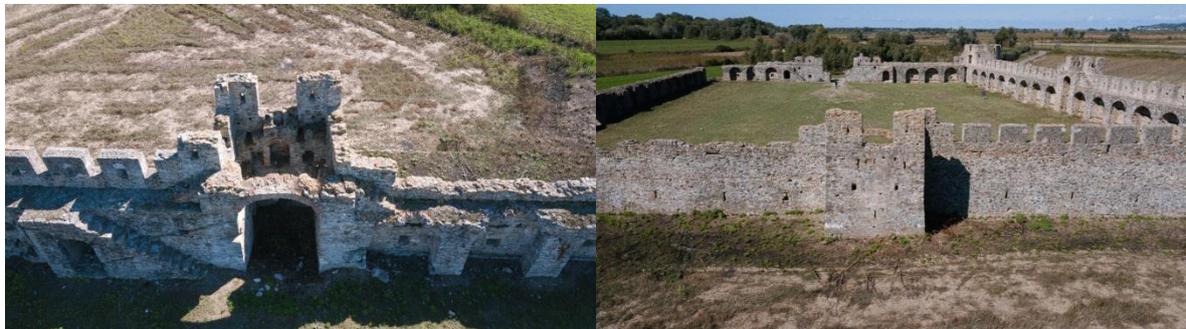
Fig. 29: The Tower IV (Current Condition)
