UNICEF FAIL-SAFE DESIGN

BUILDING PLAN "FAIL-SAFE" LOW COST TOILET

MULTIPLE HAND WASHING STATION

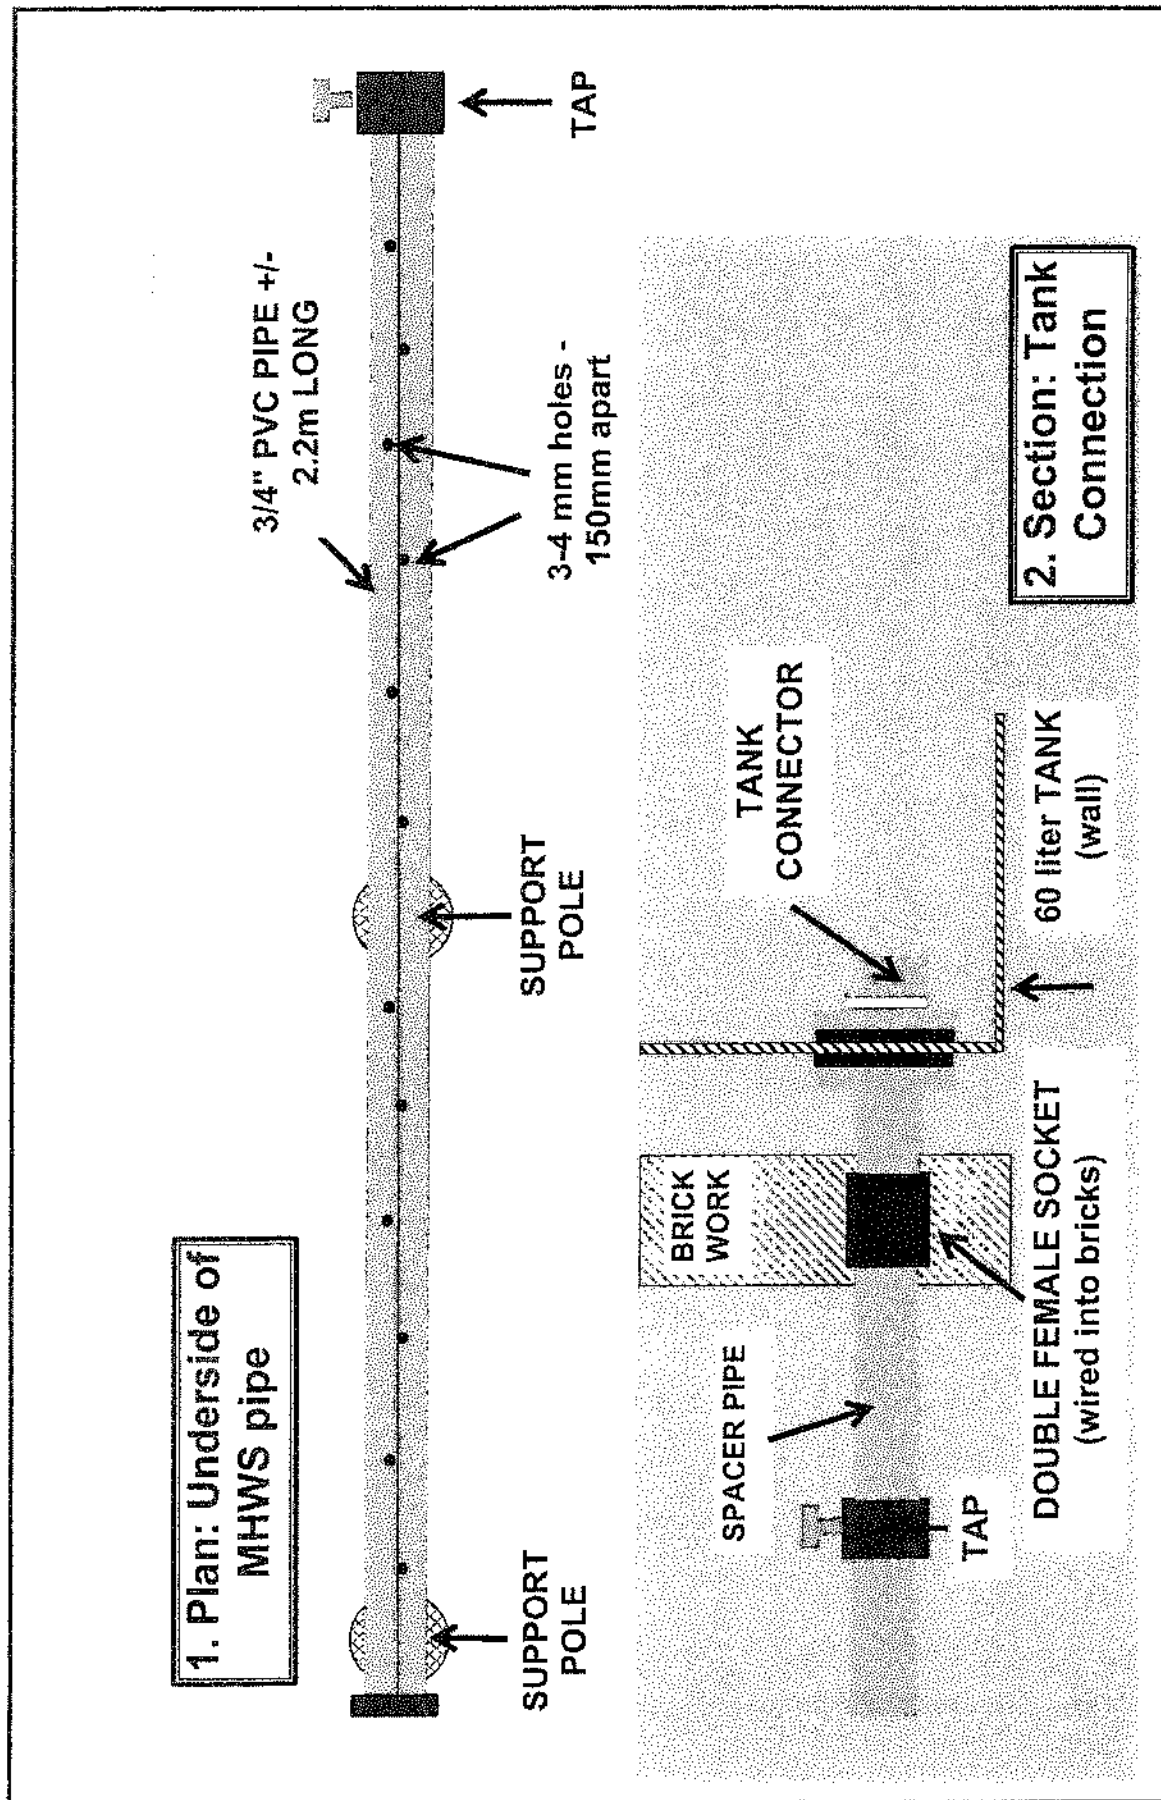
PIPE UNDERSIDE ZOOM IN

MASS HAND WASHING STATION PIPE, FITTINGS AND HOLE POSITIONS
