Notice to Bidders - III:

Title: BEI/ITB/24/26-Invitation to Bid for the Restoration of the east and west lateral elevations of the Sursock Palace

Subject: Response to Bidder's Request for Clarification and Extension of Bid submission Deadline

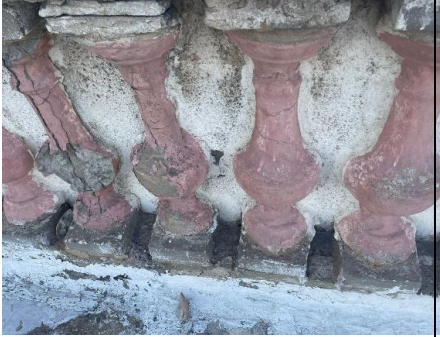
<u>Question #</u>	<u>Questions</u>	<u>Photos</u>	<u>UNESCO Response to bidder's "Request for Clarification"</u>
1	As shown in picture, the roof balustrade at east facade has been closed maybe to cover behind technical areas, the replacement of concrete balustrade may affect the closure, and the fibre covering from roof side, is works related to roof closure included in the maintaining and restoration of concrete Balustrade?

The roof parapet and its waterproofing system from internal side falls under the scope of another project already assigned to another contractor mobilized on site. It's the duty of the awarded bidder to schedule and coordinate the restoration of altered balustrade bollards with the other contractor to the consultant approval. For the moment bidders shall price the restoration of the altered bollards only as well as the parapet from external side as existing. If after investigations during works the consultant and the owners requested reopening this parapet and replacing all the apparently half shaped bollards by full bollards this will be covered as necessary by BOQ Provisional Sum item: 1.5-Provisional works.

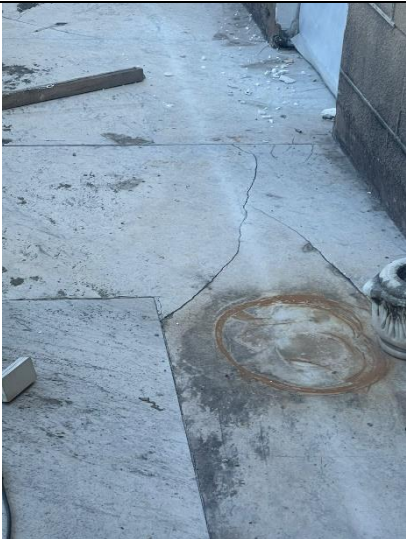
2	The Marble Slab laying on corbels has cracks and breaks in some areas, as restoration, in old historical buildings this is embedded in the external wall (depth is at least 3-4 cm), it is required to remove and insert new marble slab or only restoration of existing marble?

BOQ item 9632.0: "Restoring of white Carrara Marble Slab, include removal and replacing of heavily deteriorated pieces". However, we do not foresee for the moment any full replacement of marble slabs. Restoration of existing marble slabs is required using stainless steel plates to stitch the cracked parts all together. Whenever after investigation during works a piece can't be stitched, replacement of slab will be considered by consultant and only the supply of new similar marble slab shall be covered as necessary by BOQ Provisional Sum item: 1.5 -Provisional works.
3	In such cases, patching the Carrara is accepted or new column base to be inserted?
