Annex E - Yatta Assessment Report

Yatta Water Supply Project (YWSP) Phase 1

Technical Assessment Report

Universal Group for Engineering and Consulting
Main Office: Nablus
Tel.: +972 (09) 238 3281/2
Fax: +972 (09) 238 3280

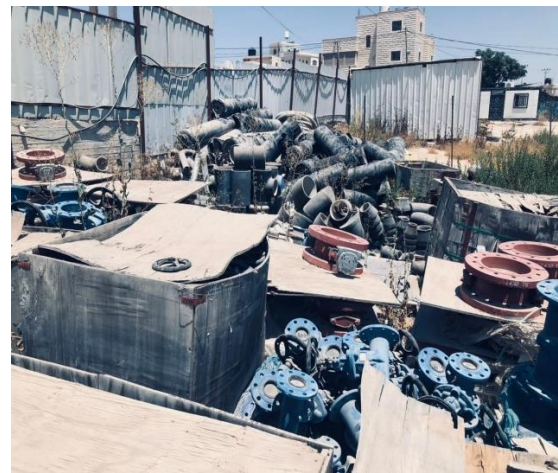
More Valves stored in un-appropriate way

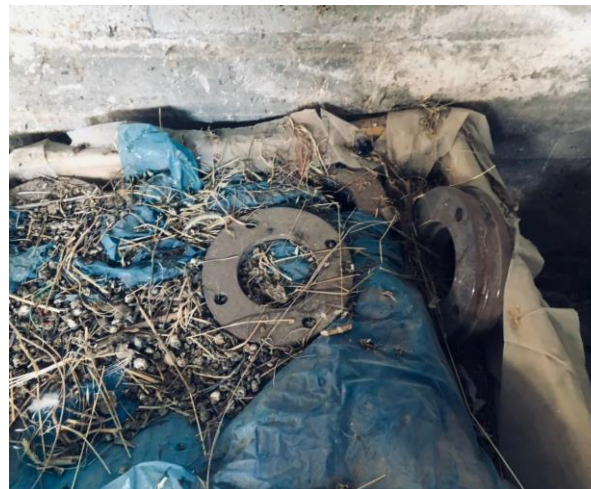
Cleaning is required

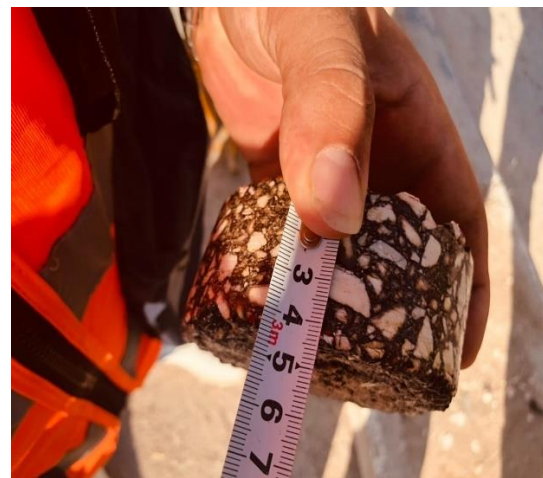
Core Test for Asphalt #1 – 4.40 cm

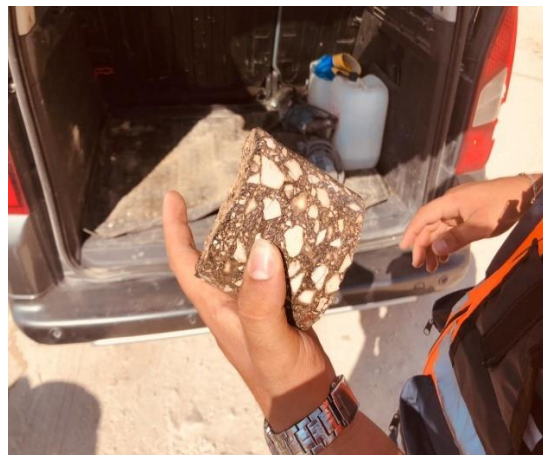
Core Test for Asphalt #10 – 7.10 cm

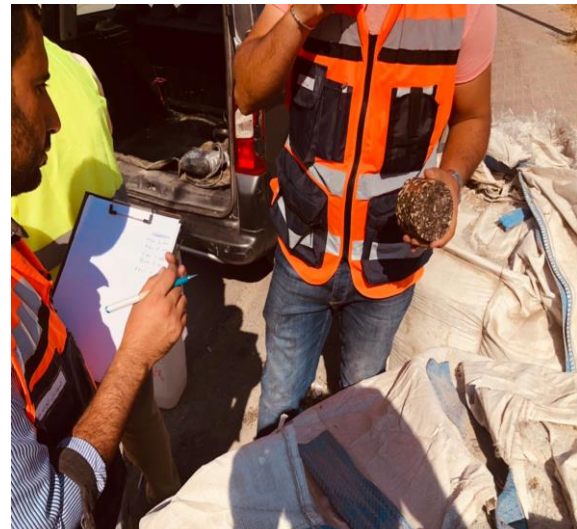
Core Test for Asphalt #30 – 8.20 cm

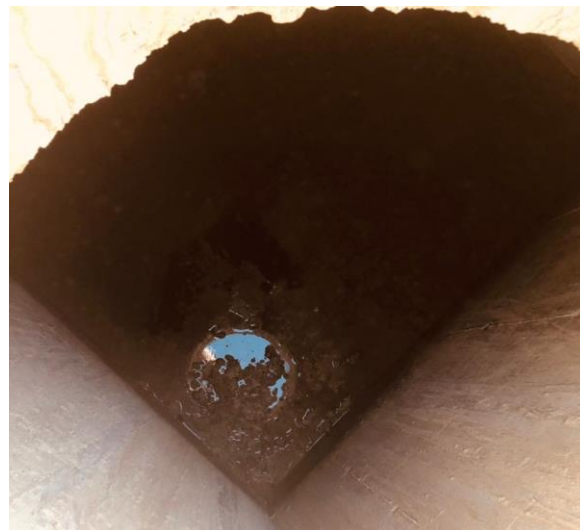
Some manholes were full of mud and water

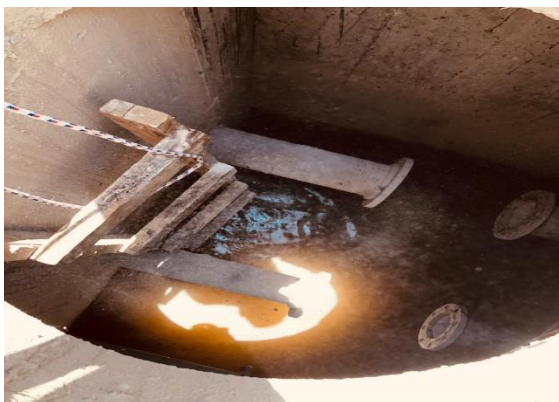
More manholes were full of mud and water

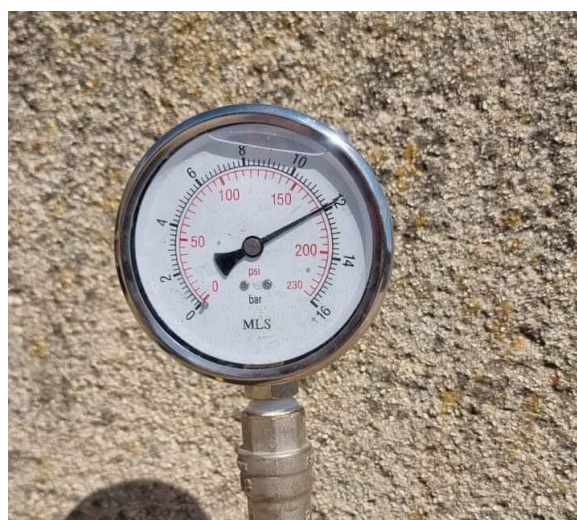
Pressure Test No. 1: 11.9 bar. reading after the pressure test.

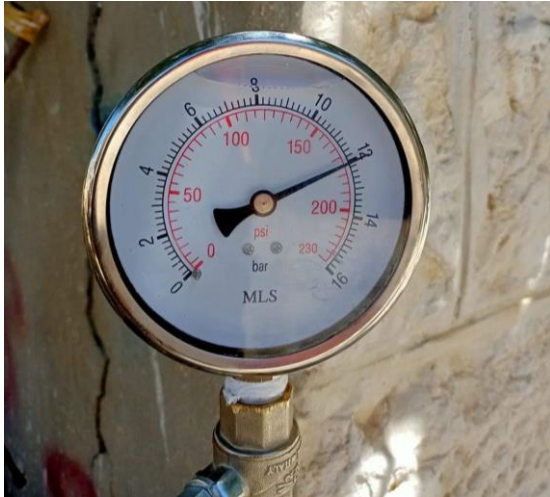
Pressure Test No. 2: 12.0 bar reading once pressurized

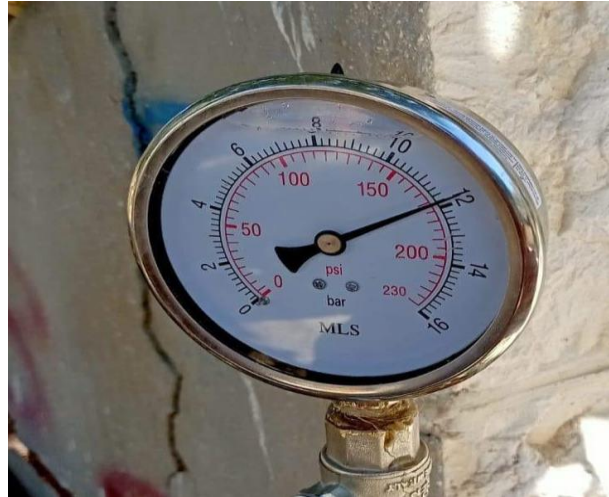
Pressure Test No. 1: 11.9 bar. reading after the pressure test.

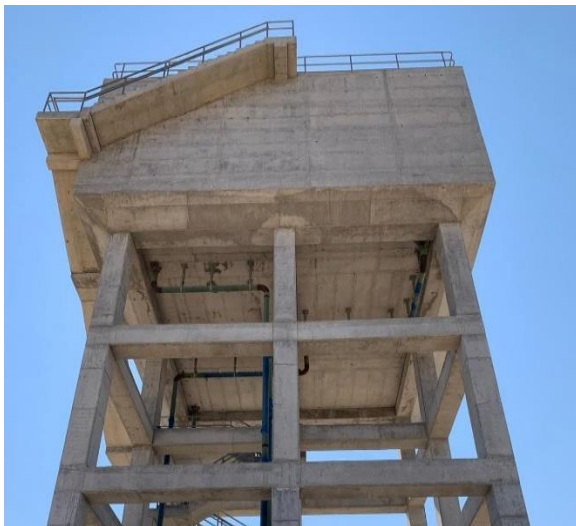
The body of the tank is not painted. The tie rods locations must be treated.

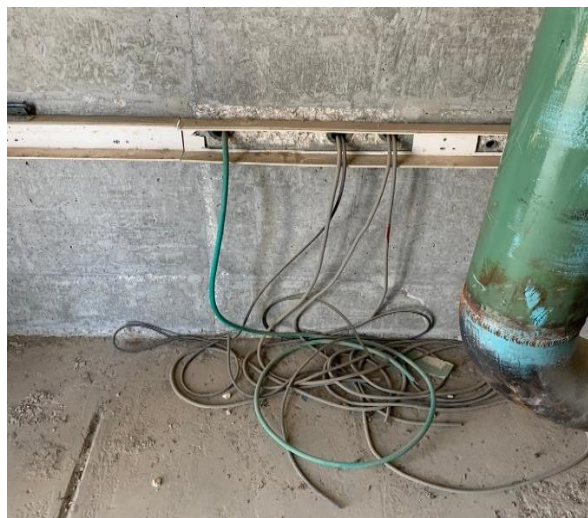
Electrical and SCADA works are not complete

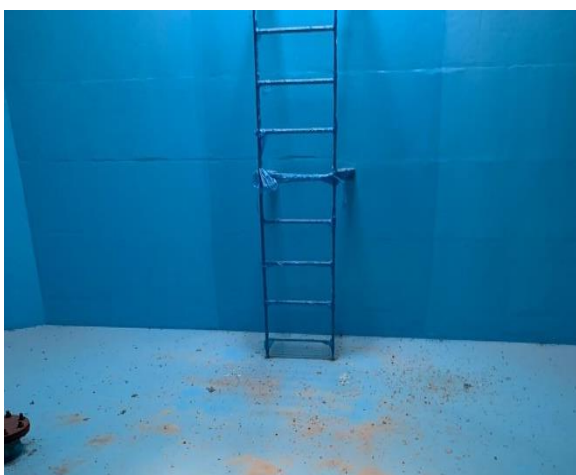
Tank is Epoxy coated from inside but need to improve its tightness

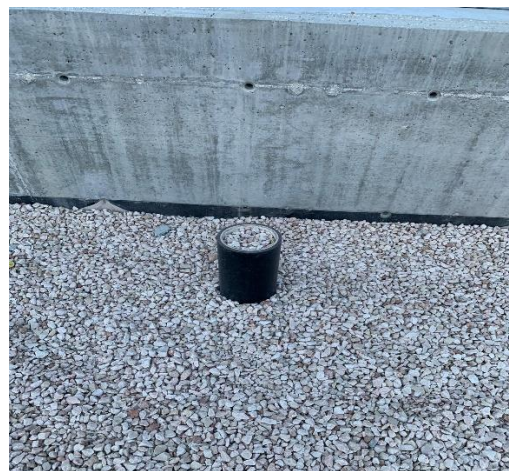
Not presented in the as built Drawings

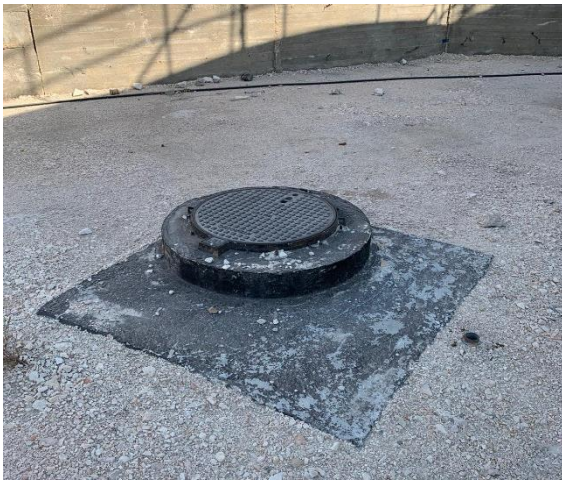
Reservoir yard level is not reached. Additional layers are required
